Town of Maynard, Massachusetts Building Observation Report

AECOM Technical Service Inc.
66 Long Wharf, 3rd Flr.
Boston, MA 02110
(617) 723-1700

December 2010

Executive Summary

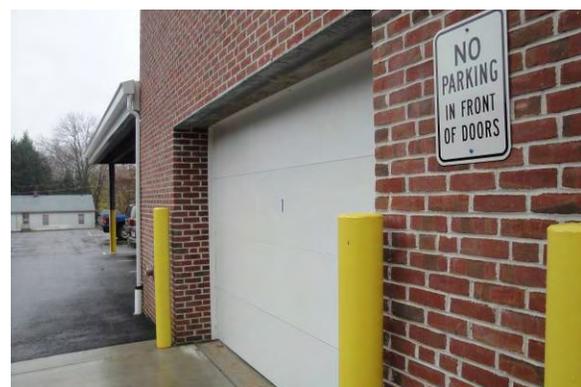
Figure 2.04 – Sectional Overhead Doors

The Police Department also has insulated metal sectional overhead doors at the vehicle bays / sally port (figure 2.04).

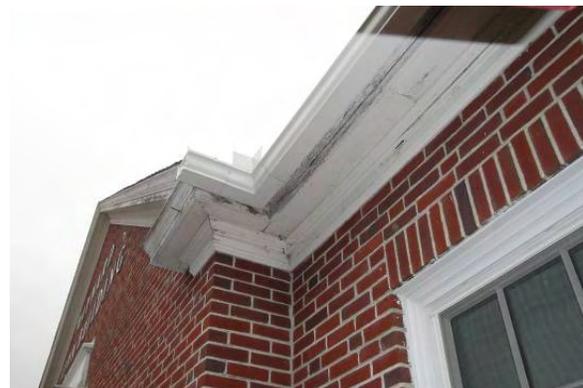
Figure 2.18 – Exterior Trim

The paint finish at the wood soffit and gable trim also appears to be weathered and sections are currently peeling (figure 2.18)

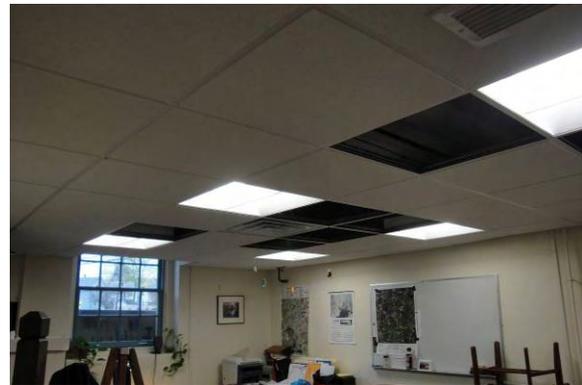
Figure 2.50 – Recessed Light Fixture

The office areas have recessed 2' x 2' recessed fluorescent light fixtures (figure 2.50).

Most of the lights appear to be in good condition and functioning well. There are a few fixtures that appear to have lamps (bulbs) in need of replacement.

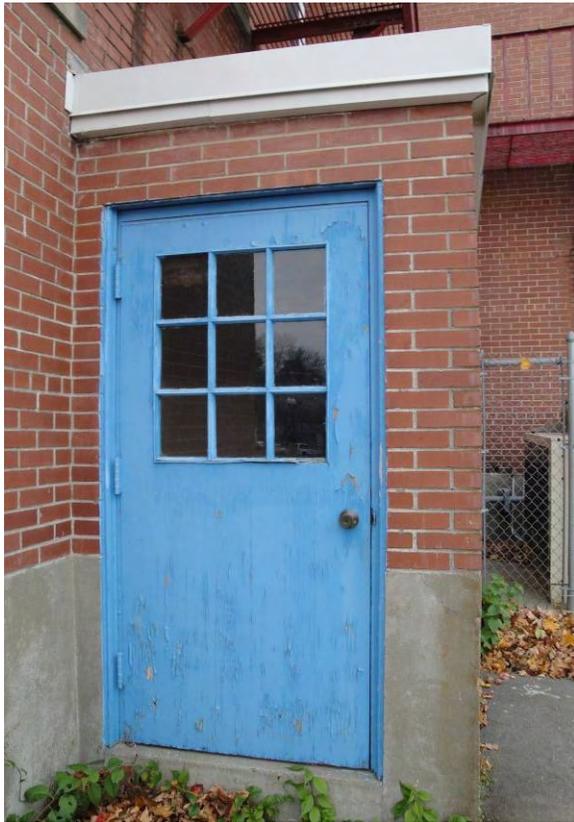
Figure 3.12 – Basement Door

The painted wood door and frame at the basement entrance is in poor condition. The paint finish appears weathered and some sections of the paint are peeling off. Also, there is a section of the glazing trim missing from the door (figure 3.13).

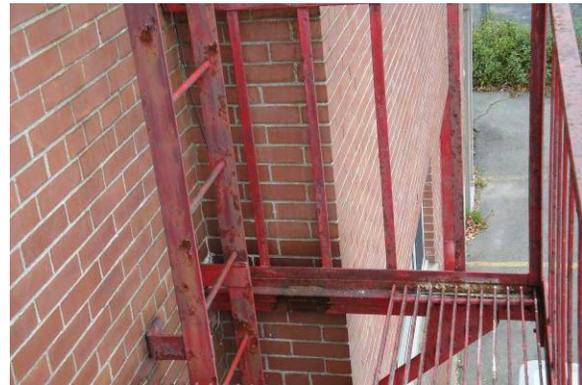
Figure 3.14 – Fire Escape

The fire escape/ladder system appears rusty and there are sections of the paint finish that are peeling off (figure 3.14).

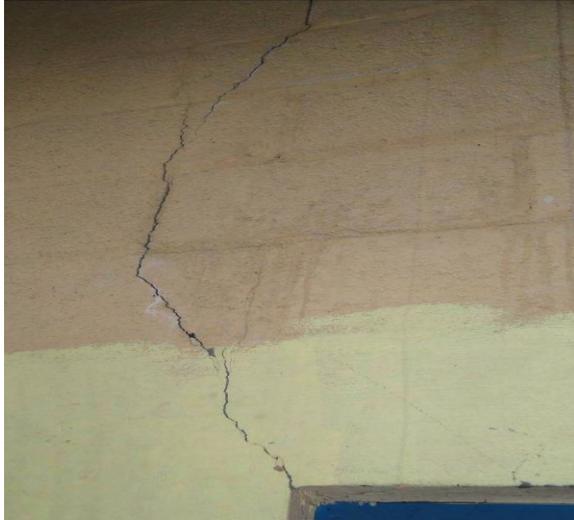
Figure 3.28 – Cracks in CMU Wall

There are cracks in the CMU walls surrounding the basement stair. Further investigation may be required to determine if these cracks are related to stress cracking and/or settlement cracking (figure 3.28).

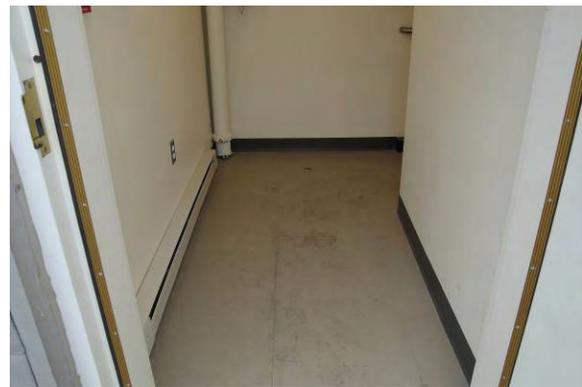
Figure 4.25 – VCT Tile at South Stair

The VCT at the south stair appears to be stained and worn, which may have been caused from water from the roof. Further investigation may be required (figure 4.25).

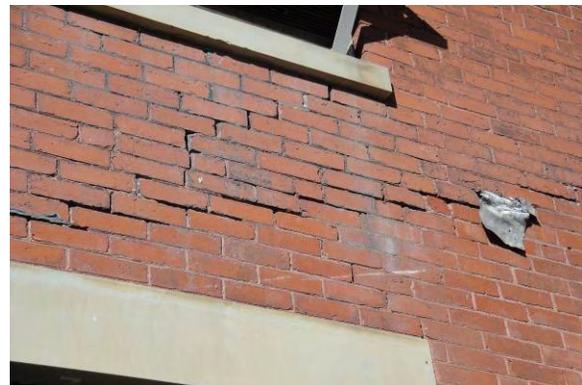
Figure 5.11 – Brick Mortar Joints

The exterior brick walls appear to be in fair condition. The mortar appears to be aging and weathered. There are several areas where the mortar appears deteriorated, loose, and/or cracked (figure 5.11). The brick at the corners display significant amount of deterioration as well.

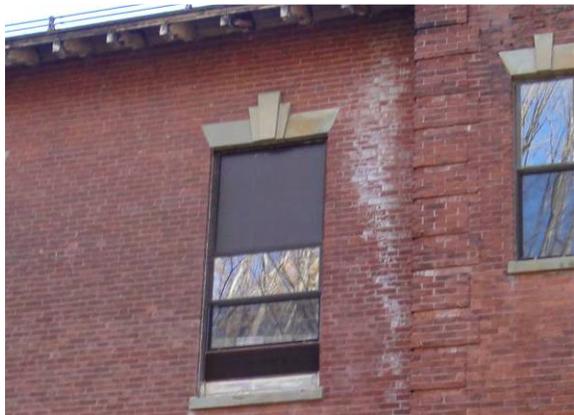
Figure 5.12 – Efflorescence in the Brick

patches), which indicates water penetration through the exterior wall (figure 5.12). Further investigation may be required to confirm where/how the water is penetrating the wall.

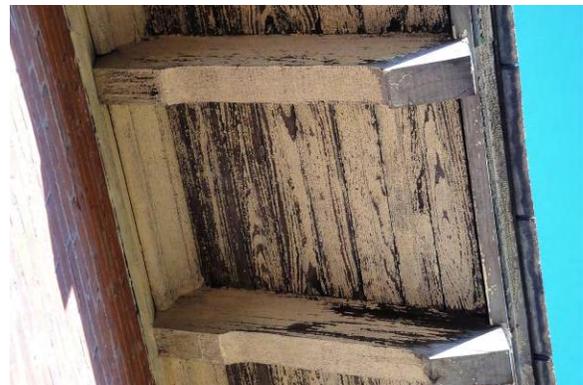
Figure 5.19 – Roof Overhang

The underside of the roof overhang is painted wood, and the paint finish appears weathered and sections are peeling. Further investigation may be required to determine if there are any rotted and/or loose sections of wood, molding, or trim (figure 5.19).

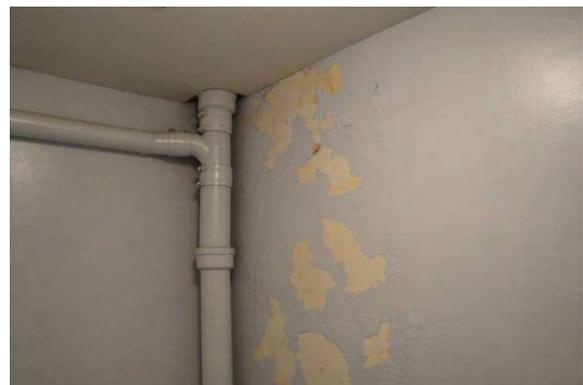
Figure 5.36 – Chipped Paint

There are other plaster walls where the paint finish has chipped of and sections of paint are missing (figure 5.36).

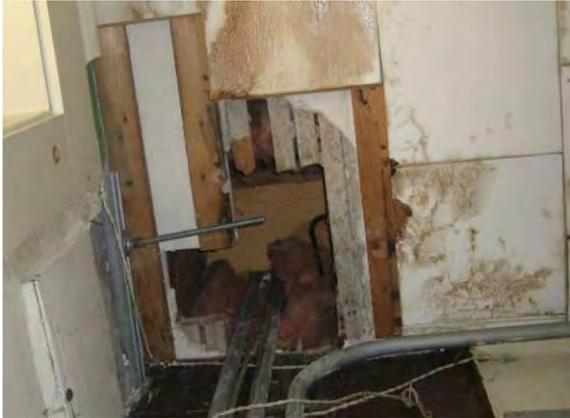
Figure 5.42 – Electrical Closet Ceiling

The ceiling in the first floor electrical closet adjacent to the main entrance displays signs of water damage and there are several ceiling tiles that are missing. The original wood lath and plaster is also damaged at this location (figure 5.42).

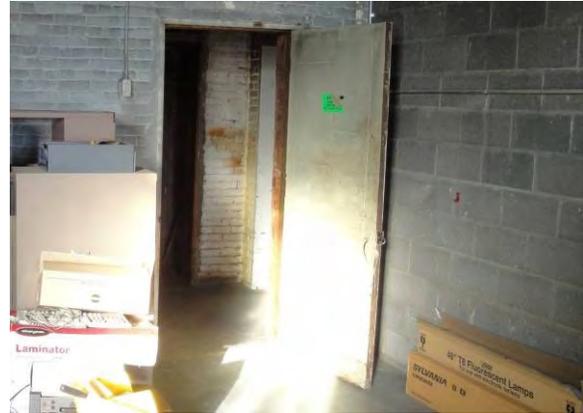
Figure 5.44 – Basement Metal Doors

The basement painted metal fire doors also appear worn. The door hardware is old but appears to be functioning properly (figure 5.44).

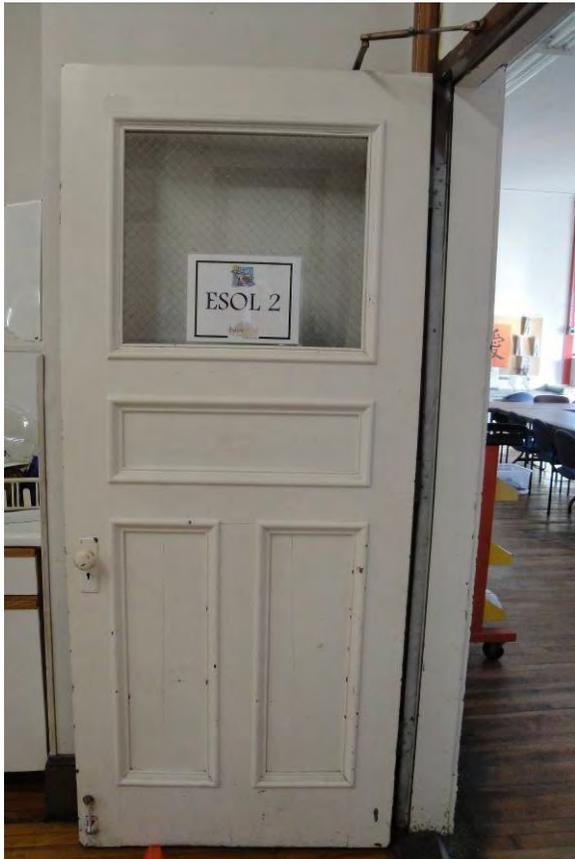
Figure 5.47 – Second Floor Doors

The second floor wood panel doors and frames are worn and the paint finish is old. The door hardware is old but appears to be functioning properly (figure 5.47).

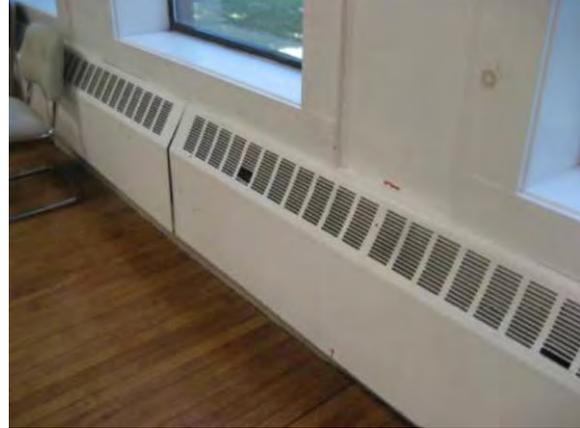
Figure 5.49 – Fin Tube Radiation

The fin tube radiators located throughout the building have painted steel covers. Some of the covers have broken louvers and some scratches and dents (figure 5.49).

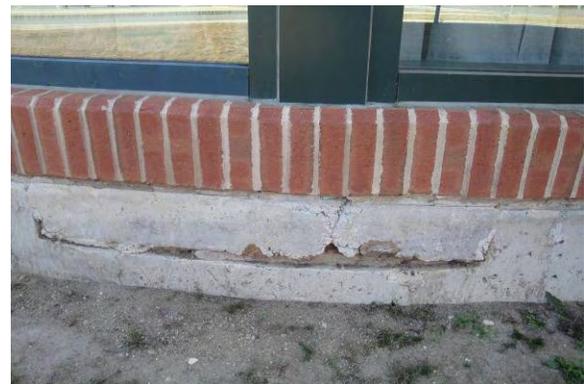
Figure 6.07 – Column Base Concrete Infill

The concrete foundation appears to be in overall good condition with a few deficiencies noted below. There are two areas at the library where the exterior column base concrete infill is cracked and pieces of the concrete are missing (figure 6.07).

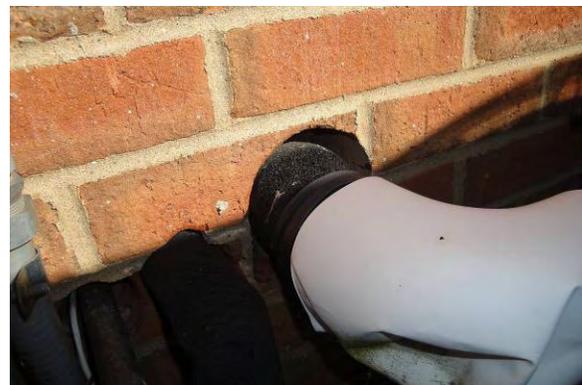
Figure 6.13–

There was a pipe protruding out of the brick veneer near the rear of the building and the opening was not sealed. This may allow water to penetrate into the wall cavity (figure 6.14).

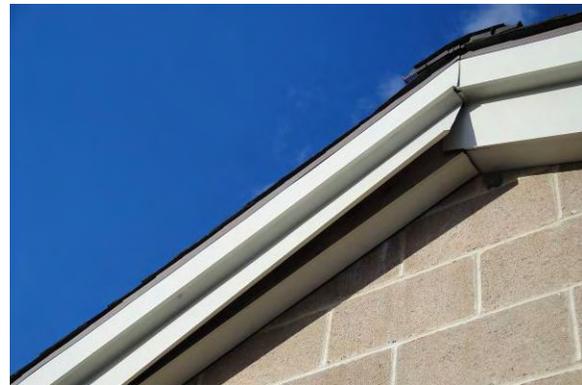
Figure 6.23 – Gable Trim

There are also sections of the metal gable trim along the roof line that appear loose and detached (figure 6.23).

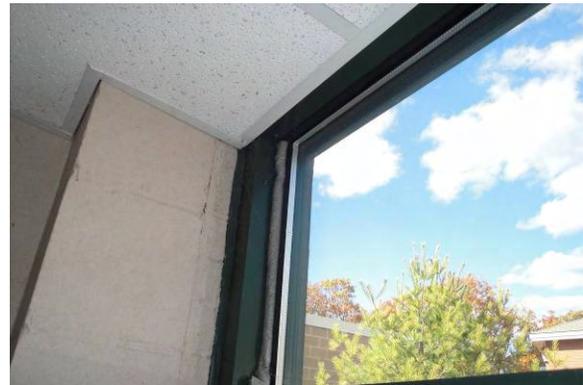
Figure 6.32 – Interior Gasket

The courtyard doors also have a few areas where the interior glazing gaskets appear to be loose and detached (figure 6.32).

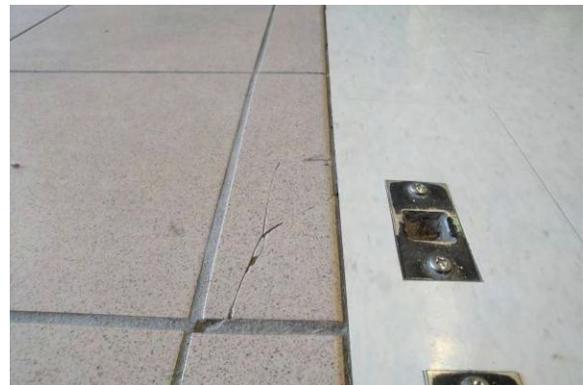
Figure 6.33 – Cracked Ceramic Tiles

The ceramic floor tiles have a few areas with cracked tiles and there are some locations that do not have metal transition strips installed (figure 6.33).

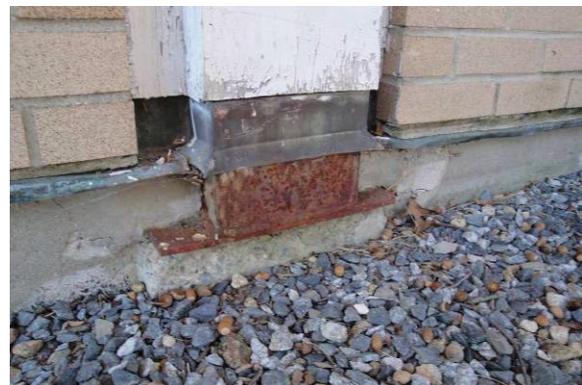
Figure 7.14 – Exposed Steel Column

There are also sections of the steel structure that are exposed to the exterior weather and the steel base plates and columns display areas of rusting (figure 7.14).

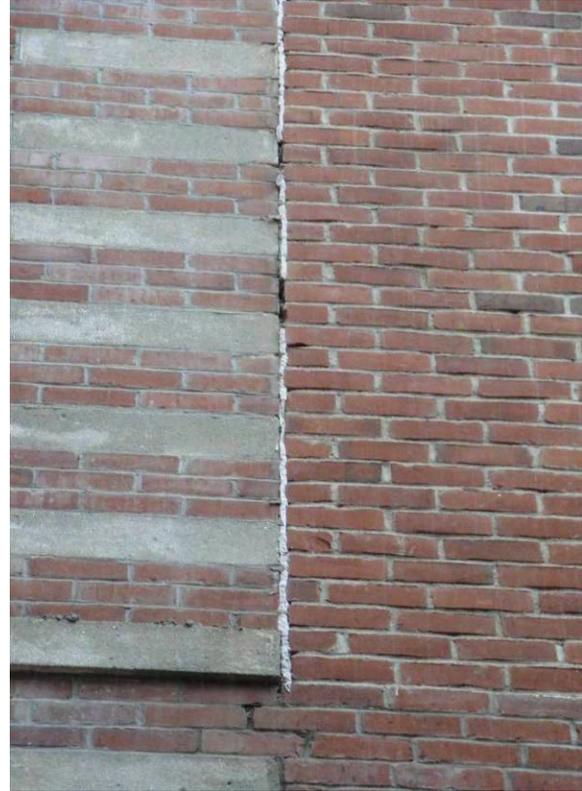
Figure 8.15 – Exterior Expansion Joint

The sealant at some of the exterior joints was cracked and the joints open. Further investigation is required to confirm if the joint separation is due to the building settling or if the sealant has failed, and also to confirm if water is penetrating the wall (figure 8.15).

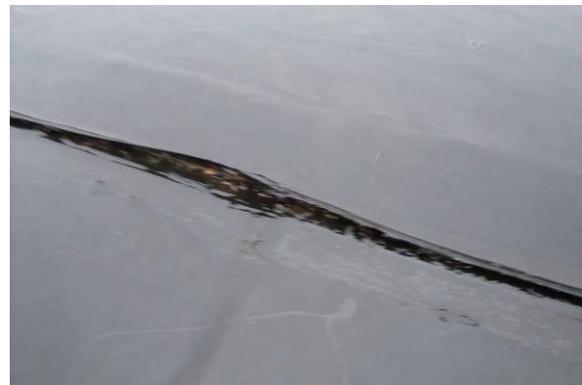
Figure 8.26 – Membrane Roof Seam

The main roof appears to be in overall fair condition. The roof was reported to be over 30-years old. There are sections where the seams were starting to separate, which may allow water to penetrate into the building (figure 8.26). Further investigation is required to confirm condition of the roof.

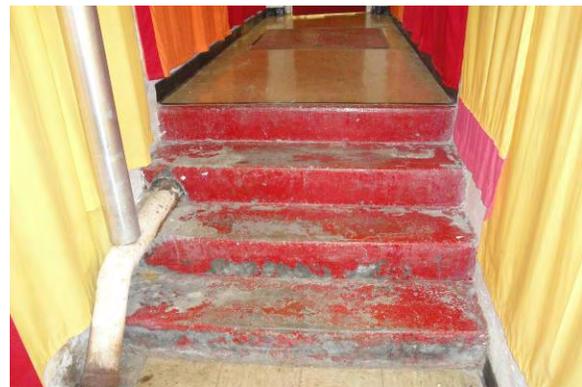
Figure 8.44 – Steam Pipe at Basement Stairs

There is a section of steam pipe installed within the tread area at one of the basement stairs; the stairs also lack handrails (figure 8.44).

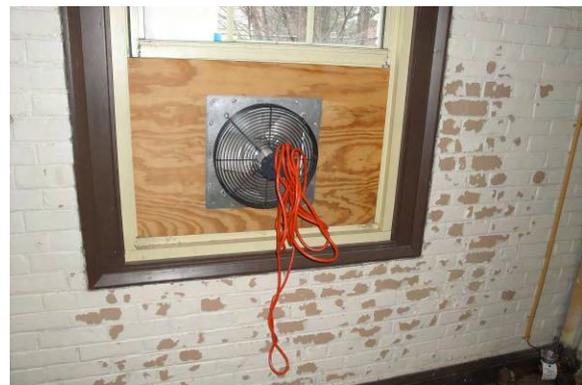
Figure 8.45 – Peeling Paint

The paint finish on the interior brick and CMU walls is in poor condition. There are several areas where the paint finish is missing or peeling off (figure 8.45).

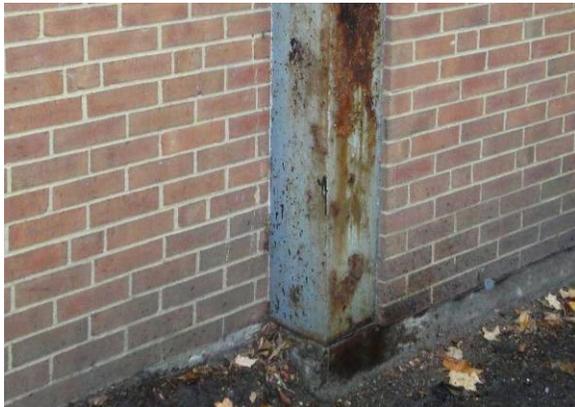
Figure 8.698 – Exterior Columns

The exterior columns display areas of rust and the paint finish is weathered and peeling (8.69).

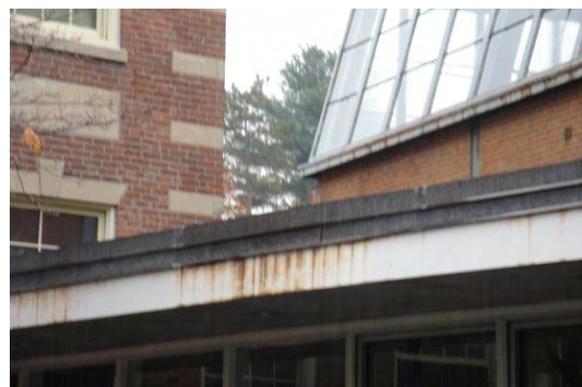
Figure 8.73 – Plywood Fascia Trim at Front Roof

There are sections of the metal roof edge that display areas of rust and sections that appear loose and detached. There are also sections of the plywood fascia board that appear warped and sections where the paint finish appears weathered and faded (figure 8.73 and 8.74).

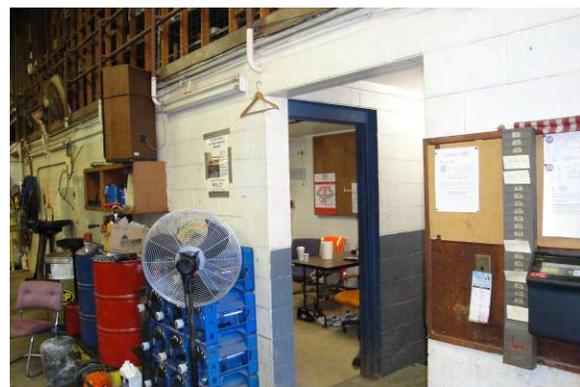
Figure 9.15 – Interior CMU Walls

The CMU walls appear to be in good condition with minimal cracking visible. The paint finish appears worn and stained in several areas (figure 9.15).

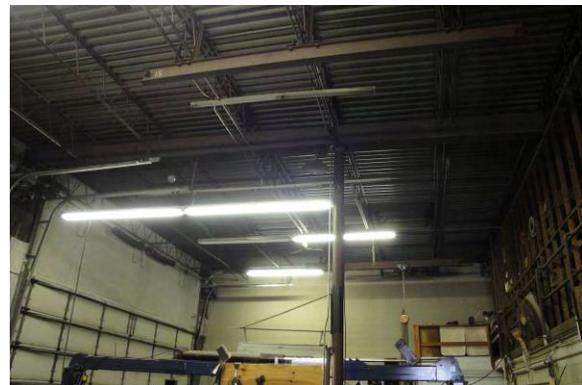
Figure 9.19 – Strip Fluorescent Lights

The building has two different types of light fixtures: surface mounted 4-foot and 8-foot dual lamp strip fluorescent lights, mounted to the underside of the roof joists (figure 9.19). Most of the lights appear to be in good condition and functioning. There are a few fixtures with burned out lamps.

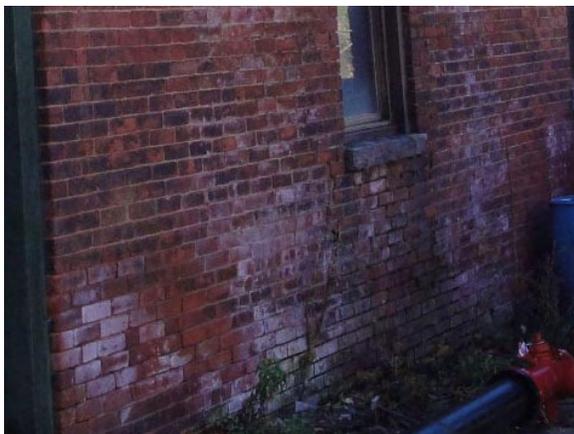
Figure 9.34 – Efflorescence on the Brick

There are also areas in the brick that display efflorescence (chalky white patches), which indicates that water has penetrated behind the face brick (figure 9.34). Further investigation is required to verify where water is penetrating the wall.

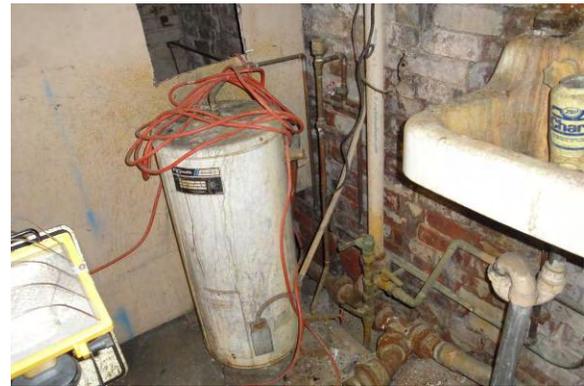
Figure 9.50 – Water Heater

The building does not appear to have any toilet facilities, but does have a 40-gallon electric water heater that connects to a small hand sink. Both the water heater and the sink appear to be old and in poor condition (figure 9.50).

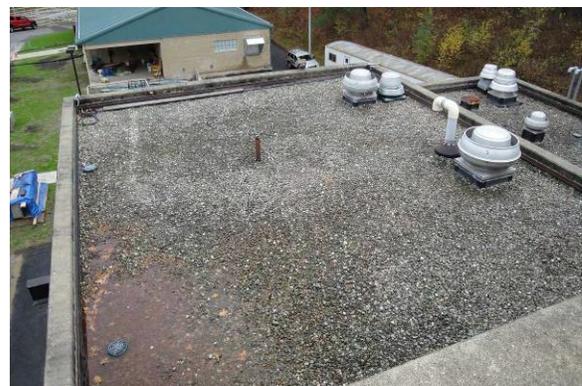
Figure 10.24 – Stone Ballasted Roof

The roof appears to be in fair condition. The age of the roof is not known; however, it appears to be approximately 15 years old (figure 10.24).

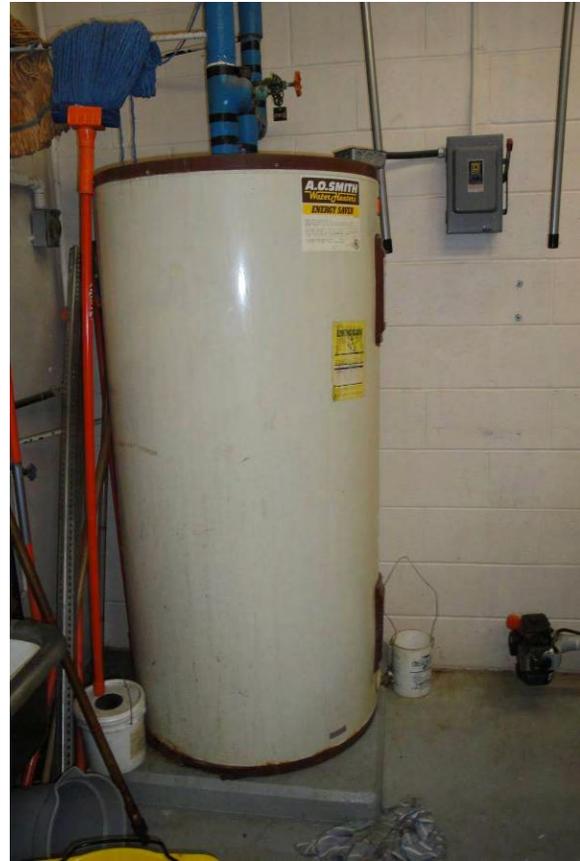
Figure 10.52 – Hot Water Heater

The building hot water is provided by an electric water heater (capacity could not be confirmed) located in the boiler room. The water heater is old and the bottom of the heater displays a significant amount of rust (figure 10.52).

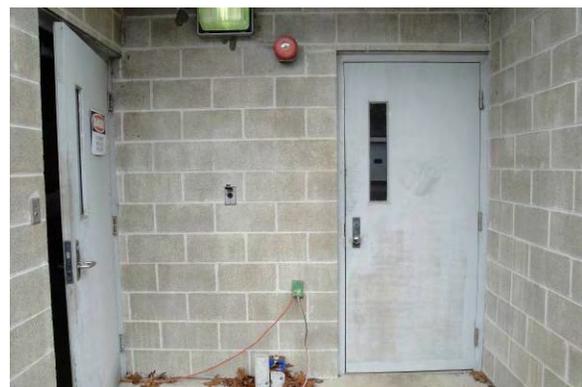
Figure 10.62 – Exterior Doors

The paint finish on the exterior door and frame appears weathered and faded (figure 10.62).

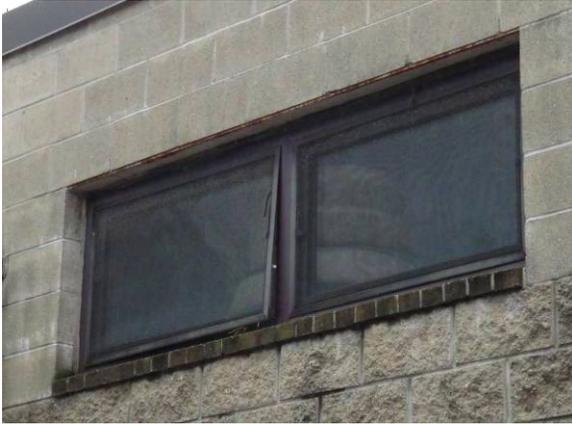
Figure 10.63 – Window Lintel

The steel lintel above the window openings displays areas of rust, and the window screen appears to be detached (figure 10.63).

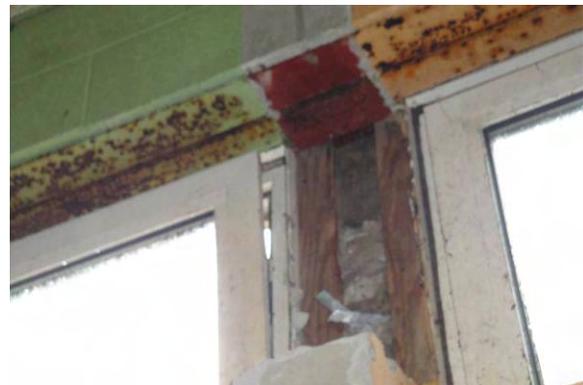
Figure 10.67 – Exposed Framing

There is a section of wood framing between the aluminum windows that is exposed. The metal lintels are rusted (figure 10.67).

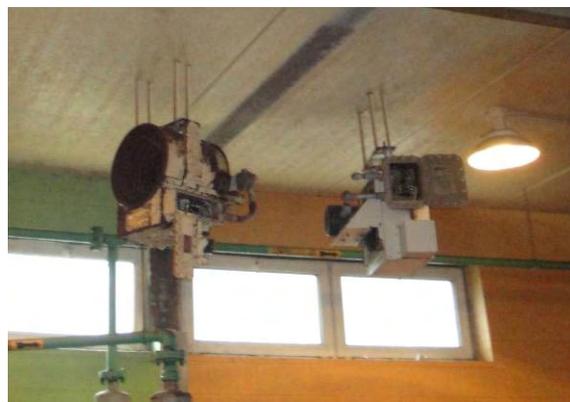
Figure 10.71 – Electric Unit Heaters

The building heating system is comprised of two pendant mounted electric unit heaters; one unit appears old and rusted; the other unit appears to be newer. Both units have exposed wiring and do not appear to be functioning (figure 10.71).

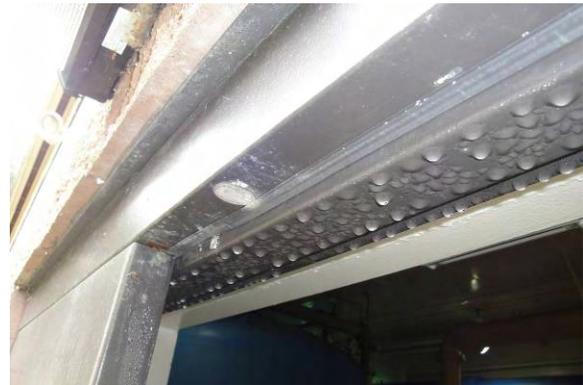
Figure 11.55 – Condensation at Exterior Doors

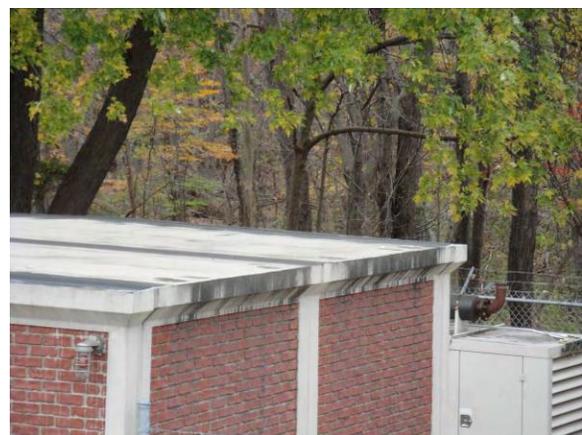
Figure 12.7 – Wash-off/Staining from Roof
