ASSESSMENT FOR THE:

COOLIDGE SCHOOL BUILDING

MAYNARD, MA

Project Overview

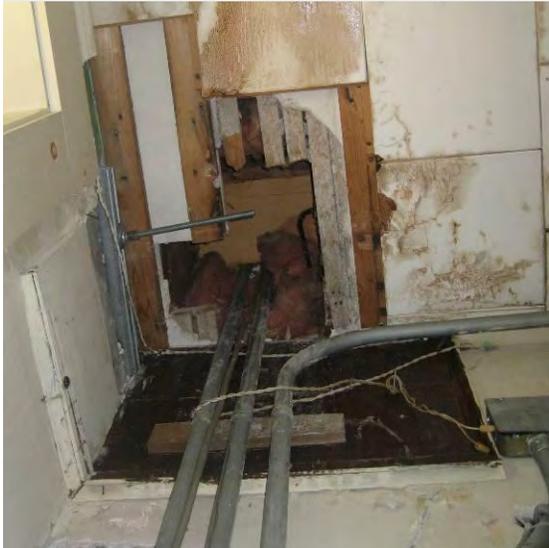
Failing Plaster Ceiling and Walls in Electrical Room

2. **Plaster Walls:** The original interior plaster walls show signs of wear. Isolated cracking and damage is evident through out the building. It should be noted that within the electrical closet on the first floor adjacent to the entry shows serious failure and should be immediately repaired.

- *Recommendation: Ensure that the source of the cracks or damage is repaired such as roof or envelope leaking and patch and repair plaster as required.*

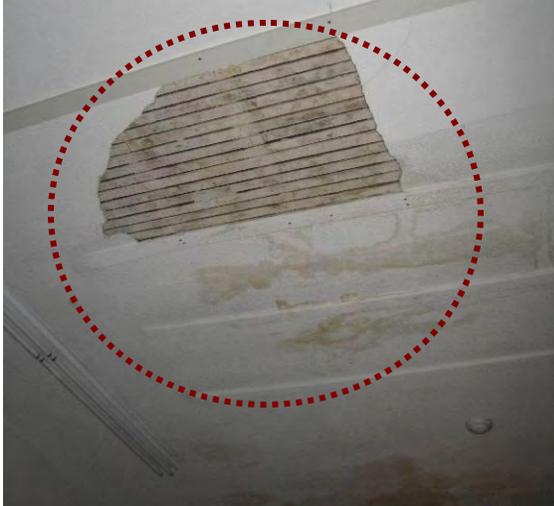
Failing Plaster Ceiling at Second Floor Corridor

2. **Plaster Ceilings:** Plaster Ceilings are located on the lower level and second floor ceilings. There are signs of moisture penetration, cracking and some significant crumbling at some isolated areas. It can be assumed that the poor condition of the plaster is due to water infiltration at the roof and/ or exterior walls.

- *Recommendation: Repair the source of the leaks in the envelope before plaster is repaired and/or replaced. Immediately repair serious plaster crumbling located on the second corridor area to ensure the safety of the building's occupants.*

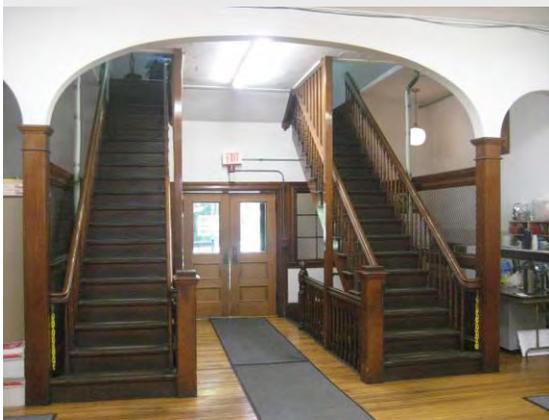
Main Central Stair

Worn metal plates

The main connecting stair between the first and second floor are wood stairs with metal inset plates are showing signs of wear and age. The railing is not compliant and the stair does not serve as an enclosed fire rated egress

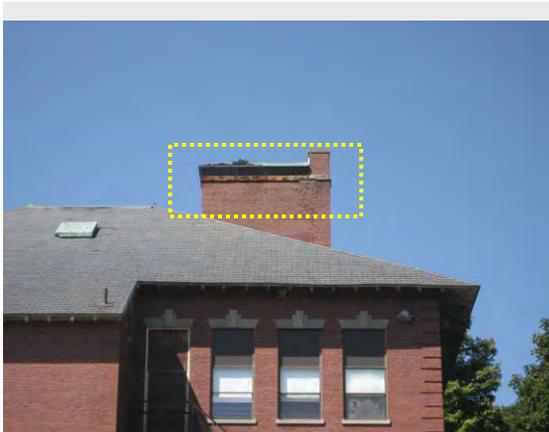
Slate Roof / Damaged Chimney Cap

Slate Roof: It was reported by the staff that the slate roof has received minimal maintenance over the years. The metal roof at the chimney caps are aged, worn and torn. The second floor ceiling shows marks of roof leaks in many locations, which suggests water infiltration due to poor flashing, ridge connections and age.

C-CHIMNEY: Metal roof cap on the brick chimney is damaged. Signs of prior repairs and replacement of some bricks at the top of the chimney is evident. Mr. Lombardo confirmed that the damage to the copper hood has existed for a few years.

- *Recommendation: Confirmation is required that the leaks are not active. If leaks still exist, roofing should be repaired to the extent possible as a temporary solution.*
- *If extensive renovation is planned in the future, complete roof refurbishing or replacement should be considered because of the roof age and potential for continuous failure. Options for new roofs include composite Architectural shingles, which give the appearance of slate at a fraction of the cost. In addition, Snowguard rails should be provided above all walking surfaces.*

- *Recommendation: Replace damaged cap to prevent further decay of chimney brick structure.*

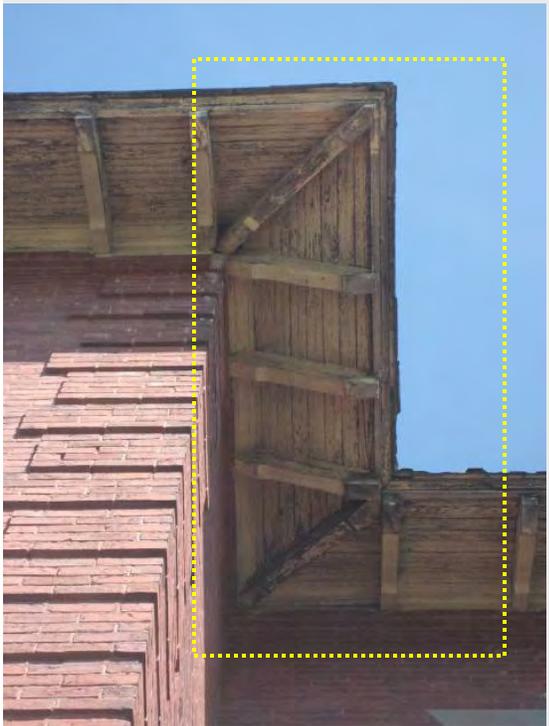
Overhang at Deteriorated Building Facia

B-FACIA / OVERHANG: In some areas the underside of overhang is exposed bare wood. It is suspected that deteriorated (rotted) wood exists due to continuous exposure to weather. (Paint is peeling off at underside of overhang.)

- *Recommendation: Strip remaining of paint, inspect for rotted, damaged wood. Repair, epoxy and replace wood as necessary, then prime & paint.*

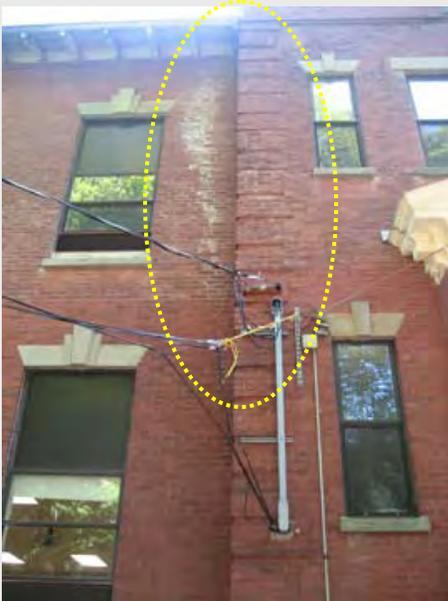
Efflorescence at Masonry

1.1 Efflorescence indicates water penetration behind brick and consequently, potential damage inside the wall. Further investigation inside the building confirmed that the wall had deteriorated due to a roof leak.

- *Recommendation: repair source of leak and clean brick as required. (See also 1.3)*

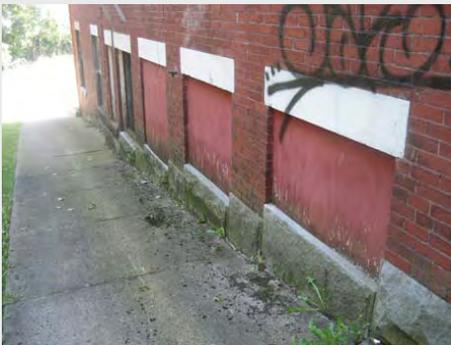
Graffiti on Brick Wall

1.2 Traces of Graffiti are visible on brick around the building. It appears that in some areas an attempt was made to clean it, while in other areas it remains clearly visible.

Recommendation: Clean brick to remove graffiti. (See also 1.3)

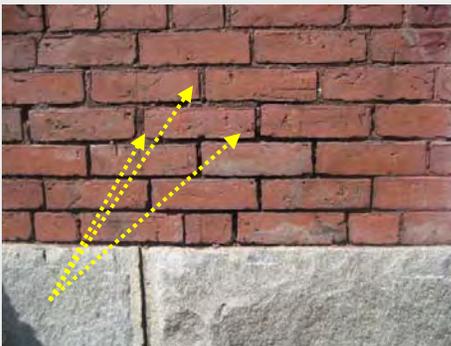
Eroded Mortar Joints

1.3 Mortar joints: Mortar joints have eroded from the bottom four courses (most drastically) plus to a lesser extent in other locations in the rear façade. Also observed was a gap in vertical joints at the edge of quoins.

Recommendation: Repoint walls where joints have disintegrated and at locations of moisture penetration. (Cracks) Cleaning of the brick is recommended to eliminate all traces of graffiti and efflorescence; however, special care must be taken to prevent disturbance of existing mortar joints, otherwise further repointing might be required.

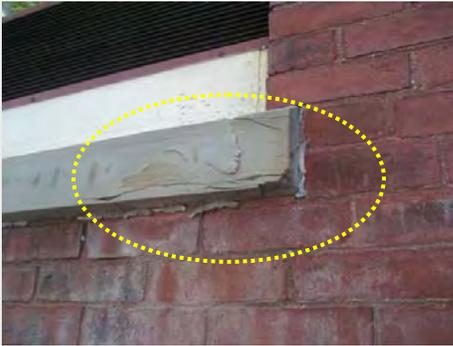
Spalling Stone Sill

3. STONE WINDOW SILLS AND HEADS: Stone sills and heads show signs of spalling, and cracks in many locations are observed. These may be due to freeze-thaw cycles, i.e. water accumulated behind the stone pushes out as if freezes.

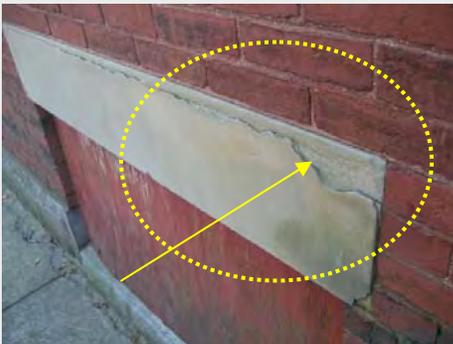
Spalling Stone Head

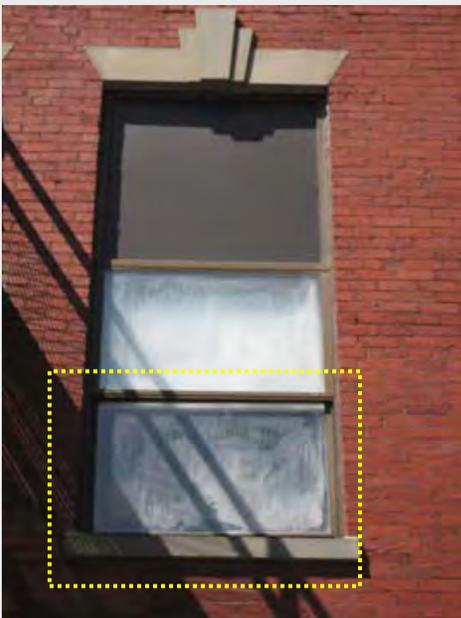
Failed seal at insulated glass

It was noted by the users that these windows do not operate properly. Gaskets and sealants have failed and windows leak throughout the facility. Also in a few

locations, the windows appear “foggy” i.e. condensation is occurring between the panels of insulated glass most likely due to failure of the glass seal. (Note that the basement openings are blocked with painted plywood panels.)

- *Recommendation: It is recommended that windows be replaced with insulated glass, thermally broken frame windows.*

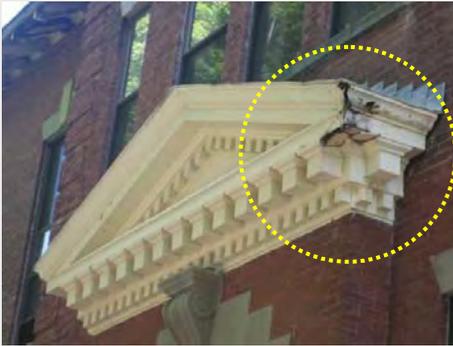
Entry Pediment

1. Existing entry pediment shows signs of corrosion, particularly at the lower right hand corner where the damage is most severe and a large portion has rusted away.

- *Recommendation: Paint must be stripped and entire pediment inspected for further rust decay, make necessary repairs, rebuild corner to match existing dentil work, and treat entire pediment with rust inhibitor primer*

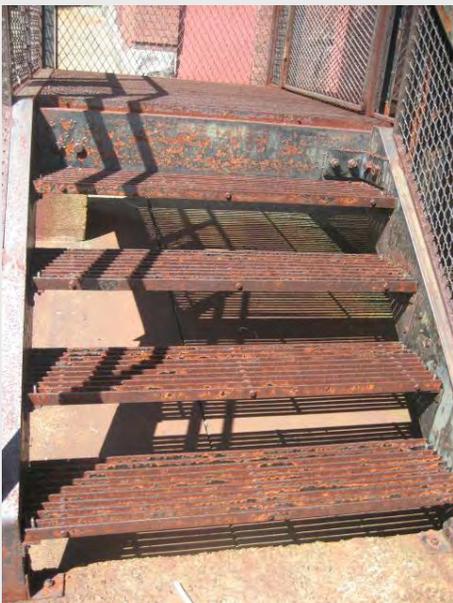
Rusted Exterior Stairs

1. Existing exterior exit stairs at side and rear of the building are severely rusted and generally they are in

poor condition.

- *Recommendation: As a temporary measure to prevent further decay, paint must be stripped and entire stair inspected for rust, make necessary repairs, and treat with rust inhibitor primer.*
- *If major renovations are undertaken, a more permanent solution such as new fully Code compliant fire stairs should be considered.*

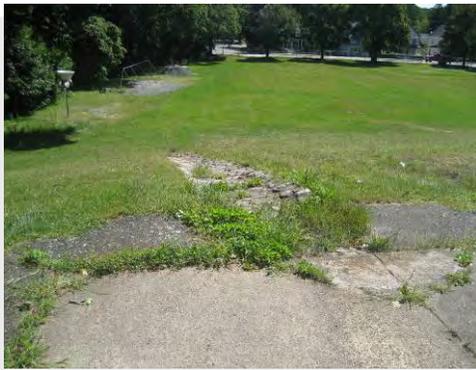
Trough Drain at Rear of Coolidge Facility

1. Existing building has neither gutters /downspouts nor storm water collection system. Roof runoff falls to the ground and finds its way to existing drainage troughs. Soil erosion adjacent to these troughs indicate that they are not adequate to handle heavy downpours.

Recommendation: Install downspouts. Enlarge troughs.

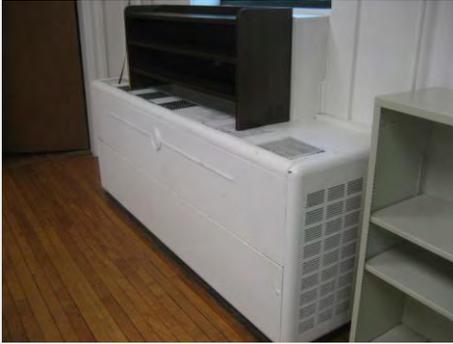
Unit Ventilator

Recommendations: Existing Unit ventilators are at the end of their useful life. UVs, fin tubes and associated piping should be replaced. The boiler is in good condition. Life expectancy for this type of equipment is about 15 to 20 years. Since the existing boiler is only seven years old it is reasonable to anticipate still several years of service. Continue flushing the heating system as frequently as recommended by the service company.

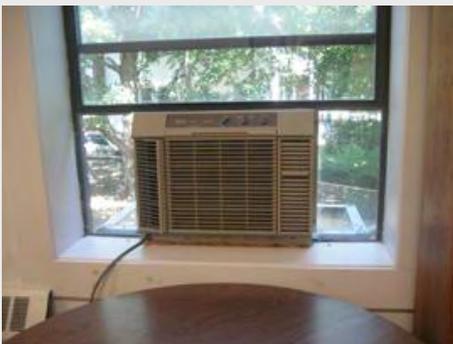
Window Mounted AC

There is NO central air conditioning in the building. There are numerous individual window mounted air conditioners, which tend to tax the electrical service capacity in the summer.

Recommendations: Upgrade electrical service to provide enough capacity for Acs. If major renovation is undertaken, central AC maybe considered in areas of full time occupancy.

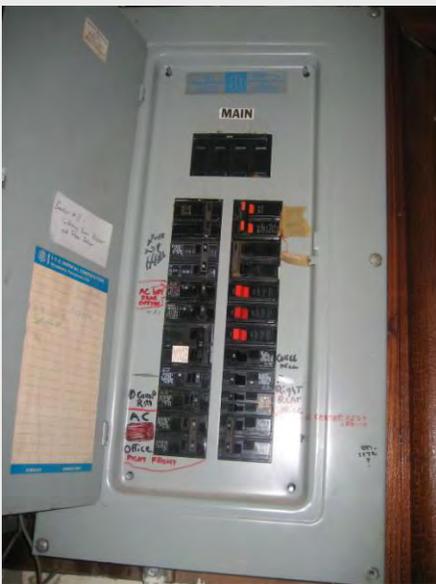
The power distribution is via a main panel and four sub panels. Mr. Cosetta also indicated that the wiring in some locations is old knob and tube.

Electrical Panel

Recommendations: Existing system is outdated and insufficient. Install new 400 AMP minimum electric service, and replace all obsolete panels and wiring.

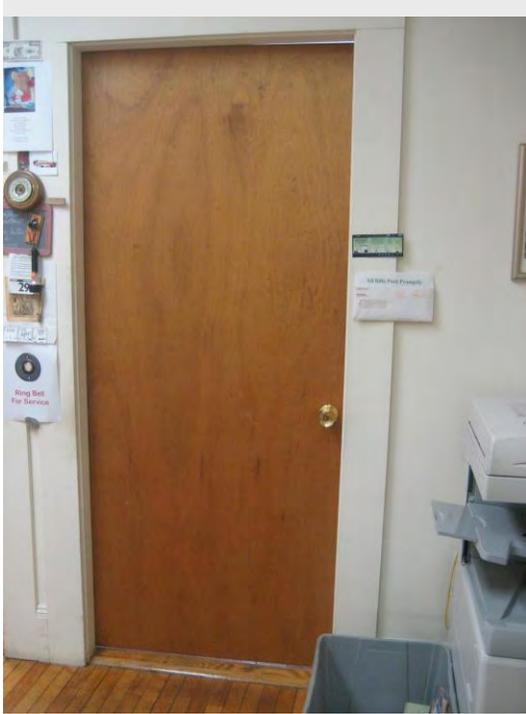
Door with Non- compliant knob type hardware

1. **Elevator:** Building does not have an elevator or handicap accessible lift.
2. **Hardware:** Interior door hardware is non-compliant. (Knob type)
3. **Stairs:** Stairs do not meet Code requirements for handrails and handrail extensions as well as exceeding maximum allowed nosing projection at treads.
4. **Toilet rooms:** It appears that the toilet rooms were recently renovated and an attempt was made to size them to accommodate a wheelchair. However items such as grab bars and mirror, plus clearances around the toilet are non-compliant.
5. **Building entrance:** wood HC accessible ramp and steps built over existing original stone and brick steps provide accessibility at the front entrance, although not in full compliance with current code. (Single handrail instead of High/low; bottom of ramp exceed ½” vertical where the ramp meets the ground.)

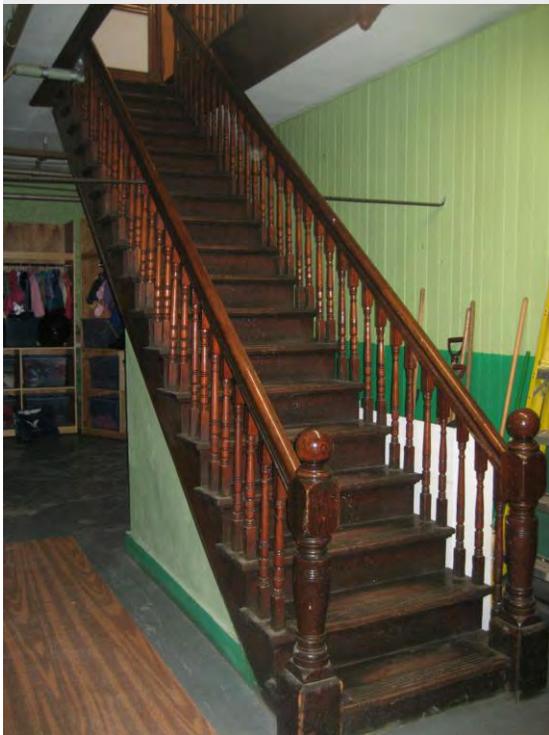
Non-compliant handrails at stair
