Coolidge Administration Building

Exterior

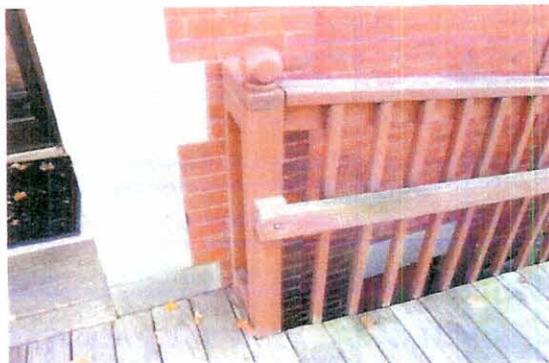
Figure 5.09 – Top of Accessible Ramp

The accessible ramp appears to have several code compliance issues: the handrails do not have extensions at either end; the handrails do not conform to the profiles and minimum clearances (figure 5.09); the tread condition at the bottom of the ramp does not conform to the change in level requirements; and there is no level platform at the bottom of the ramp (figure 5.10). The maximum slope of the ramp was not confirmed. Further investigation may be required.

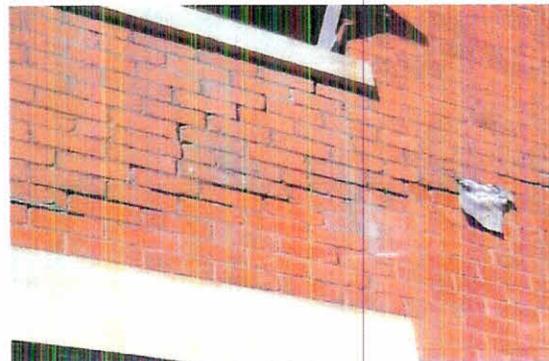
Figure 5.11 – Brick Mortar Joints

The exterior brick walls appear to be in fair condition. The mortar appears to be aging and weathered. There are several areas where the mortar appears deteriorated, loose, and/or cracked (figure 5.11). The brick at the corners display significant amount of deterioration as well.

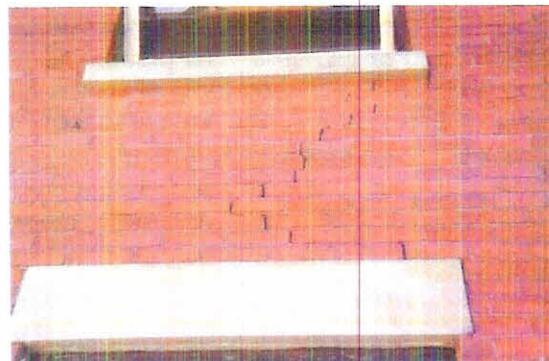
Figure 5.11a – Cracks in Brick Mortar Joints

There are several areas where the mortar joints appear cracked (figure 5.11a).

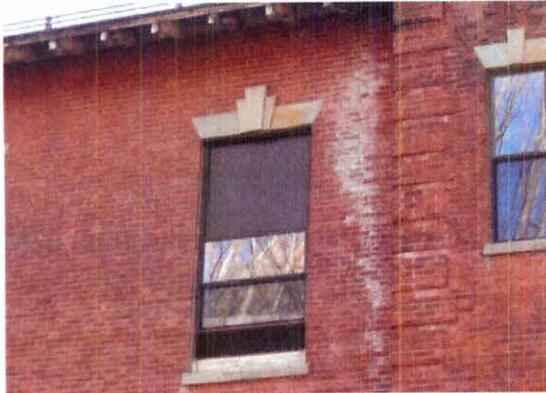
Figure 5.12 – Efflorescence in the Brick

There are also areas in the exterior brick that display efflorescence (white chalky

patches), which indicates water penetration through the exterior wall (figure 5.12). Further investigation may be required to confirm where/how the water is penetrating the wall.

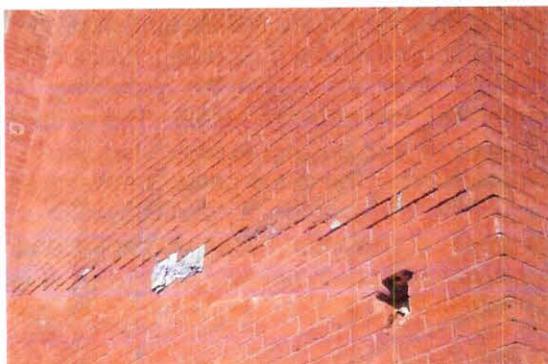
Figure 5.13 – Flashing and Beam Pockets in Brick

There appears to be remnants of a previous canopy construction at the rear of the building. At the brick wall there are visible pieces of metal flashing inserted into the mortar joints where this canopy once was located. There are also several holes in the brick, which appear to form abandoned beam pockets. The mortar joints at the flashing have deteriorated and the beam pockets have not been filled. This may allow water to penetrate into the masonry wall. Further investigation may be required (figure 5.13).

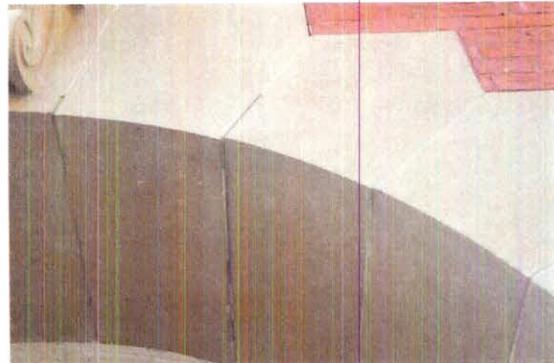
Figure 5.14 – Main Entrance Archway Stone

The mortar joints in the stone archway around the main entrance door have deteriorated and sections of mortar are missing (figure 5.14).

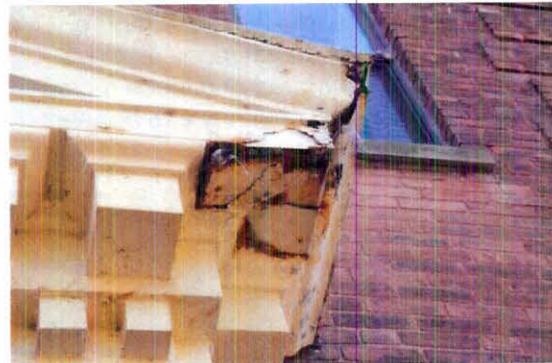
Figure 5.15 – Main Entrance Pediment Assembly

The pediment assembly over the main entrance doors displays visible signs of deterioration and corrosion on the right side (figure 5.15).

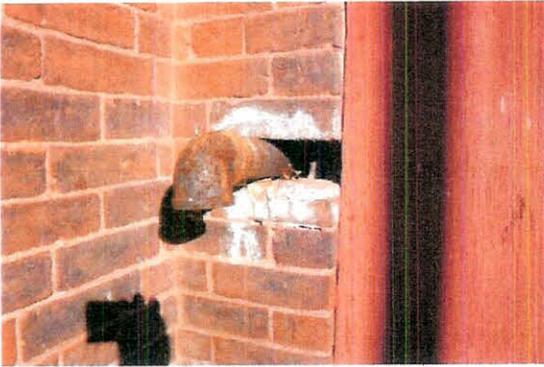
Figure 5.16 – Pipe Penetrating the Brick Wall

There is a pipe protruding out of the brick wall near the rear of the building and the opening was not sealed which may allow water to penetrate into the masonry wall. Further investigation may be required (figure 5.16). Several of the basement windows have been removed and the openings covered with plywood. The plywood displays numerous areas of rotting and bowing out. The paint is weathered and there are visible signs of sealant failure around the openings.

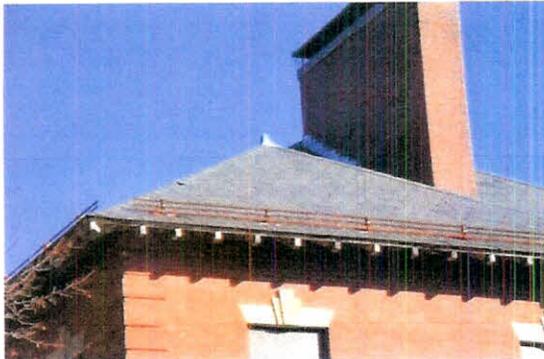
Figure 5.17 – Slate Shingle Roof

The slate roof shingles appear to be in fair condition. Based on observations on the interior of the building; there appears to be several previous or current leaks in the roof assembly. The snow fence appears rusty and detached in some locations (figure 5.17). The brick at the chimney displays evidence of deteriorated and loose mortar joints and the metal chimney cap appears worn and damaged.

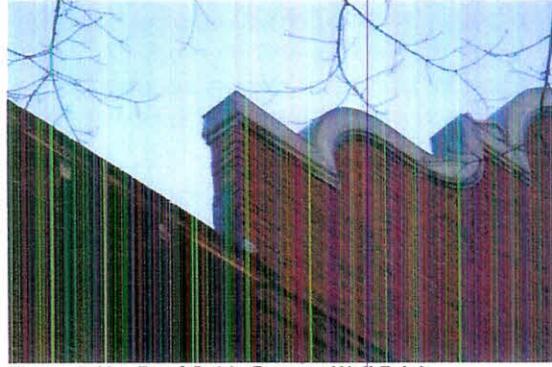
Figure 5.18 – Roof Gable Parapet Wall Brick

The brick at the decorative gable parapet wall at the roof line near the main entrance displays signs of deteriorated and loose mortar joints (figure 5.18).

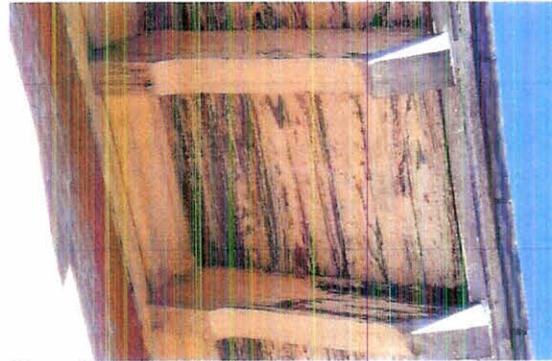
Figure 5.19 – Roof Overhang

The underside of the roof overhang is painted wood, and the paint finish appears weathered and sections are peeling. Further investigation may be required to determine if there are any rotted and/or loose sections of wood, molding, or trim (figure 5.19).

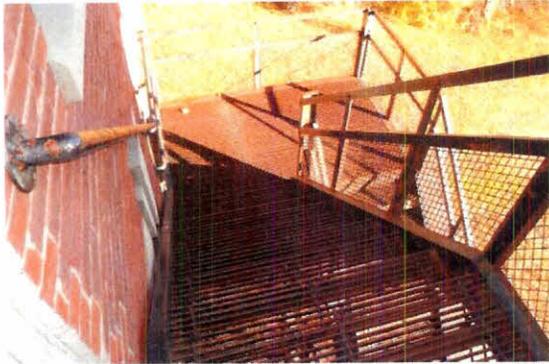
Figure 5.20 – Fire Escape Stair

The paint finish on the fire escape stair, handrails, gates, and supporting structure is severely deteriorated, and the underlying metal structure appears rusted. The paint is chipped off and peeling at several areas (figure 2.20). One of the gates is missing at one of the fire escapes, a condition which might allow unwanted access to the second floor from the grade below.

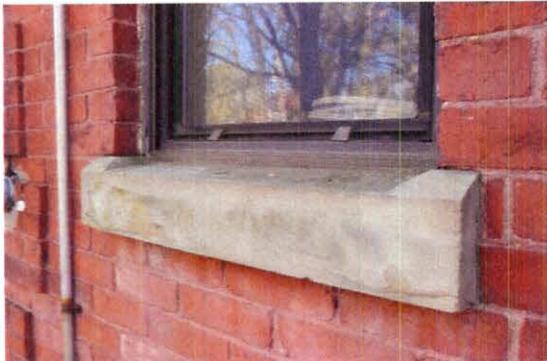
Figure 5.21 – Windows Sills

Several of the cast stone window sills and heads display signs of deterioration and are currently spalling. Several of the mortar joints are cracked and/or missing mortar (figure 5.21).

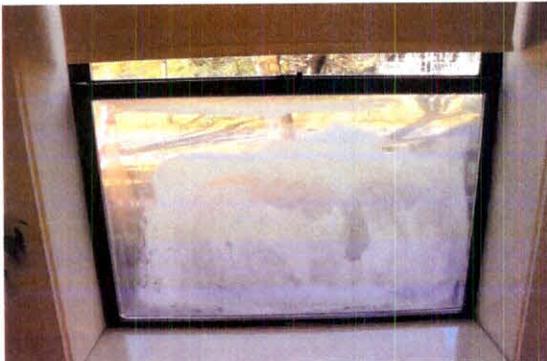
Figure 5.22 –Exterior Windows

Some of the exterior windows are difficult to open and the gaskets and seals in the insulating glass sash have failed at several of the windows causing clouding of the glass (figure 5.22).

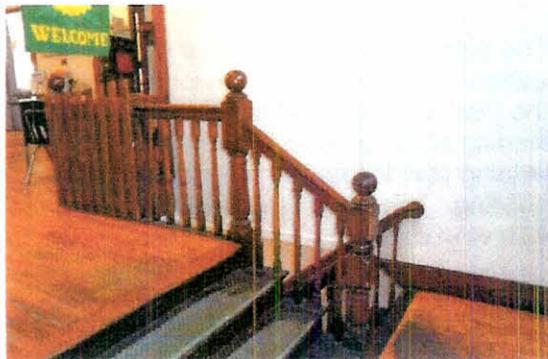
Figure 5.33 – Second Floor Wood Flooring

The second floor wood flooring appears to have an older finish. There are a few areas that display water damage; possibly resulting from previous or current roof leaks above (figure 5.33).

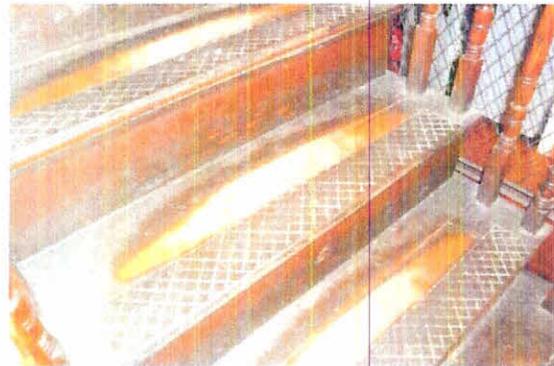
Figure 5.34 – Stair Treads

The stair treads are in poor condition. The vinyl treads and the metal plates are old and their surfaces are worn (figure 5.34).

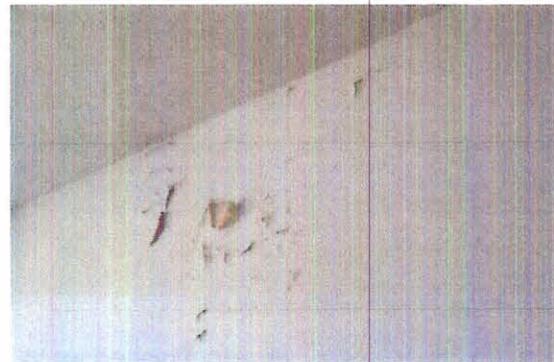
Figure 5.35 – Peeling Paint

The interior walls display several areas where the paint finish on the walls is peeling (figure 5.35).

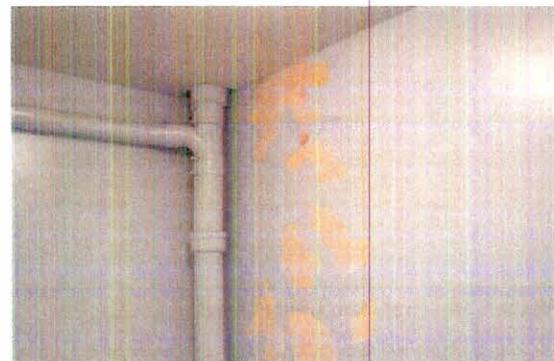
Figure 5.36 – Chipped Paint

There are other plaster walls where the paint finish has chipped of and sections of paint are missing (figure 5.36).

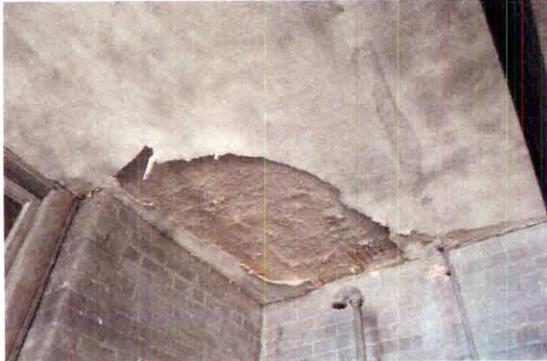
Figure 5.37 – Boiler Room Ceiling

The boiler room ceiling displays an area that appears to be damaged from the steam relief valve below (figure 5.37).

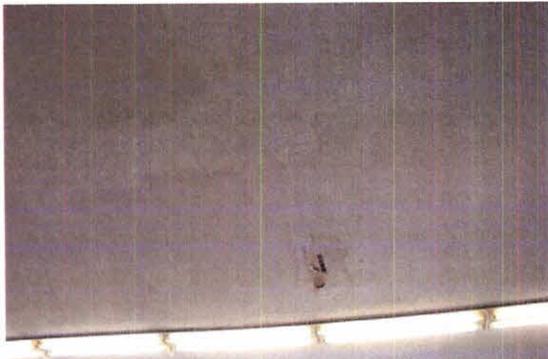
Figure 5.38 – Plaster Ceiling Damage

The plaster ceilings on the second floor display several areas that appear to be damaged from roof leaks above. There are also a few areas where the ceilings are water stained, plaster was missing and/or deteriorated. Sections of the paint are peeling off (figure 5.38).

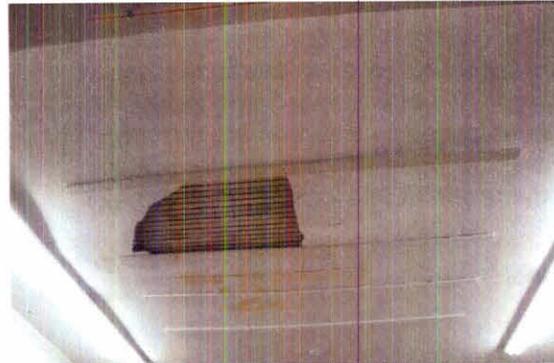
Figure 5.39 – Plaster Ceiling Damage

There is one area located in the second floor corridor where a large section of the plaster was missing (figure 5.39). This area appears to have been previously repaired, but the existing condition appears to be deteriorating further. Additional investigation may be required at this location.

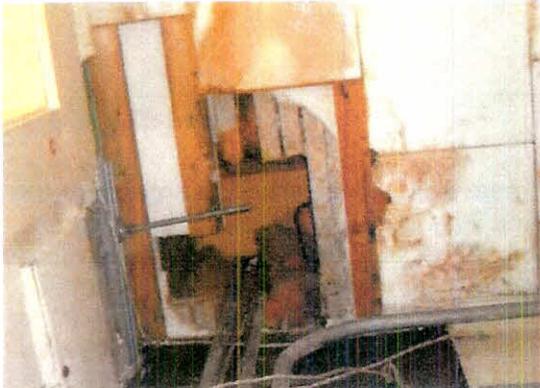
Figure 5.42 – Electrical Closet Ceiling

The ceiling in the first floor electrical closet adjacent to the main entrance displays signs of water damage and there are several ceiling tiles that are missing. The original wood lath and plaster is also damaged at this location (figure 5.42).

Further investigation may be required to determine the cause of the water damage and if there is any significant damage to the roof and/or building structure.

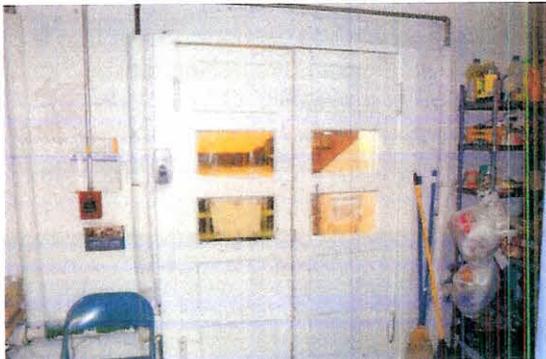
Figure 5.43 – Basement Wood Doors

The basement wood doors and frame surfaces are worn and the paint is deteriorated. The door hardware is old but appears to be functioning properly (figure 5.43).

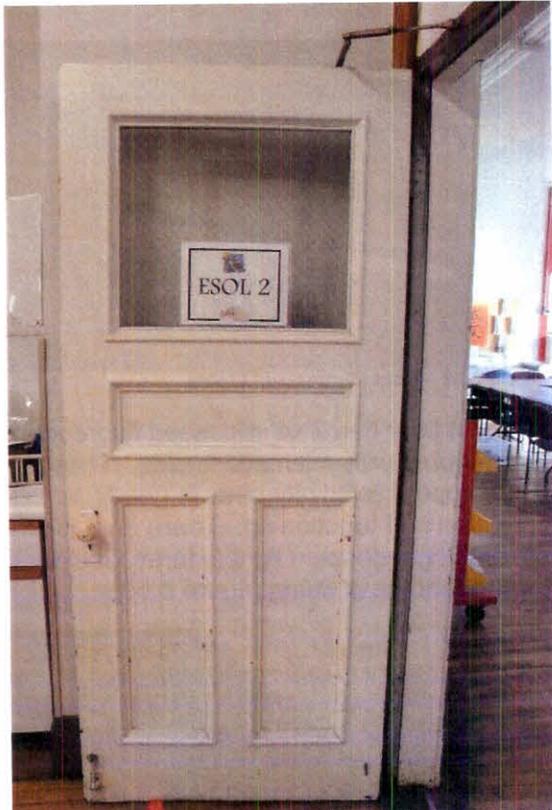
Figure 5.47 – Second Floor Doors

The second floor wood panel doors and frames are worn and the paint finish is old. The door hardware is old but appears to be functioning properly (figure 5.47).

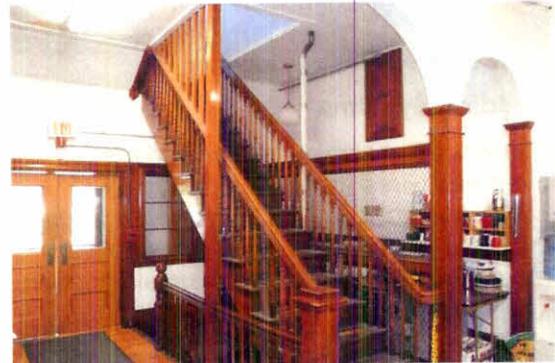
Figure 5.48 – Interior Stairs at Main Entrance Lobby

The interior stairs do not appear to conform to current building code and/or ADA requirements. The guardrail and handrail heights appear lower than current code requirements, and the handrails do not extend beyond the top and bottom nosing (figure 5.48). The tread nosing appears to exceed the current code allowed maximum projections.

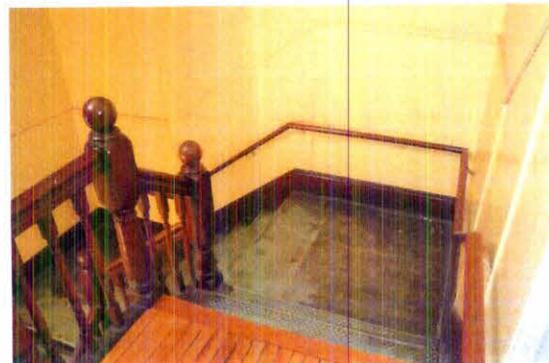
Figure 5.48a – Multi-level stair at Rear

Further investigation may be required to determine which code requirements are applicable to this stair (figure 5.48a).

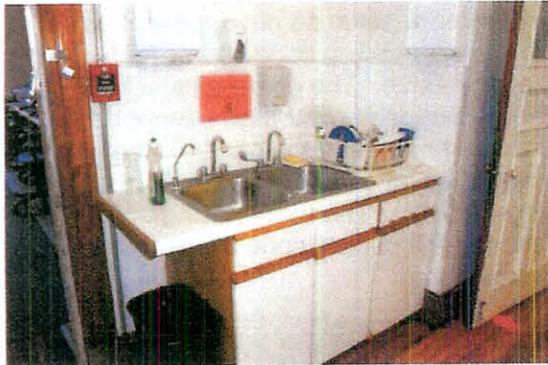
Figure 5.49 – Second Floor Casework

The small section of built-in casework located at the second floor is in overall good condition; however the countertop height and cabinet hardware do not appear to be ADA compliant (figure 5.49).

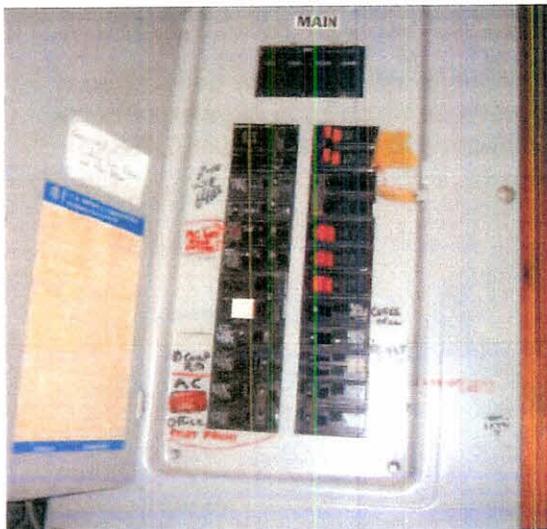
Figure 5.50 – Main Electrical Panel

The electrical service is provided by overhead wires adjacent to the main building entrance. The main electrical panel indicates 200A/240V/single phase power (figure 5.50). The electrical panels appear to be over 30 years old.

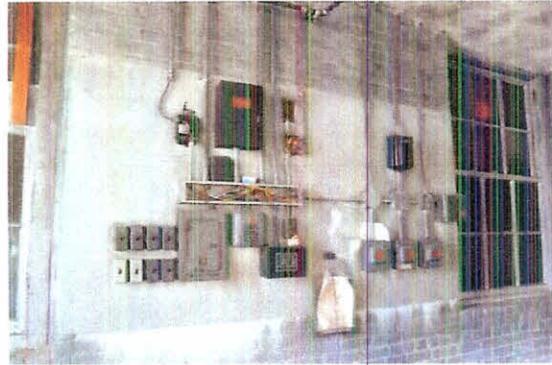
Figure 5.51 – Boiler Room Electrical Devices

There are three sub-panels; one on each floor. The panels and wiring appear to be old and there is some wiring that was exposed and visible. There are several electrical disconnect switches located throughout the building related to the associated equipment (figure 5.51). Further investigation may be required to confirm if electrical distribution is adequate to meet the building needs, and to evaluate the code compliance of the electrical system.

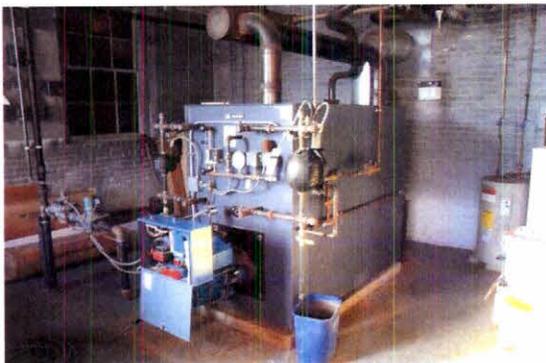
Figure 5.55 – Main Boiler

The boiler is approximately 10 years old, in good condition, and appears to be functioning. The capacity of the boiler could not be confirmed (figure 5.55). There are some minor rust spots on the piping and surface of the boiler. There are also some rust stains around the perimeter of the boiler pad; most likely from the general maintenance related to the piping system.

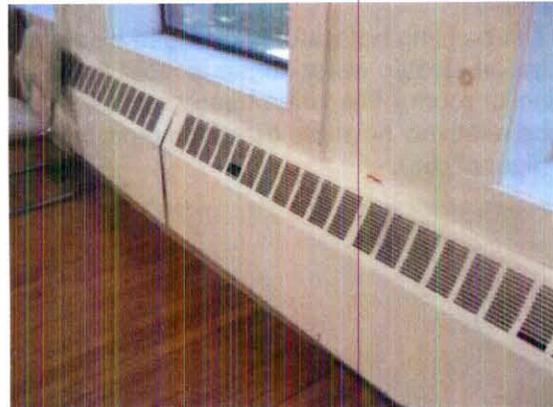
Figure 5.56 – Fin Tube Radiation

The fin tube radiators located throughout the building have painted steel covers. Some of the covers have broken louvers and some scratches and dents (figure 5.56).

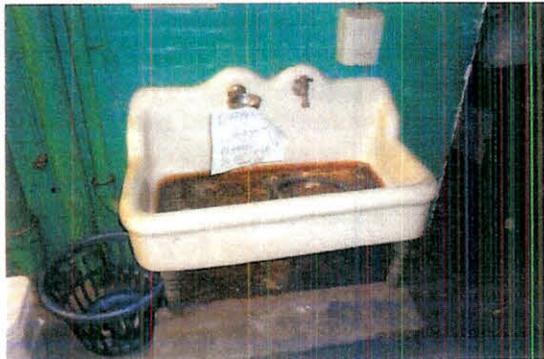
Figure 5.59 – Utility Sink

There are a few utility sinks located in the basement that appear to be old and are not currently functioning (figure 5.59).
