From: Victor A. Olson, P.E.

Date: December 8, 2015

**Reference: Hayes Street Drain Pipe Investigation Memorandum
Maynard, MA**

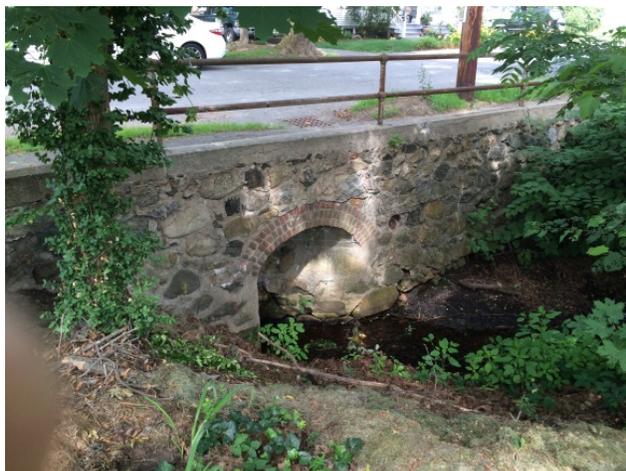
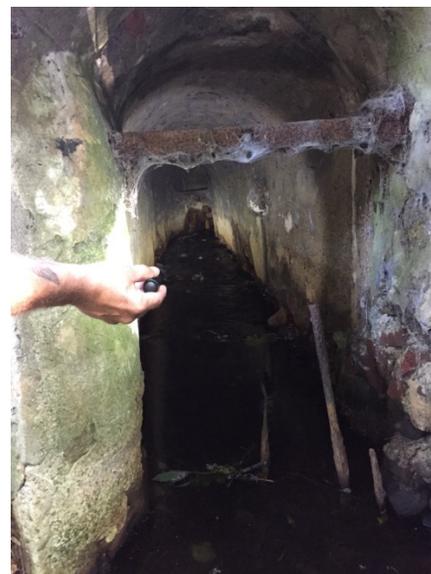
Open stream enters Hayes Street drain at the McKinley Street headwall.

Visual inspection of this arch culvert shows it is structurally sound and functioning adequately. Periodic inspection should be done to monitor conditions over time and complete minor masonry repairs to they don't progress into major repairs. The original grate over the culvert has corroded away and a replacement grate was reported to be available but was not in place during inspection. The grate will prevent large debris washing into culvert during high flows and will keep trespassers from entering culvert .

Periodic inspection should be done to monitor conditions over time and complete minor masonry repairs so they don't progress into major repairs. The original grate over the culvert has corroded away and a replacement grate was reported to be available but was not in place during inspection. The grate will prevent large debris washing into culvert during high flows and will keep trespassers from entering culvert. Consider adding an access manhole just beyond the downstream end of the culvert to improve operations access.

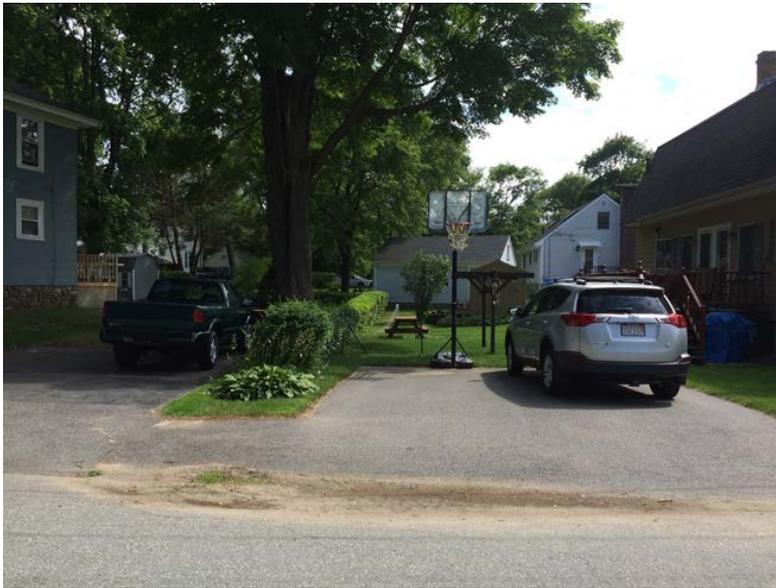
Garage at house number 22 Hayes Street has encroached over the drain.

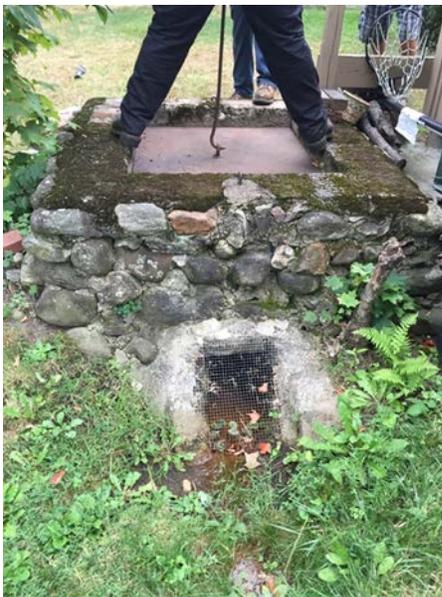
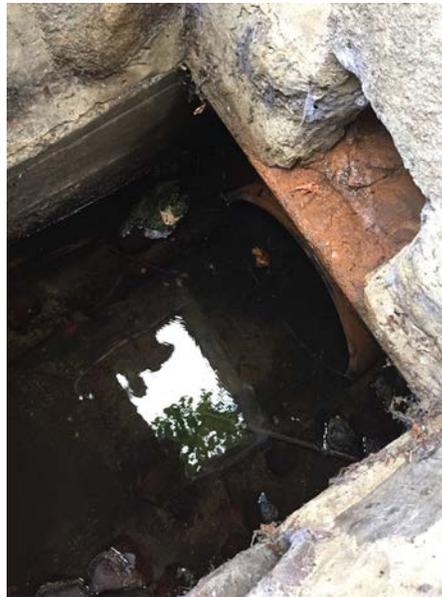
Drain Line runs cross country behind house number 22 and parallel to Hayes Street to drainage structure behind house number 20 Hayes Street.

We were unable to inspect approximately 100 feet of this drain because we could not gain access through the backyard without impacting fences and rutting lawn area. In addition the bend in pipe prevented access from the upstream arch culvert. It is recommended that this be inspected when follow-up construction recommendations are completed to verify condition and sizes throughout length. The garage at house number 22 Hayes St. encroaches over the drain.

It is recommended that this be inspected when follow-up construction recommendations are completed to verify condition and sizes throughout length. The garage at house number 22 Hayes St. encroaches over the drain. Line pipe with cured in place liner if line is to remain in service.

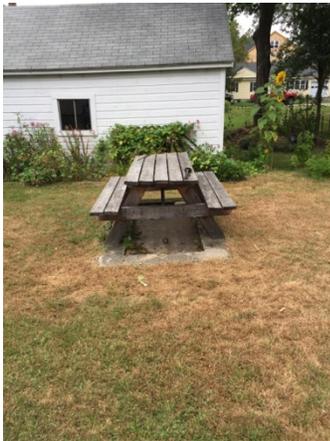
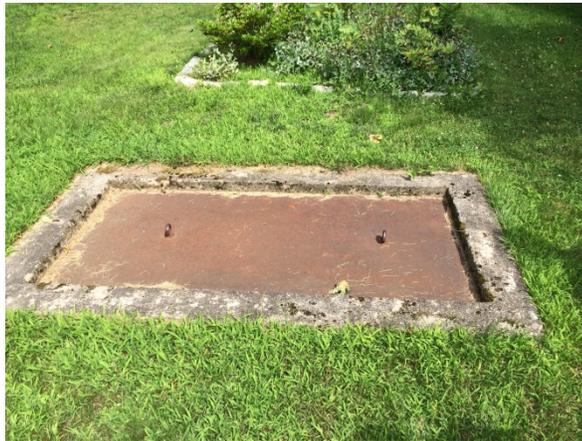
The structure at house number 14 Hayes Street has a larger 4'x8' steel plate cover that required machinery to remove to gain access to the drain and is also located on private property. The 30 inch drain continues to run northerly approximately 150 linear feet in private property crossing under two garages at 14 and 12 Hayes Street that also have been constructed over the top of the drain line to a drain manhole at Arthur street.

Drainage structure behind house number 14 Hayes Street.

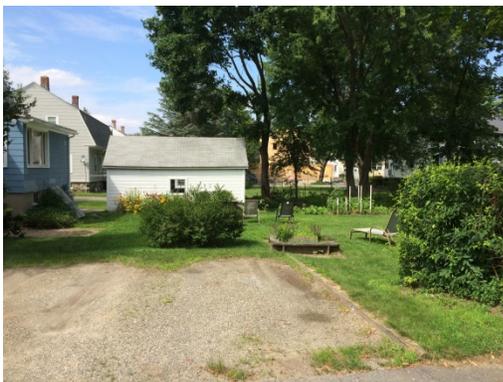
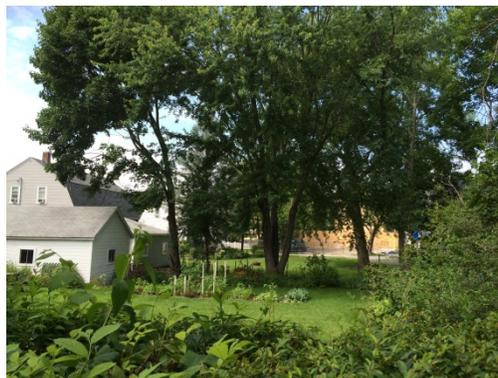
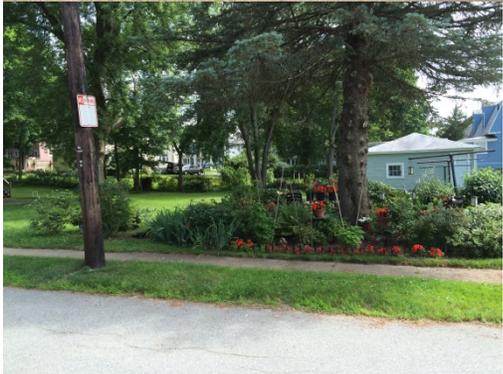
Two garages have encroached over the drain line.

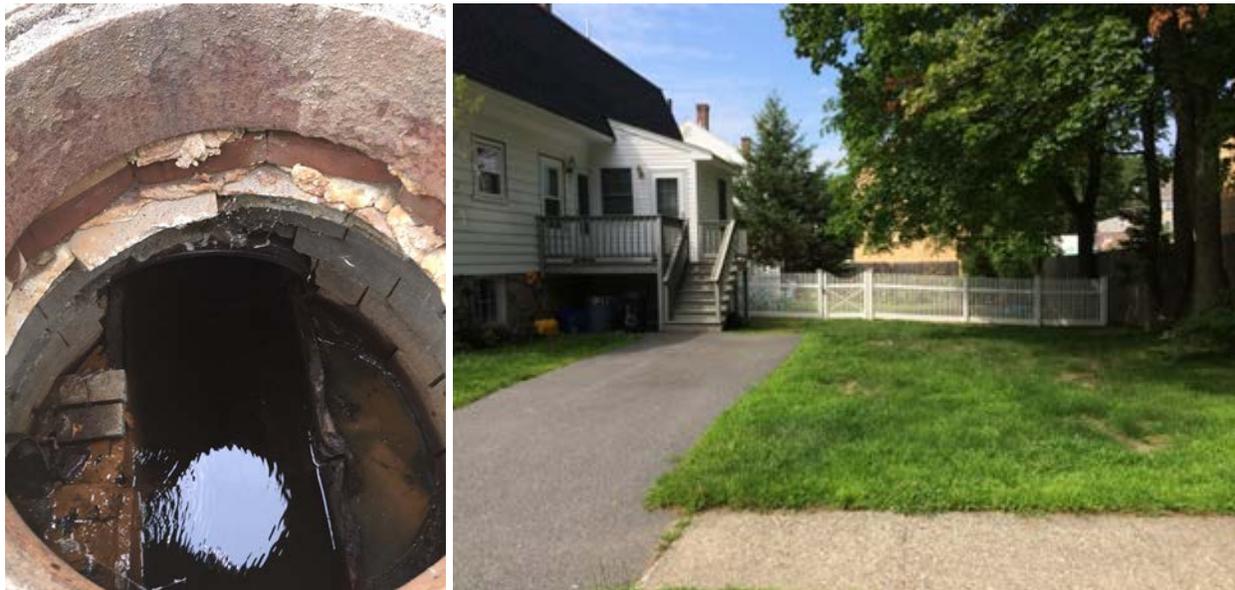
Drainage manhole 1 at Arthur St Looking north from Arthur Street towards DMH 2 behind 8 Arthur St.

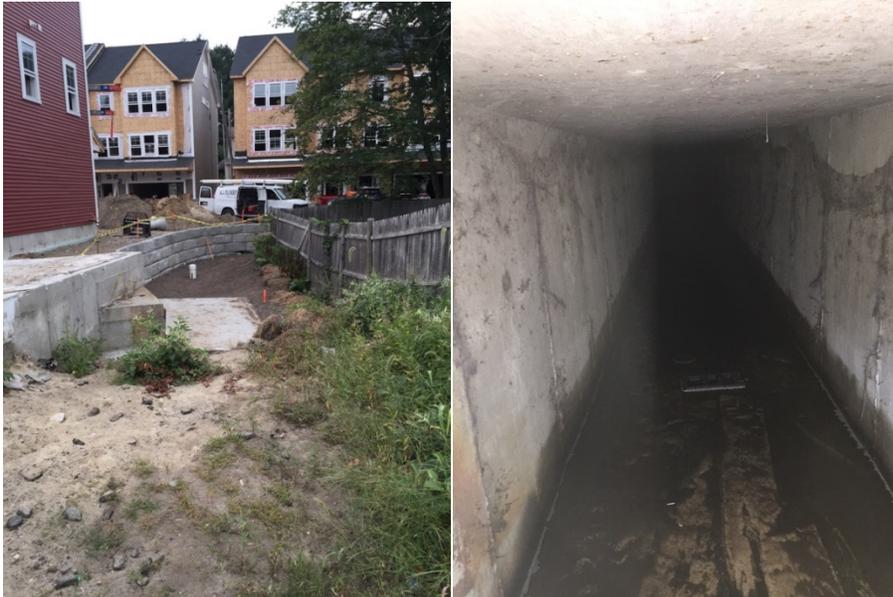
View of 49 -51 Waltham Street development under construction from Hayes Street. Drain Line runs under corner of concrete slab that has since been removed. The corner of the special transition structure can be seen in center of photograph where the 36 inch diameter drain discharges into the box culvert shown..

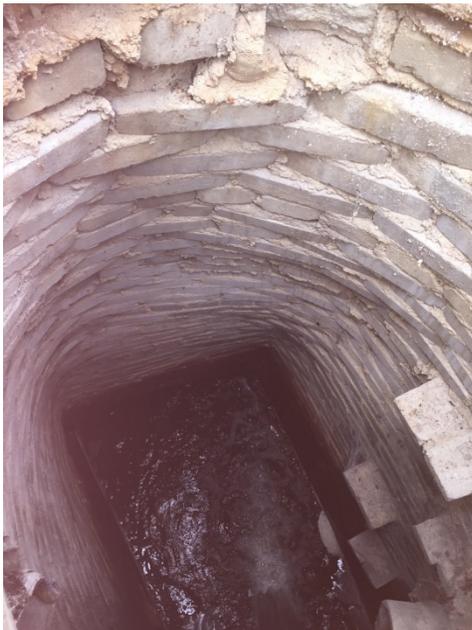
View looking down DMH 4 at Waltham Street where the 42 inch diameter cast iron drain drops into the 48 inch diameter RCP drain before crossing under Waltham Street. Additional drainage from Waltham Street also discharges into this manhole.

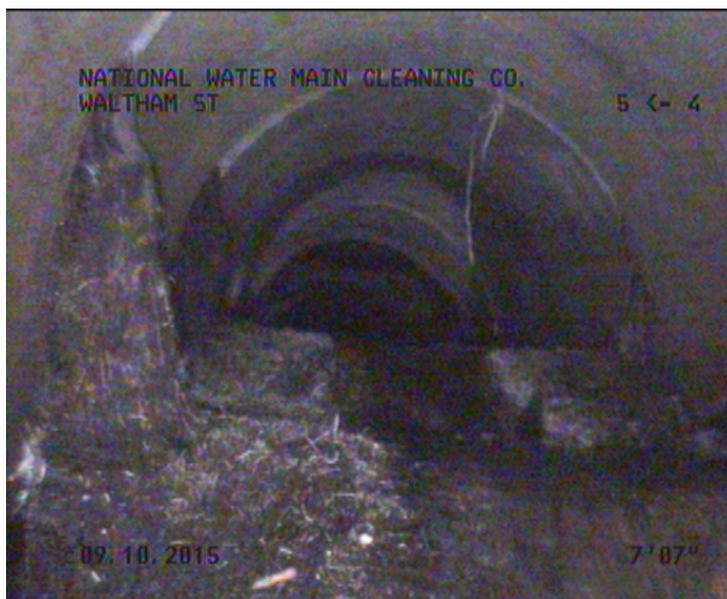
48 inch diameter drain under Waltham Street is severely constricted with roots.
Design with community in mind

This 48 inch diameter RCP drain is severely restricted with root intrusion with more than half the pipe obstructed by roots, grit and debris.

Manned entry is required to remove roots, grit and debris in this 48 inch diameter RCP drain to restore full flow capacity. Dewatering of upstream DMH 4 will be required to safely remove roots. The Town should consider removal of roots as soon as possible in this severely restricted pipe to restore flow capacity. It is also recommended that the pipe be treated for roots and periodically monitored to ensure full capacity is maintained and that root intrusion is controlled. This effort will require specialty firms to complete the work.

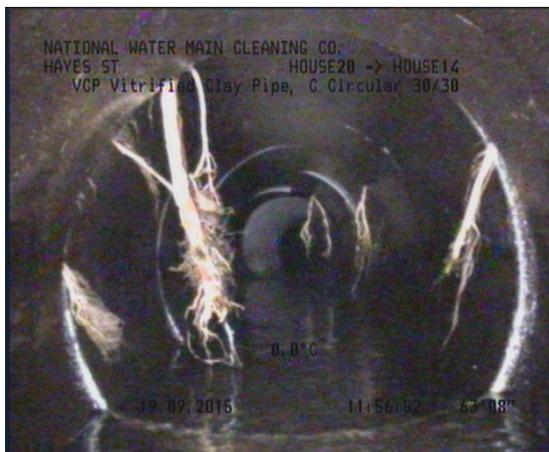
This line exhibited longitudinal cracking and medium root intrusion. In addition, this line has another section that is beginning to collapse.

Medium root intrusion

It is recommended that this section be completely replaced from drainage structure to drainage structure. There have been a few repairs on the line already including a section that reduces the capacity from a 30 inch down to a 24 inch diameter line and the sections between repairs that are cracked, with root obstructions and beginning to collapse.

Replace existing pipe with a 36 inch class IV reinforced concrete pipe and gasketed joints. The drainage structure at House number 20 will need to be reconstructed along with the invert at drainage structure at house number 14. There is a drainage connection on Roosevelt Street at the 123 foot position at which a new drain manhole is recommended to be constructed to accommodate the connection and to provide access. A private connection to the new drain at the 113 foot position is also required.

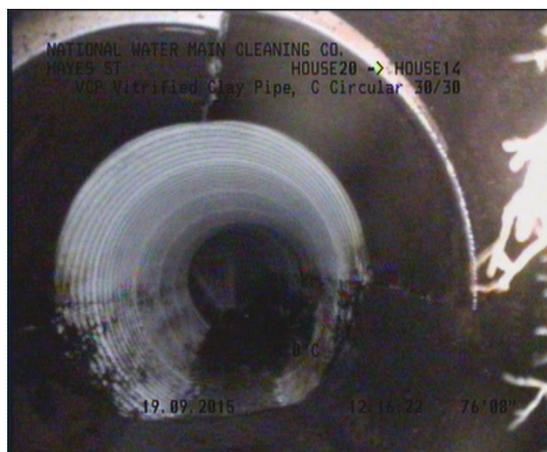
This section of drain was in poorest condition. There were three previous repairs made to this line that included excavated spot repairs. A 40 foot section of the 30 inch VC line was replaced with 24 inch diameter HDPE truss pipe to repair a collapsed section. A 20 foot section of the VC line was replaced with 30 inch corrugated metal pipe (CMP) to replace another collapsed section. An excavated spot repair was also identified that patched a hole in the pipe with a section of VC pipe and masonry.

Previous spot repair and adjacent longitudinal pipe crack

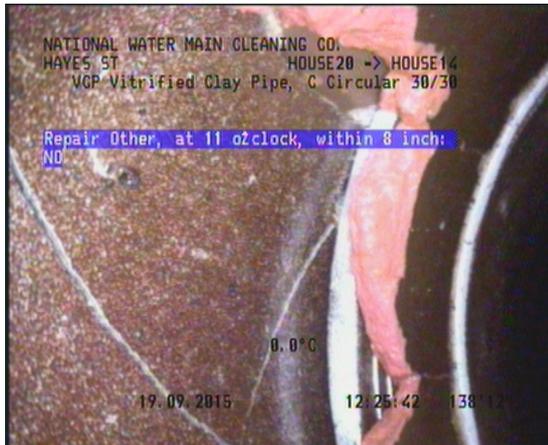
Previous hole repair

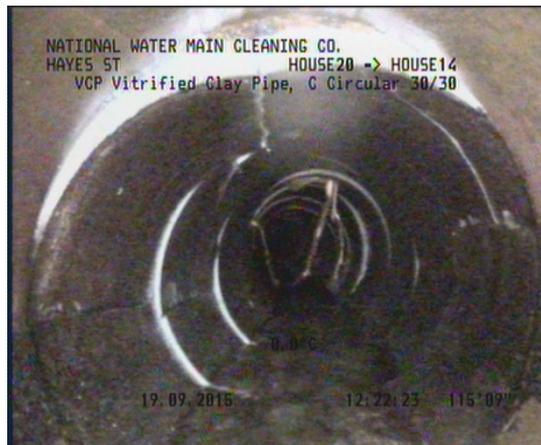
Partial collapse of Drain

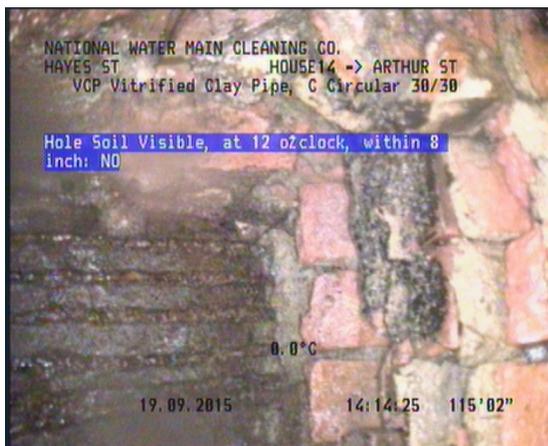
This section of drain also has a section that is beginning to collapse just before it connects to DMH 1 under Arthur Street. In addition there is a hole in the pipe where soil is visible just before Arthur Street. The remainder of the line is intact with some medium roots but the two garages at House numbers 14 and 12 encroach over the drain.

Hole in pipe, soil is visible

This section of drain also has a section of it that is beginning to collapse just before it connects to DMH 1 under Arthur Street. In addition, there is a hole in the pipe where soil is visible just before Arthur Street. There is a section of 8 inch sewer in Arthur Street that has also collapsed near where the sewer crosses under the drain. This section of drain should be replaced when the sewer is replaced because it will completely collapse when the sewer is reconstructed. The sewer work is currently under design and replacement of this section of drain should be accommodated at the same time.

Replace existing pipe with a 36 inch class IV reinforced concrete pipe and gasketed joints. The remainder of the line is intact with some medium roots. The two garages at House numbers 14 and 12 encroach over the drain which make replacement difficult and failure may produce collateral damage. It is recommended that the pipe be treated to remove roots and that the line be thoroughly cleaned and a cured in place liner be installed through this section to protect the structural integrity of the pipe and extend its design life.

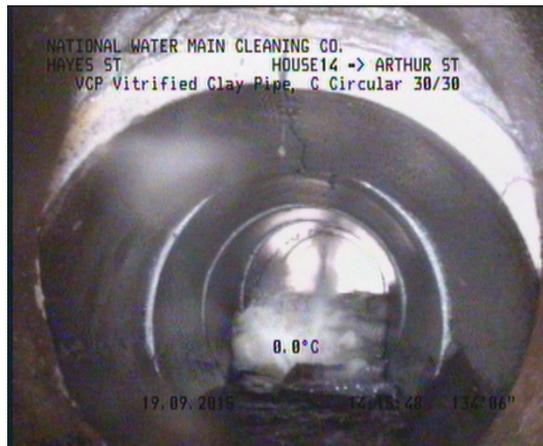
Partial collapse of Drain

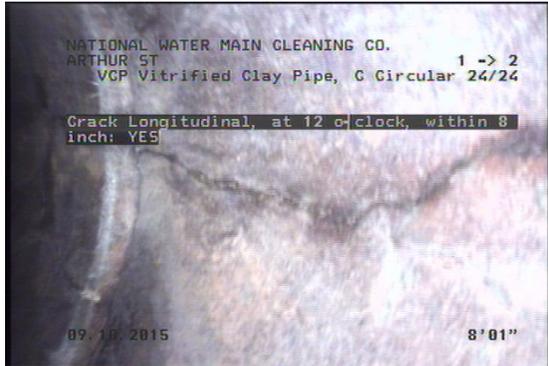
There is a 12.5 foot section of 24 inch VC pipe that leaves DMH 1 and transitions to a 30 inch CMP where 22 foot section all the way to DMH 2 was replaced. It is functioning but the decrease in size constricts the flow .

Longitudinal crack in VC pipe

There is a section of 24 inch VC pipe that leaves DMH 1 and transitions to a 30 inch CMP. It is recommended to replace this line with a 36 inch class IV reinforced concrete pipe and gasketed joints to improve pipe capacity and restore structural integrity. In addition, it is recommended that drain manhole 1 be replaced and drain manhole 2 be reconstructed to accommodate replacement pipe.

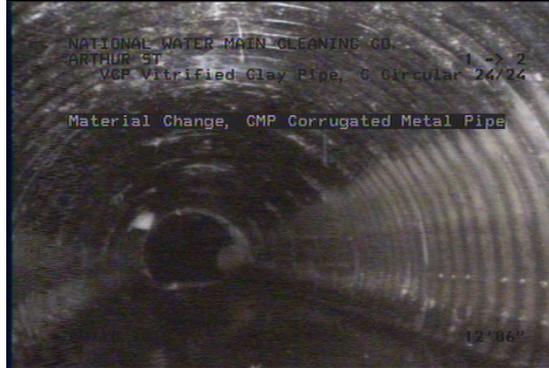
Section of drain was replaced with CMP

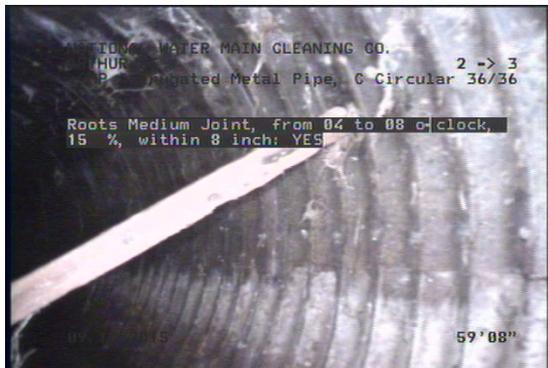
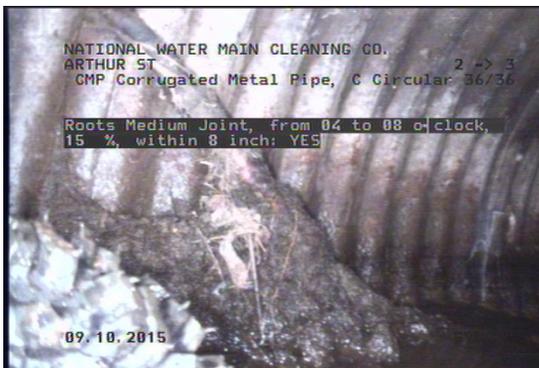
This section of drain was previously replaced with corrugated metal pipe. It has some medium root intrusion but is functioning. The drainage structure at DMH 3 sits in low elevation and can be subject to ponding. As previously stated, DPW made repairs to concrete block DMH 3.

Section of drain replaced with 36" CMP Medium roots at joint

Periodically monitor this line for roots and provide root treatment as needed.

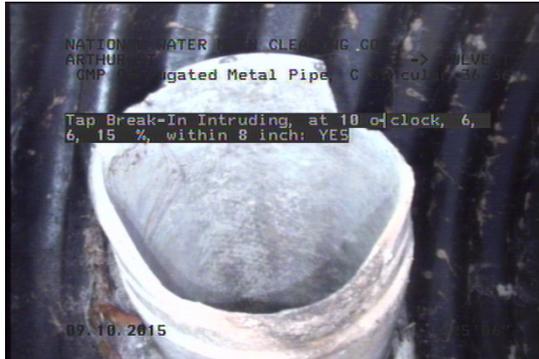
This approximately 30 foot long section of drain was also previously replaced with corrugated metal pipe. It has a couple of intruding connections at approximately 25.5 and 26.5 feet respectively that could be trimmed back to remove obstructions but is functioning well.

Protruding connection

Periodically monitor this line for roots and condition. Consider trimming two protruding connections at approximately 25.5 and 26.5 feet respectively.

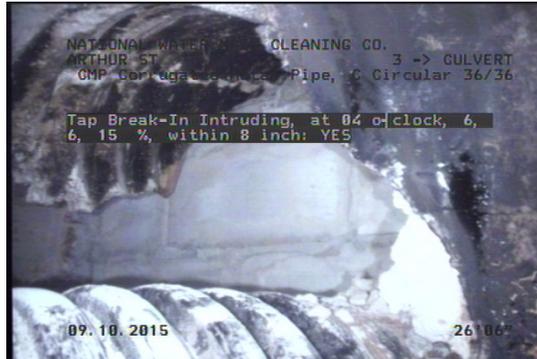
Protruding drainage connection

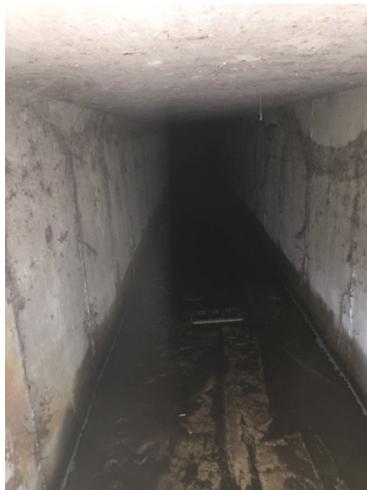
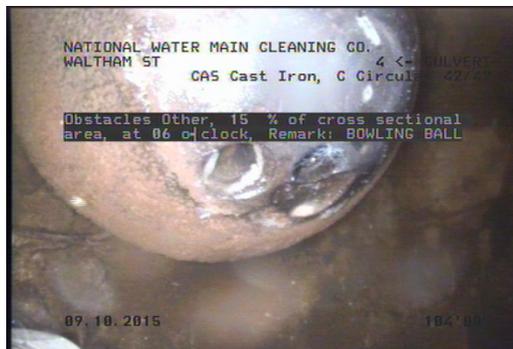
The RCP box culvert is in excellent condition with some minor debris including a cinder block and bowling ball that should be removed. The 42 inch diameter cast iron portion section of this drain is also in very good condition

Box culvert with minor debris

Manned entry is required to remove minor debris including a cinder block and bowling ball. It is recommended that this debris be removed when manned entry is performed to remove roots from next section.

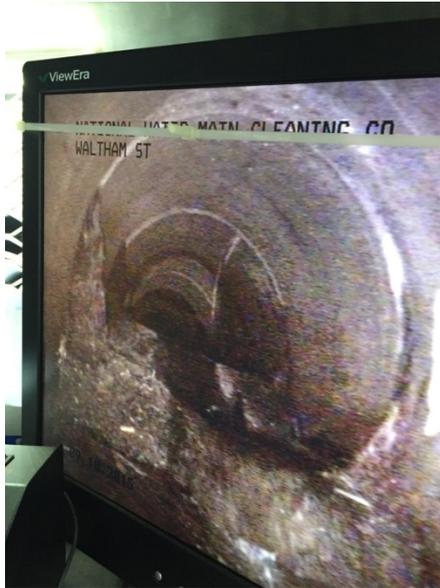
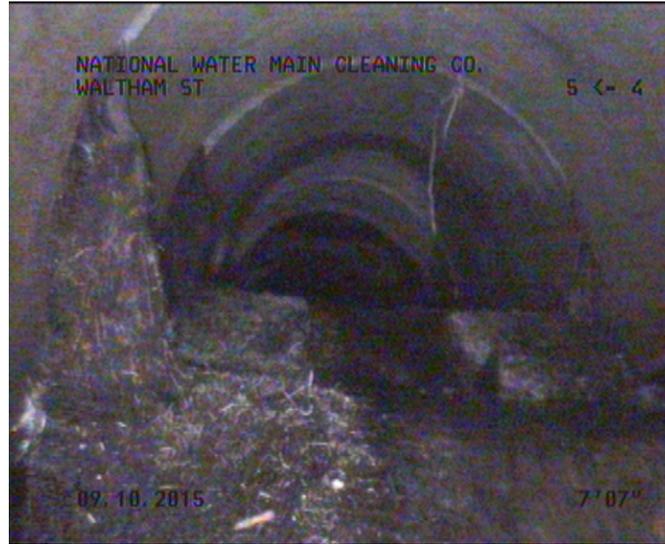
Sewer root balls and intrusion

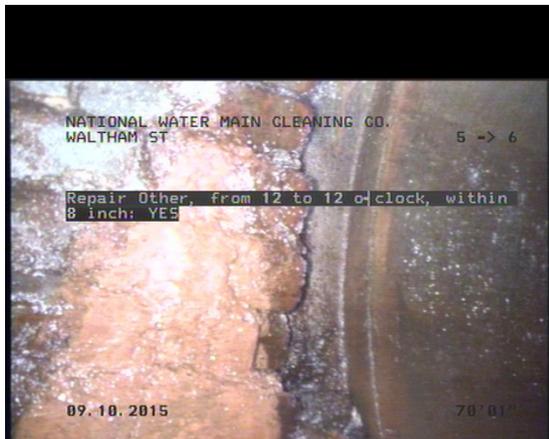
This 48 inch diameter RCP is in good condition with a previous repair noted at the 70 foot mark and some minor encrustation and fine roots noted

Previous pipe repair

Remove some minor fine roots and perform spot root treatment when upstream manned entry root removal is completed upstream. Inject grout at previous spot repair and areas where encrustation noted.

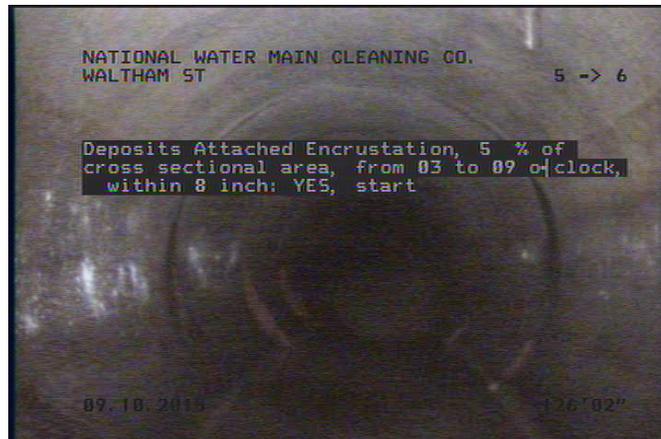
Minor Encrustation

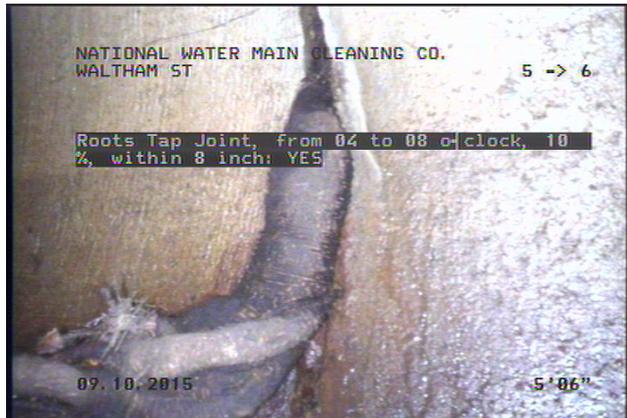
Tap root

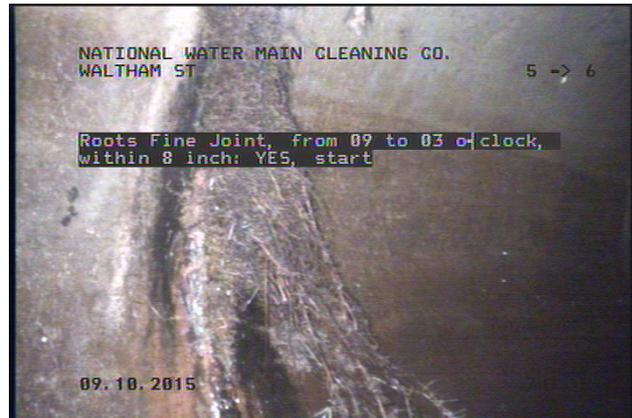
Fine roots at joint
