Town of Maynard, Massachusetts Building Observation Report

AECOM Technical Service Inc.
66 Long Wharf, 3rd Flr.
Boston, MA 02110
(617) 723-1700

December 2010

Executive Summary

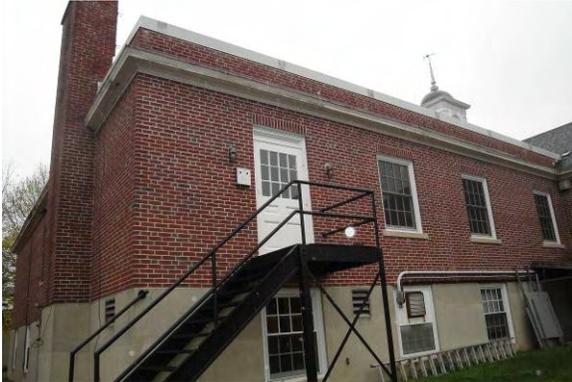
Figure 2.10 – Painted Metal Stair

The Town Hall has a lower concrete stair and a painted metal stair located at the rear entrances, which do not currently have

balusters within the guardrail system (figure 2.10).

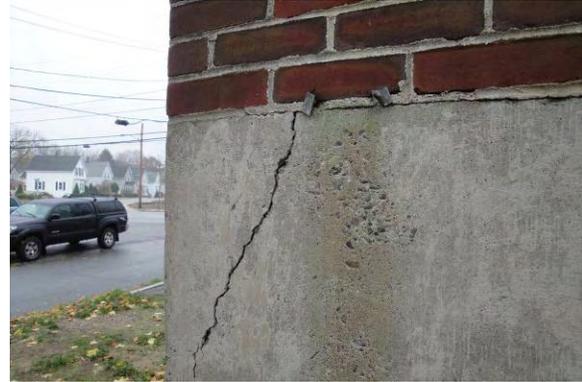
Figure 2.11 – Foundation Corner Cracks

The foundation walls appear to be in overall good condition. There are a few areas, mostly at the building corners, that display some cracks (figure 2.11).

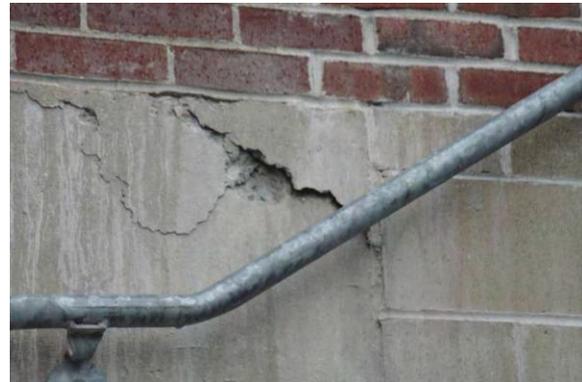
Figure 2.12 – Foundation Crack at CMU

There is an area with cracks and spalling concrete at the foundation wall adjacent to one of the exterior concrete stairs. This area is where the concrete foundation abuts a CMU wall (figure 2.12). Further investigation is required to confirm if the cracks are due to building settlement or water penetration.

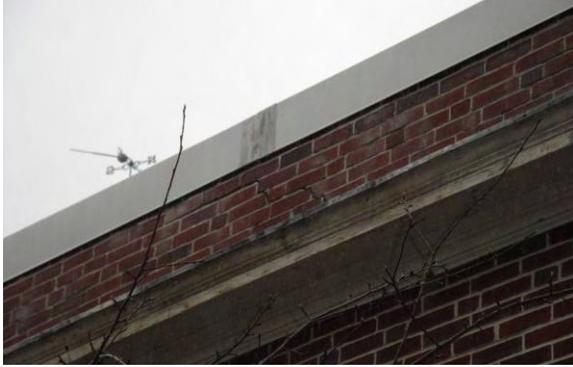
Figure 2.13 – Brick Mortar Joints

The exterior brick walls appear to be in overall good condition. Several areas of the brick veneer have been re-pointed recently. There are additional areas where the mortar joints appear to be deteriorated and cracked. These deteriorated joints may allow water to penetrate the brick veneer and enter into the wall cavity. Further investigation may be required (figure 2.13).

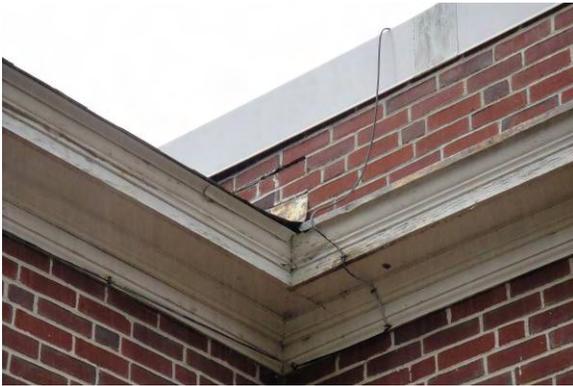
Figure 2.14 – Brick Mortar Joints

There are also sections of the brick near the roof line where it appeared that sections of flashing have been removed and the mortar joint was not repaired (figure 2.14).

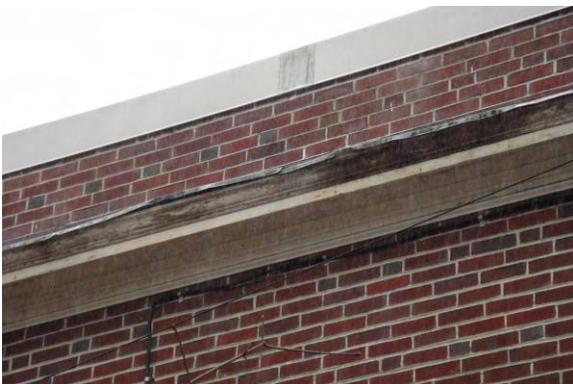
Figure 2.15 – Metal Flashing

The metal flashing at the cornice trim was in fair condition. Some areas appear to be damaged and/or loose; which may allow water to penetrate into the wall cavity. Further investigation may be required (figure 2.15).

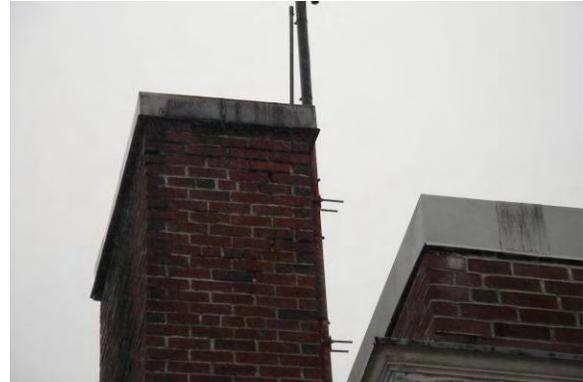
Figure 2.16 – Chimney

The brick at the chimney showed visible areas of deteriorated and/or loose mortar joints. The metal chimney cap appears to be old and worn (figure 2.16).

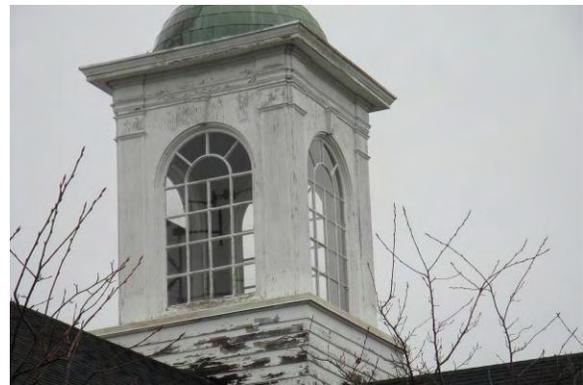
Figure 2.17 – Roof Cupola

The paint finish at the wooden roof cupola (steeple) appears to be weathered and sections are currently peeling (figure 2.17).

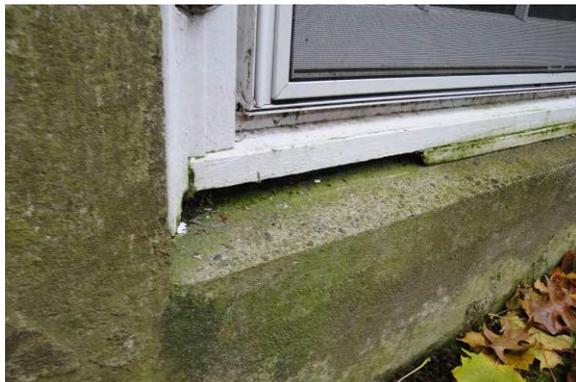
Figure 2.19 – Window Sealant

There are sections of sealant missing at some of the exterior windows (figure 2.19).

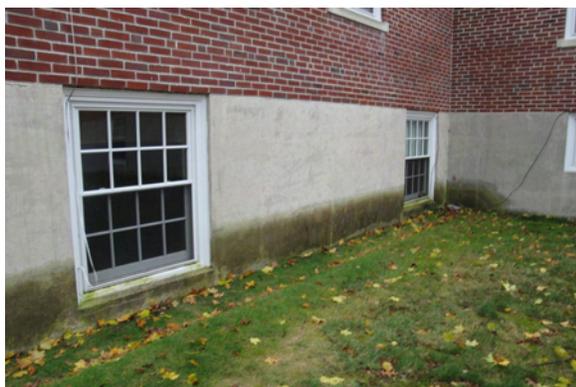
A back portion of the Town Hall roof does not currently have gutters and downspouts to capture the water run-off. There is evidence of water/moisture issues below the lower-level windows, along the building perimeter, and at the partial below grade floor in this area. Above grade staining of the concrete foundation wall is evident; and there appears to be mold/moss growth in this area (figure 2.19a).

Figure 2.19a – Signs of Roof Rain/Water Run-Off

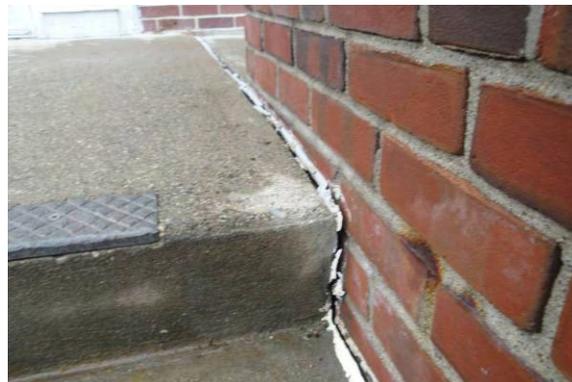
Figure 2.20 – Concrete Stair Sealant

The sealant along the edges of the Town Hall main entrance stairs has deteriorated, and may allow water to penetrate below the concrete surface (figure 2.20).

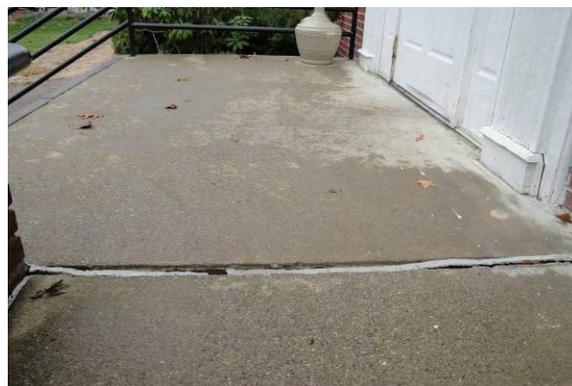
Figure 2.21 – Ramp Sealant

The sealant between the edge of the Town Hall main entrance stairs and the edge of the access ramp has deteriorated, and may allow water to penetrate below the concrete surface. There is also a deviation between the two walking surfaces that may exceed the maximum elevation change limit allow by the building code. This area may create a tripping hazard at the top of the ramp. Further investigation may be required (figure 2.21).

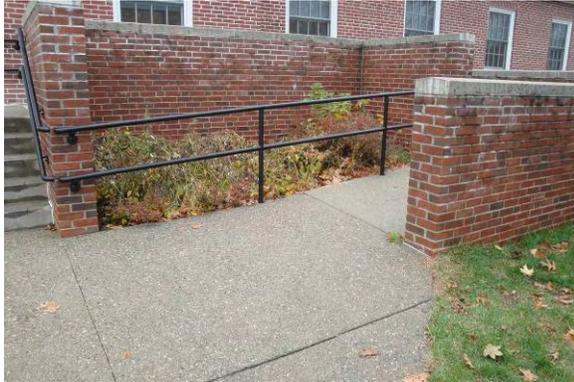
Figure 2.22 – Accessible Ramp

The accessible entrance ramp appears to have some code compliance issues; the handrails do not have code compliant extensions at the top and bottom levels; and there is no level platform area at the bottom of the ramp. The maximum slope of the ramp was not confirmed. Further

investigation and study may be required in this area (figure 2.22).

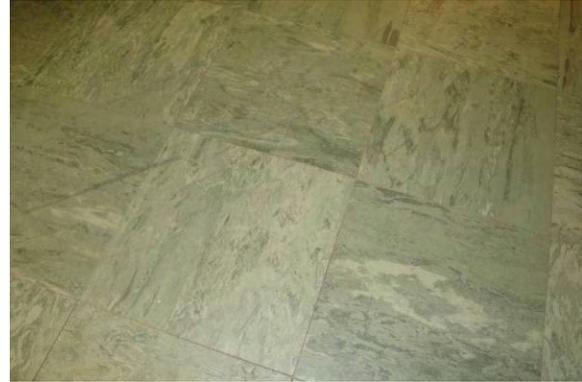
The Town Hall section of building had several different types of floor finish systems. There are 9" x 9" floor tiles located in the basement corridors and in one of the first floor storage rooms (figure 2.24), which appear to be original to the building; this floor tile and/or mastic may include asbestos containing materials (ACMs).

Figure 2.24 – Floor Tile - May contain Asbestos

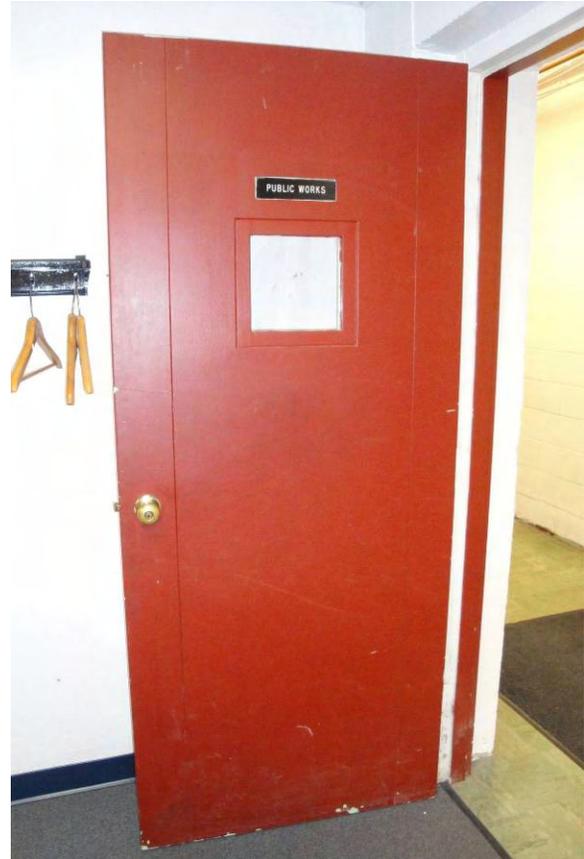
Figure 2.35 – Painted Metal Doors

There are several types of interior doors throughout the building. The Town Hall has painted metal doors within painted metal

frames throughout both floors. Some of the doors have vision panels. The door hardware does not appear to be ADA compliant in some locations (figure 2.35).

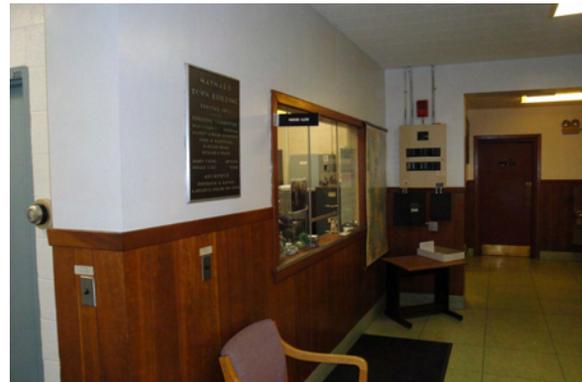
Figure 2.40 – Town Clerk's Counter

The Town Clerk and Treasurer/Collector transaction counters are also plastic laminate countertops with wood trim; but did not appear to be ADA compliant (figure 2.40).

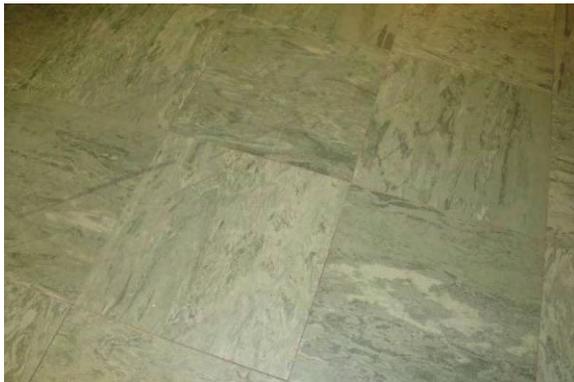
Figure 2.43 – Floor Tile - Scheduled for Abatement

It was reported to AECOM that the remaining original floor tiles at both floor levels are currently being scheduled for removal / abatement (figure 2.43).

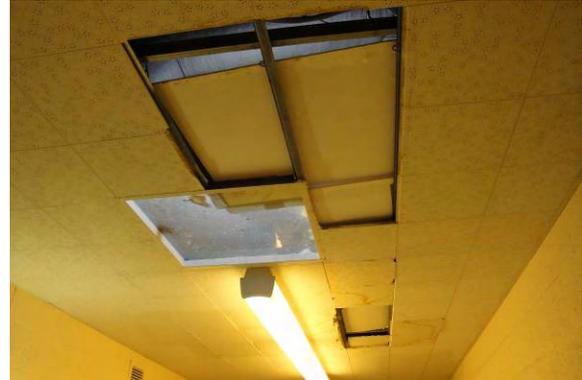
Figure 2.44 – 12" x 12" Acoustic Ceiling at Men's Room

There are several areas where the 12" x 12" acoustic ceiling tiles appear to be damaged, stained or missing. Further investigation may be required to determine if the ceiling tile damage is caused by previous or active plumbing problems and/or roof leaks (figure 2.44 and 2.45).

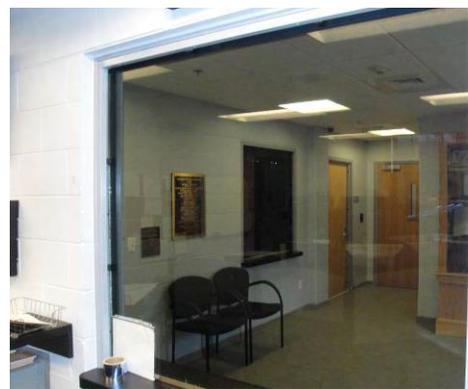
Figure 2.46 – Police Transaction Windows

The transaction window at the Police Department displayed a significant amount of cracks. Further investigation may be required to determine if the glass needs replacement and/or the frame system needs adjustment (figure 2.46).

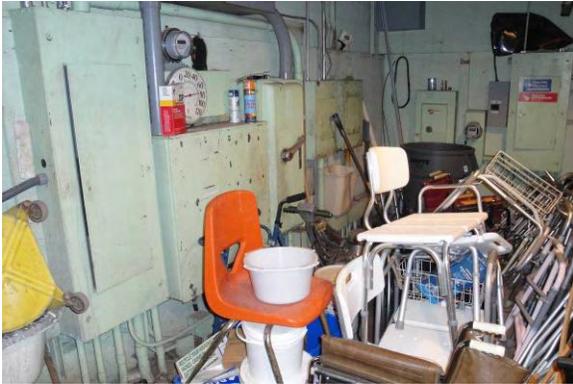
Figure 2.47 – Town Hall Main Electrical Panel

The Town Hall electrical system panels could not be accessed due to a significant amount of items temporarily stored in front of the panels (figure 2.47).

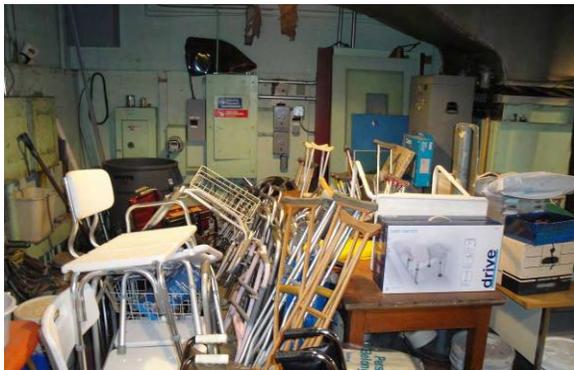
Figure 2.52 – Air Handling Unit

There is a ventilation system located in the main boiler room, which appears old and possibly original to the building. The system could not be observed due to a significant amount items stored in front of the system (figure 2.52).

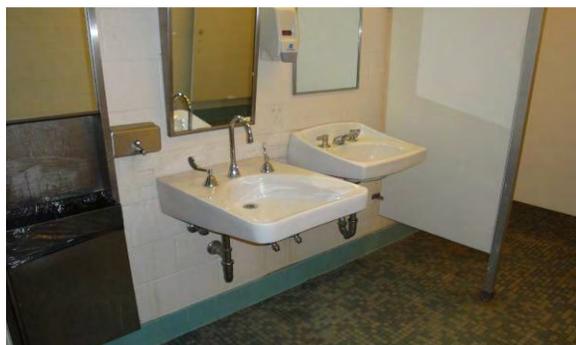
Figure 2.57 – Town Hall Second Floor Men's Room

The plumbing fixtures on the lower floor appear to consist of a combination of both original and replacement fixtures. The fixtures appear to be in good condition and are functioning properly, however the older fixtures may not be water-conserving. Further investigation may be required at

these rooms to determine if the configuration is compliant with accessibility regulations (figure 2.57).

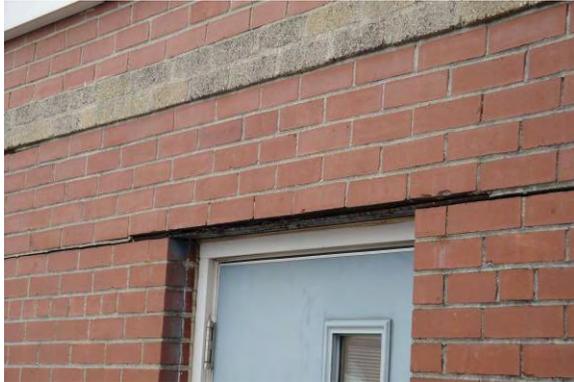
Figure 3.08 – Mortar at Lintel

The exterior brick walls appear to be in generally adequate condition with specific deficiency items noted in the comments below. There are a few areas where the mortar appeared to be aging and weathered. The mortar at some of the masonry opening lintels appeared to be in poor condition; the mortar was deteriorated, loose, and/or missing (figure 3.08). Further investigation may be required to verify if and

where water is penetrating into the wall cavity.

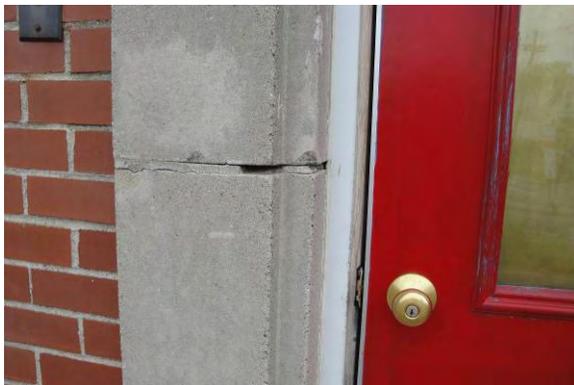
Figure 3.09 – Cast Stone at Main Entrance

The mortar joints at the cast stone jambs around the main entrance door are deteriorated and there were sections of the joints where the mortar was missing (figure 3.09).

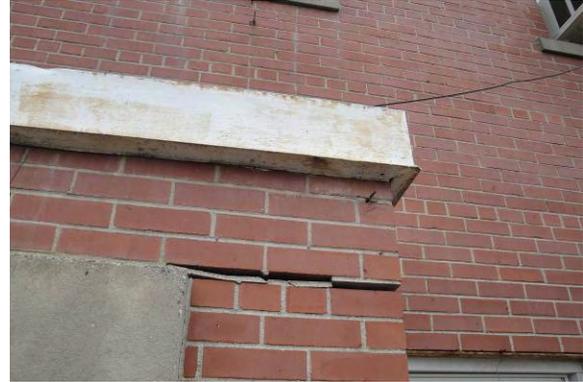
Figure 3.10 – Brick above Main Entrance

The exterior brick wall above the main entrance door's cast stone surround was in poor condition. The mortar was deteriorated, loose, and in some areas missing (figure 3.10). Further investigation may be required to verify if and where water is penetrating into the wall cavity.

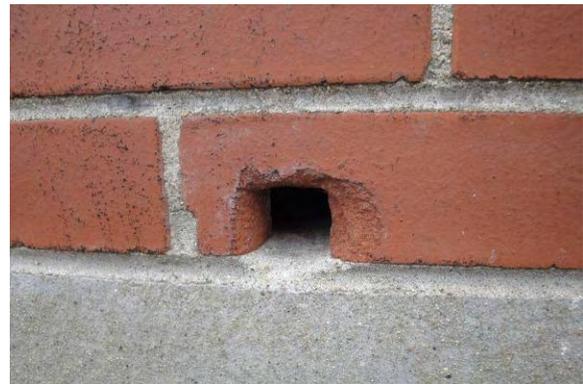
Figure 3.11 – Holes in the Brick

There are a few holes in the exterior brick veneer which appear to be from abandoned conduit (figure 3.11). Further investigation may be required to verify if and where water is penetrating into the wall cavity at these holes.

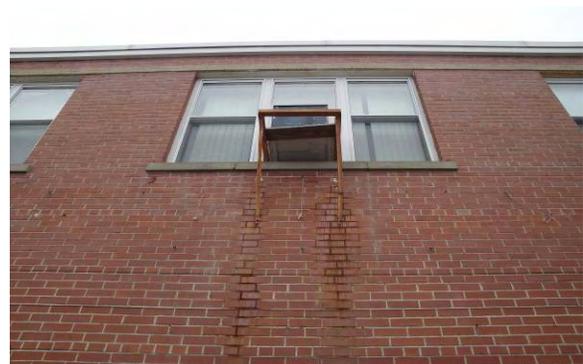
Figure 3.12 – Rust on Brick

The metal supports for the window AC units appear to be rusting, with rusty water dripping down and staining the face of the brick veneer. Further investigation may be required to confirm if the water has damaged the mortar joints or has just left surface staining (figure 3.12).

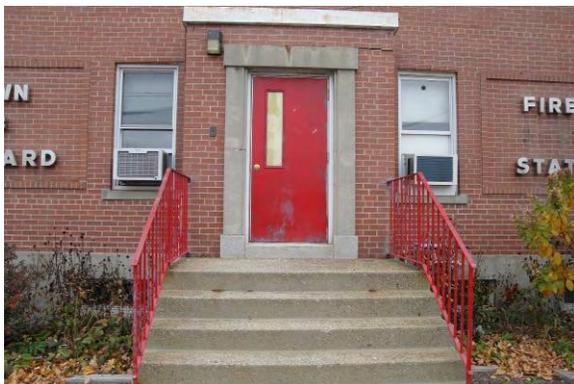
Figure 3.13 – Main Entrance Door

The paint finish on the exterior metal doors and frames appears to be weathered and faded (figure 3.13).

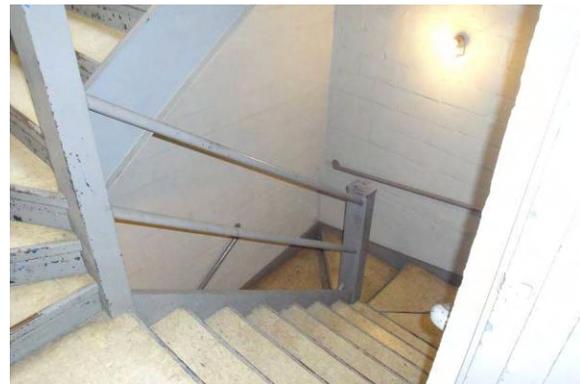
Figure 3.23 – Interior Stair

The building has one interior stairs located in the center of the building, connecting all floor levels from the basement through the second floor (figure 3.23). The stair is constructed with winders (triangular stair treads), open guardrails and other features not in compliance with current code requirements.

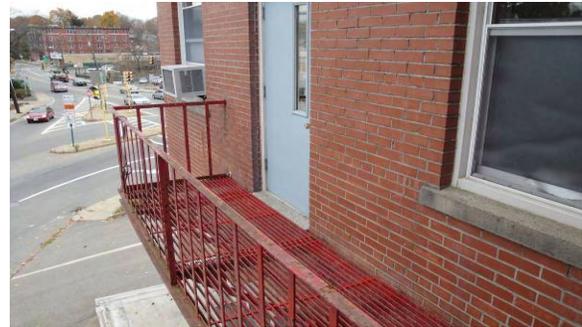
Figure 3.26 – Fire Escape

There is an exterior fire escape which provides access to the top of the tower above and to the finish grade below (figure 3.26). It was reported during our initial walk-thru that the structural capacity of the fire escape may be questionable. Further study/analysis may be required to determine the capacity and structural characteristics of the existing fire escape.

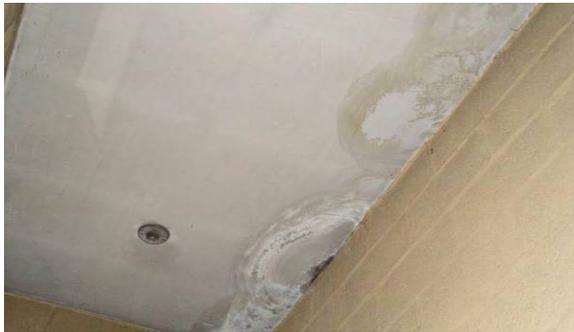
Figure 3.29 – Plaster Ceiling Damage

The plaster ceilings within the building appear to be in overall good condition, however, there are some areas in the basement stair that appear to be damaged from previous roof leaks. Further investigation may be required to determine the cause of the damage and if there is any non-visible damage to the structure (figure 3.29).

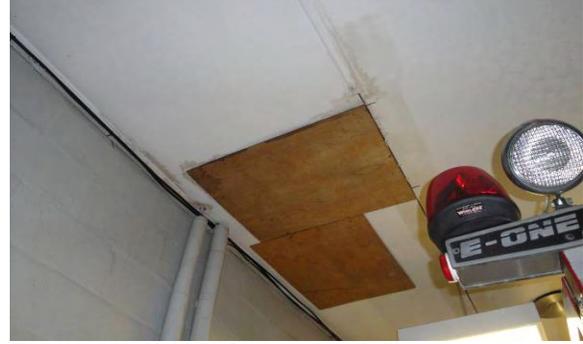
Figure 3.30 – Vehicle Storage Bay Ceiling

There are sections of the vehicle storage bay plaster ceiling that have been patched with plywood panels mounted to the underside of the ceiling. These appear to be areas with water damage, which may have been caused by a leaking pipe above. Further investigation may be required to determine the cause of the damage and if there is any non-visible damage to the structure (figure 3.30).

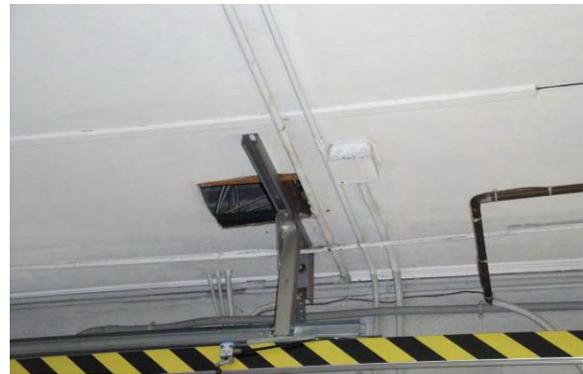
Figure 3.31 – Vehicle Storage Bay Ceiling

There are sections of the plaster ceiling missing at the vehicle storage bay ceiling (figure 3.31)

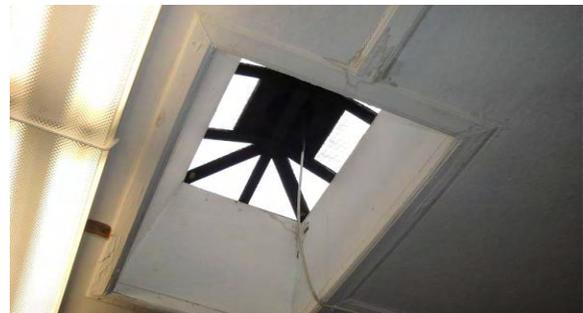
Figure 3.32 – Stair Skylight

The plaster ceiling around the skylight at the interior stair displays signs of water damage, which may have been caused by previous leaks in the roof. Further investigation may be required to determine the cause of the damage and if there is any non-visible damage to the structure (figure 3.32).

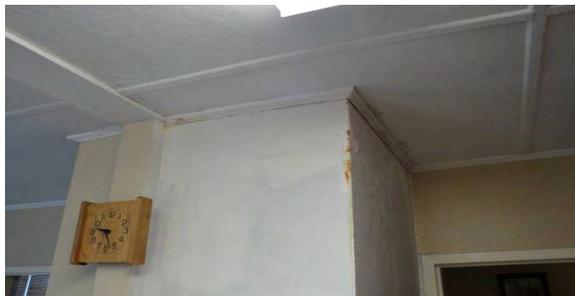
Figure 3.33 – Lunchroom Ceiling

The plaster ceiling in the second floor eating area also displays evidence of previous water damage (figure 3.33).

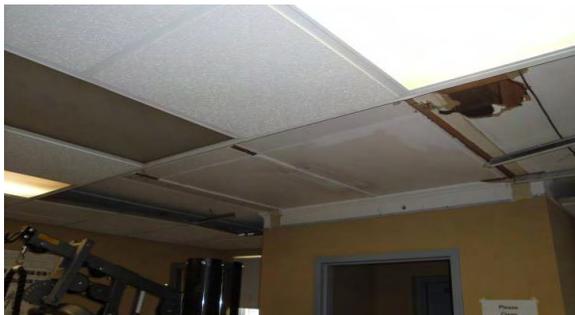
Figure 3.34 – Dismantled 2x4 Ceiling

There are missing tiles in sections of the first floor acoustic ceiling system that appear to have been dismantled and/or removed during the relocation of the police department equipment during the recent relocation (figure 3.34).

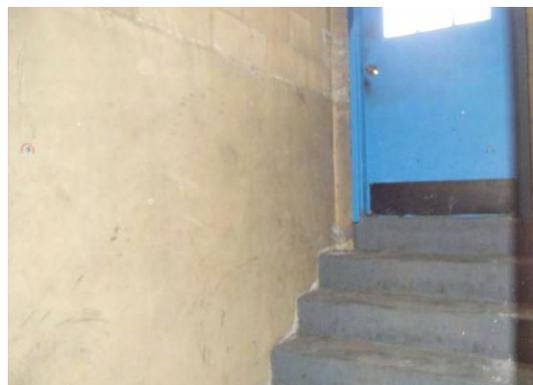
Figure 3.35 – Basement Stair

The basement stairs do not have handrails, as required by current codes. The treads are painted concrete, which creates a slippery walking surface even under dry conditions (figure 3.35 & 3.36).

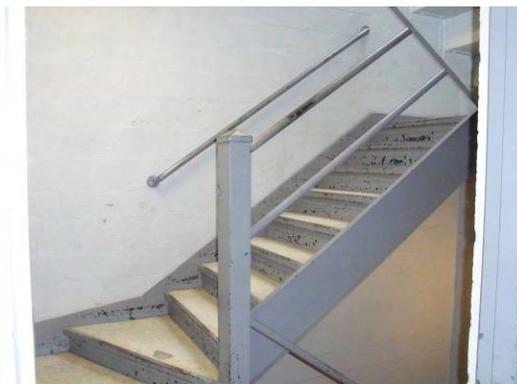
Figure 3.37 – Interior Stair

The interior stair does not appear to conform to current building code and ADA requirements. The stair winders, open guardrail system and low handrail heights appear to be not compliant with current codes (figure 3.37 & 3.38). The paint appears to be peeling and worn throughout.

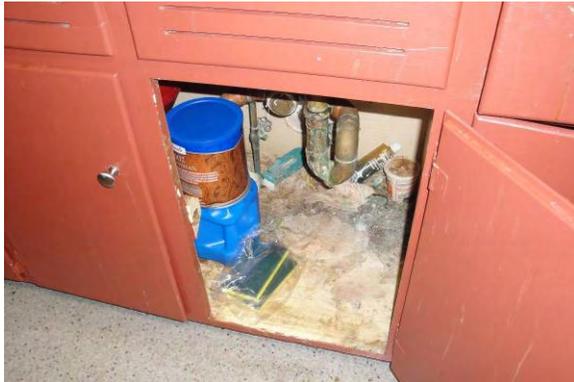
Figure 3.39 – Lunchroom Casework

The sink base cabinet in the eating area displays evidence of water damage, which may have been caused by previous leaking plumbing fixtures/pipes (figure 3.39).

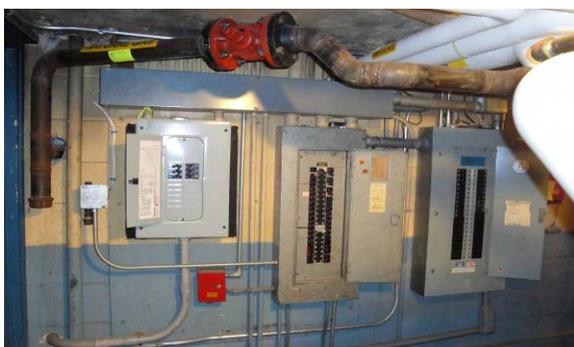
Figure 3.40– Main Electrical Panel

The electrical service is provided by overhead wires. The main electrical panel indicates 225A/240V/single phase power (figure 3.40). The electrical panels appear to be original to the building.

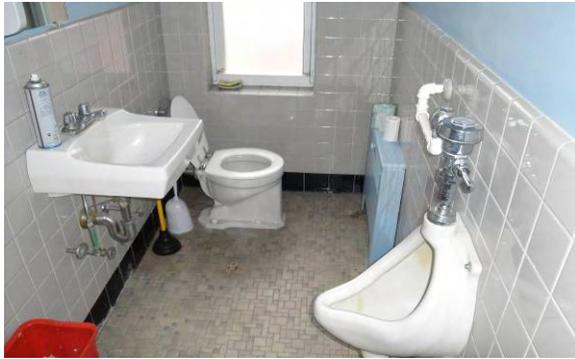
Figure 3.48 – First Floor Men's Room

The building has several toilet rooms. The first floor has a men's room, which consists of a toilet, urinal, and sink (figure 3.48); and a women's room, which consists of a toilet and sink. The fixtures appear old and dated, and likely are not water-conserving fixtures, but they appear to be functioning properly.

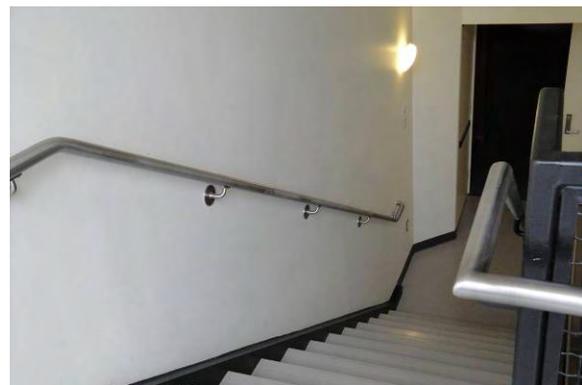
Figure 4.10 – Side Stair

The other two egress stairs are located on the north and south sides of the building. These enclosed stairs connect all three stories of the building, and the south stair extends up to the roof (figure 4.10).

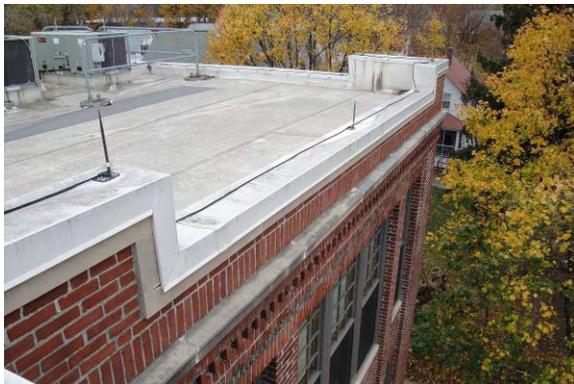
Figure 4.11 – Exterior Brick

The exterior of the building appears to be in generally good condition. The mortar at the brick, stone, and cast stone appears to be solid and in good shape. There is visible evidence that some areas have been previously repointed (figure 4.11).

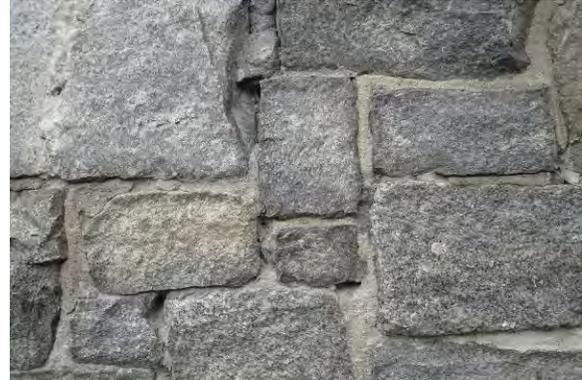
Figure 4.12 – Foundation Stone

There are a few areas in the stone foundation where the mortar was loose and sections are missing (figure 4.12).

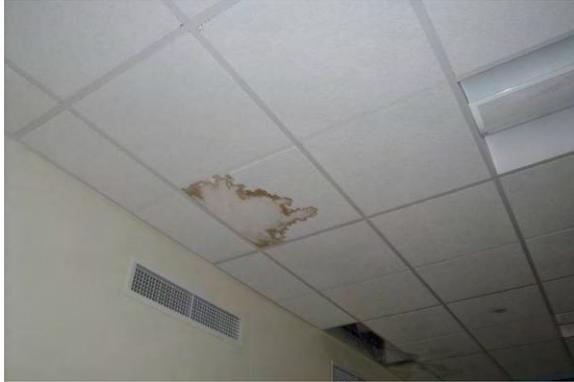
Figure 4.22 – Damaged Ceiling Tiles

The majority of the interior was in very good condition. There are a few areas where ceiling tiles are water stained; which may have been caused by prior roof leaks and/or leaking plumbing fixtures. Further investigation may be required to determine if the ceiling tile damage is caused by previous or active plumbing problems and/or roof leaks (figure 4.22).

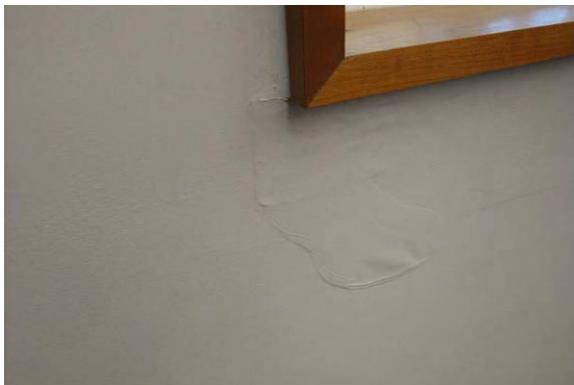
Figure 4.23 – Damaged Wall Paint

The paint on the gypsum board walls and some of the wood trim around the skylight appears water damaged, which may have been caused by leaks in the skylight assembly at the roof level. Further investigation may be required to determine the cause of the leaks (figure 4.23).

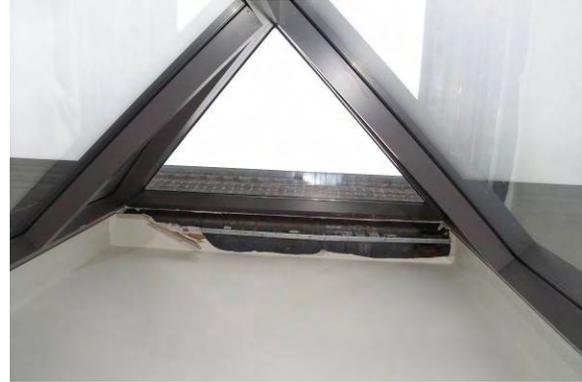
Figure 4.24 – Damaged Gypsum Ceiling

There are sections of the gypsum board ceiling assembly at the south stair (above the two-story protruding bay element) where the gypsum board appears damaged and missing, which may have been caused by water penetrating from the exterior masonry wall above. Further investigation may be required to determine the cause of this damage (figure 4.24).

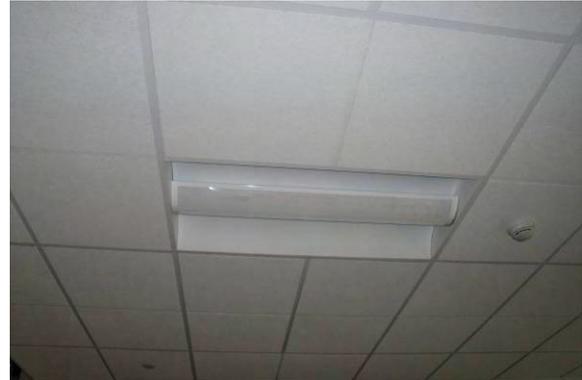
Figure 4.28 – Recessed Indirect Light Fixture

The building also has recessed 2'x4' fluorescent light fixtures within the

suspended ceiling grids (figure 4.28). There are a few fixtures with burned out lamps.

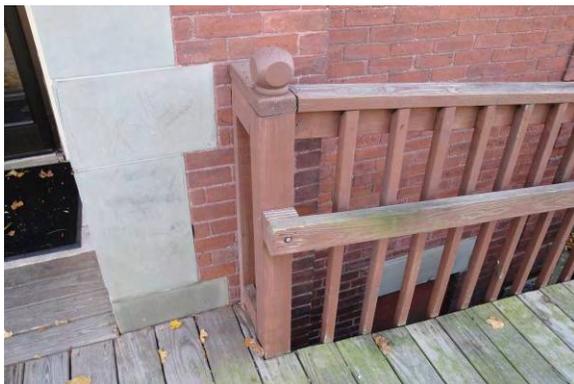
Figure 5.09 – Top of Accessible Ramp

The accessible ramp appears to have several code compliance issues: the handrails do not have extensions at either end; the handrails do not conform to the profiles and minimum clearances (figure 5.09); the tread condition at the bottom of the ramp does not conform to the change in level requirements; and there is no level platform at the bottom of the ramp (figure 5.10). The maximum slope of the ramp was not confirmed. Further investigation may be required.

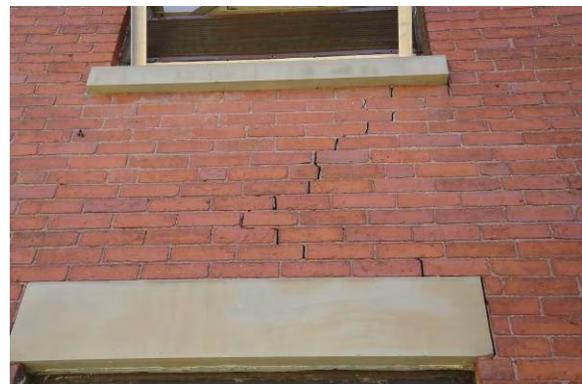
Figure 5.12 – Cracks in Brick Mortar Joints

There are several areas where the mortar joints appear cracked (figure 5.12).

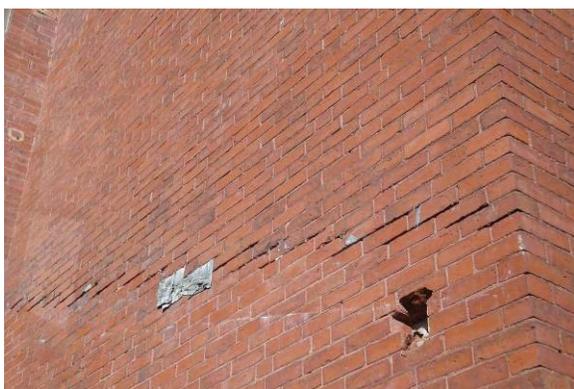
Figure 5.13 – Flashing and Beam Pockets in Brick

There appears to be remnants of a previous canopy construction at the rear of the building. At the brick wall there are visible pieces of metal flashing inserted into the mortar joints where this canopy once was located. There are also several holes in the brick, which appear to form abandoned beam pockets. The mortar joints at the flashing have deteriorated and the beam pockets have not been filled. This may allow water to penetrate into the masonry wall. Further investigation may be required (figure 5.13).

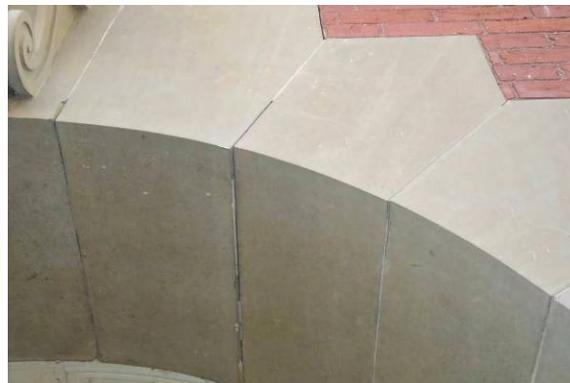
Figure 5.14 – Main Entrance Archway Stone

The mortar joints in the stone archway around the main entrance door have deteriorated and sections of mortar are missing (figure 5.14).

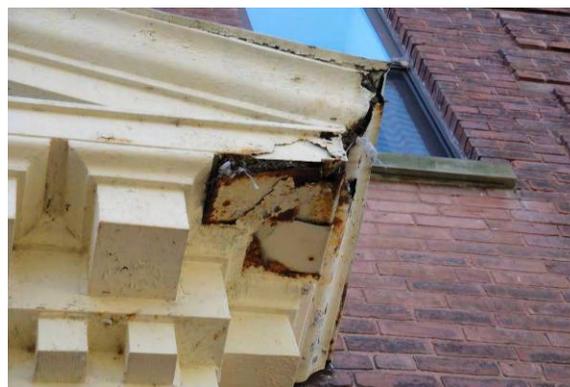
Figure 5.15 – Main Entrance Pediment Assembly

The pediment assembly over the main entrance doors displays visible signs of deterioration and corrosion on the right side (figure 5.15).

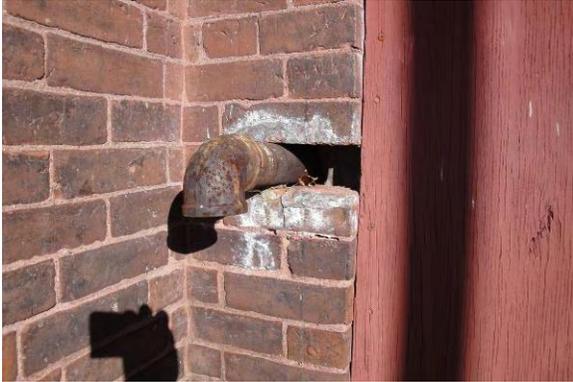
Figure 5.16 – Pipe Penetrating the Brick Wall

There is a pipe protruding out of the brick wall near the rear of the building and the opening was not sealed which may allow water to penetrate into the masonry wall. Further investigation may be required (figure 5.16). Several of the basement windows have been removed and the openings covered with plywood. The plywood displays numerous areas of rotting and bowing out. The paint is weathered and there are visible signs of sealant failure around the openings.

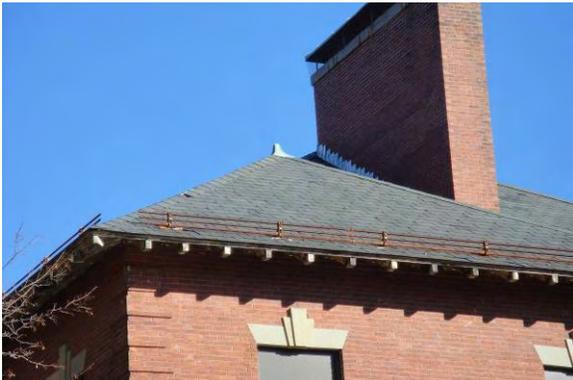
Figure 5.17 – Slate Shingle Roof

The slate roof shingles appear to be in fair condition. Based on observations on the interior of the building; there appears to be several previous or current leaks in the roof assembly. The snow fence appears rusty and detached in some locations (figure 5.17). The brick at the chimney displays evidence of deteriorated and loose mortar joints and the metal chimney cap appears worn and damaged.

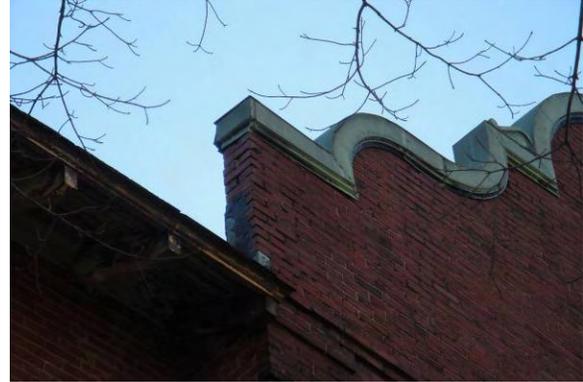
Figure 5.18 – Roof Gable Parapet Wall Brick

The brick at the decorative gable parapet wall at the roof line near the main entrance displays signs of deteriorated and loose mortar joints (figure 5.18).

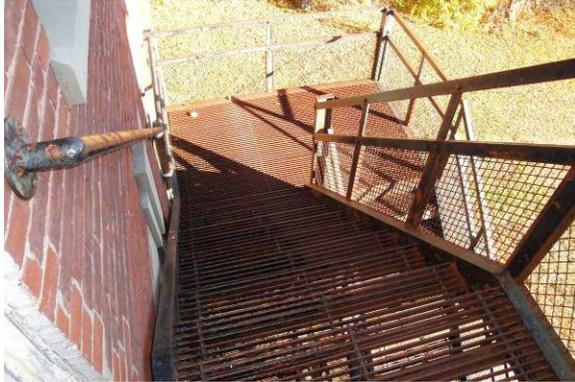
Figure 5.20 – Fire Escape Stair

The paint finish on the fire escape stair, handrails, gates, and supporting structure is severely deteriorated, and the underlying metal structure appears rusted. The paint is chipped off and peeling at several areas (figure 2.20). One of the gates is missing at one of the fire escapes, a condition which might allow unwanted access to the second floor from the grade below.

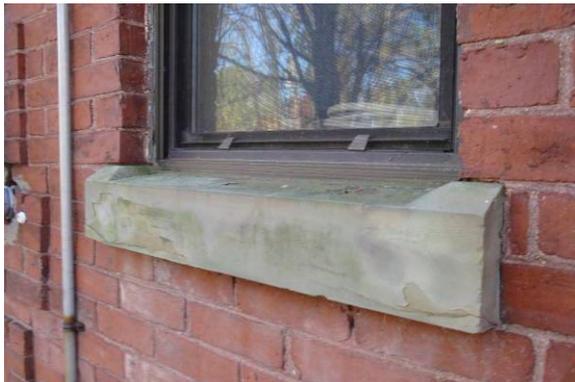
Figure 5.21 – Windows Sills

Several of the cast stone window sills and heads display signs of deterioration and are currently spalling. Several of the mortar joints are cracked and/or missing mortar (figure 2.21).

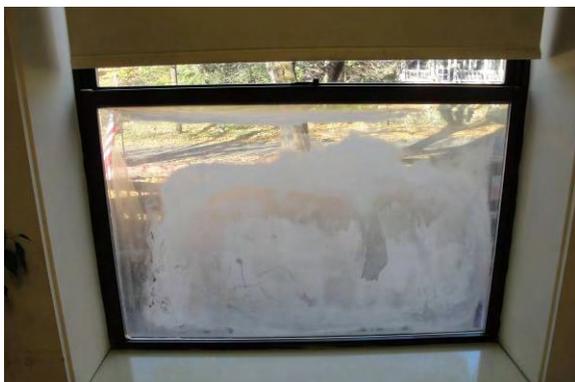
Figure 5.22 –Exterior Windows

Some of the exterior windows are difficult to open and the gaskets and seals in the insulating glass sash have failed at several of the windows causing clouding of the glass (figure 5.22).

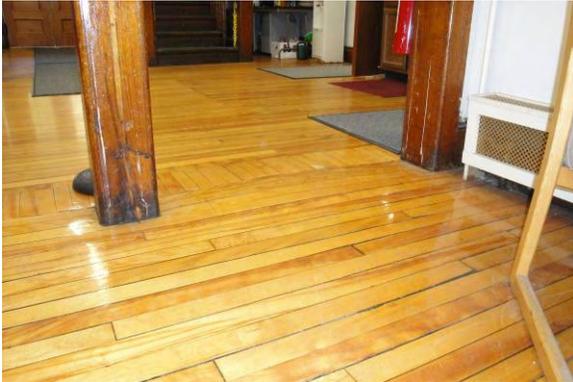
Figure 5.32 – First Floor Wood Flooring

The wood flooring on the first floor has some areas where the wood floors appear

to have been recently refinished and in good condition (figure 5.32). There are other areas that appear to have an older finish and in fair condition. There are some areas that display some minor buckling of the hardwood; but overall the wood floors appear to be in sound condition.

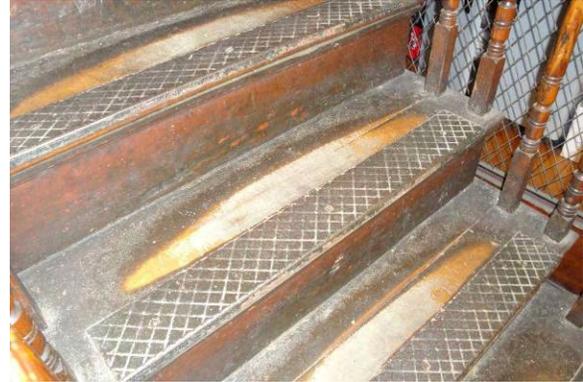
Figure 5.34 – Stair Treads

The stair treads are in poor condition. The vinyl treads and the metal plates are old and their surfaces are worn (figure 5.34).

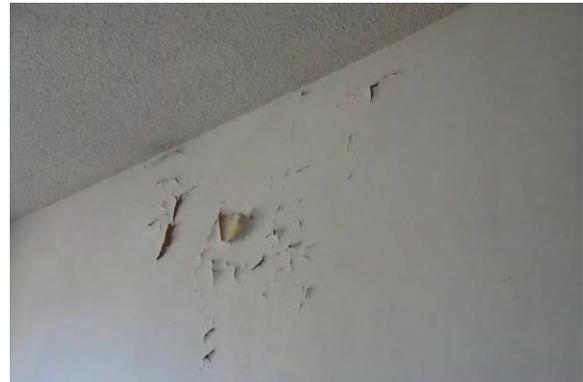
Figure 5.35 – Peeling Paint

The interior walls display several areas where the paint finish on the walls is peeling (figure 5.35).

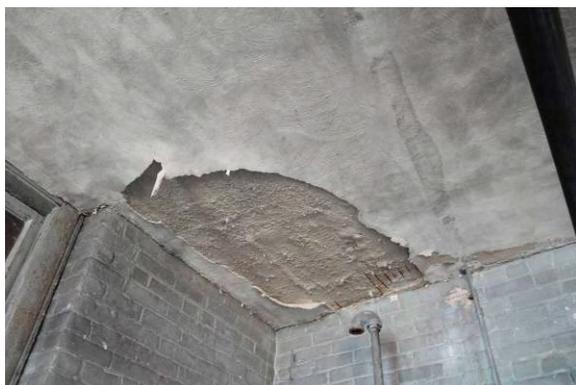
Figure 5.37 – Boiler Room Ceiling

The boiler room ceiling displays an area that appears to be damaged from the steam relief valve below (figure 5.37).

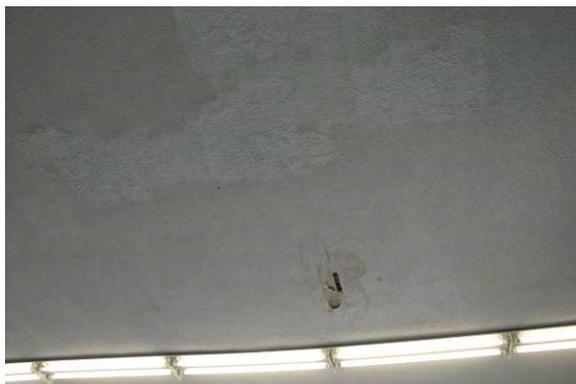
Figure 5.38 – Plaster Ceiling Damage

The plaster ceilings on the second floor display several areas that appear to be damaged from roof leaks above. There are also a few areas where the ceilings are water stained, plaster was missing and/or deteriorated. Sections of the paint are peeling off (figure 5.38).

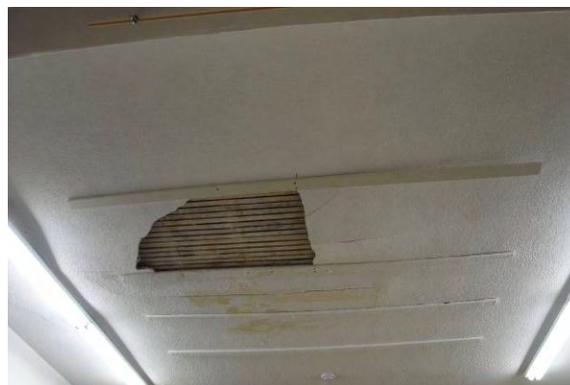
Figure 5.39 – Plaster Ceiling Damage

There is one area located in the second floor corridor where a large section of the plaster was missing (figure 5.39). This area appears to have been previously repaired, but the existing condition appears to be deteriorating further. Additional investigation may be required at this location.

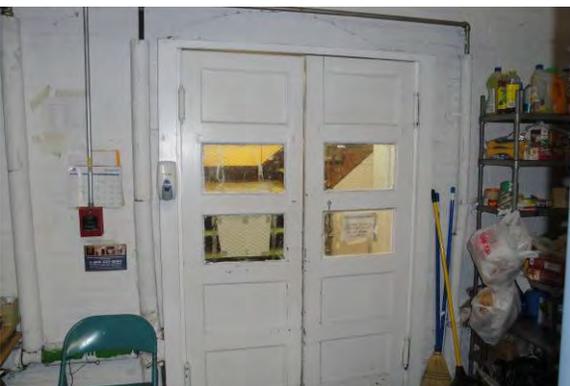
Figure 5.43 – Basement Wood Doors

The basement wood doors and frame surfaces are worn and the paint is deteriorated. The door hardware is old but appears to be functioning properly (figure 5.43).

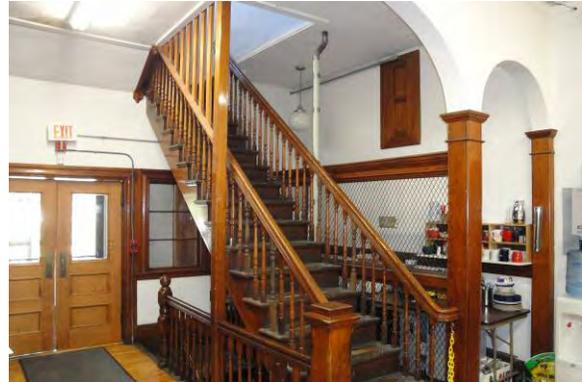
Figure 5.48 – Interior Stairs at Main Entrance Lobby

The interior stairs do not appear to conform to current building code and/or ADA requirements. The guardrail and handrail heights appear lower than current code requirements, and the handrails do not extend beyond the top and bottom nosing (figure 5.40). The tread nosing appears to exceed the current code allowed maximum projections.

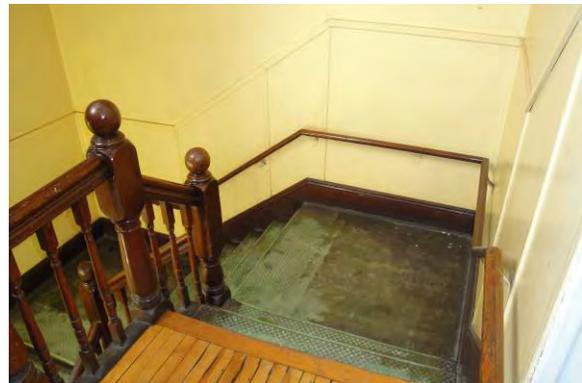
Figure 5.48 – Multi-level stair at Rear

. Further investigation may be required to determine which code requirements are applicable to this stair (figure 5.48).

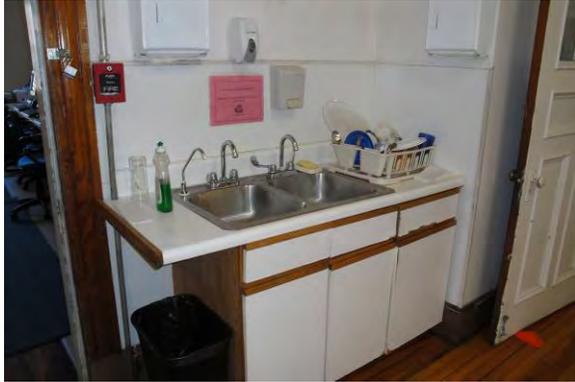
Figure 5.49 – Second Floor Casework

The small section of built-in casework located at the second floor is in overall good condition; however the countertop height and cabinet hardware do not appear to be ADA compliant (figure 5.49).

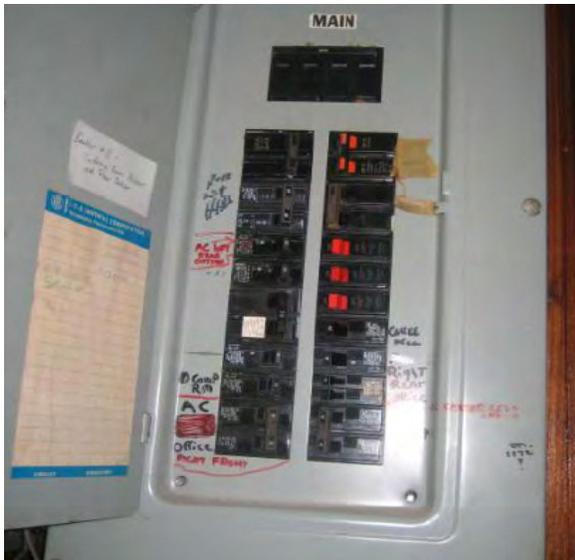
Figure 5.43 – Main Electrical Panel

The electrical service is provided by overhead wires adjacent to the main building entrance. The main electrical panel indicates 200A/240V/single phase power (figure 5.43). The electrical panels appear to be over 30 years old.

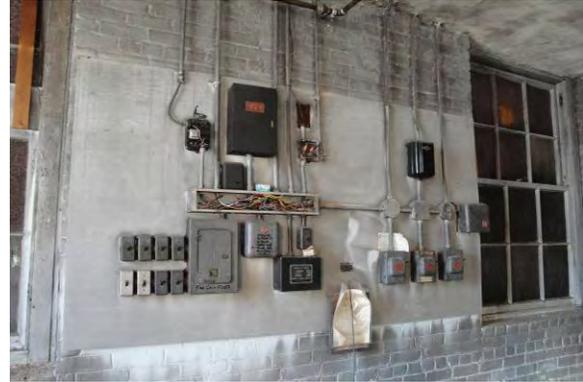
Figure 5.44 – Boiler Room Electrical Devices

There are three sub-panels; one on each floor. The panels and wiring appear to be old and there is some wiring that was exposed and visible. There are several electrical disconnect switches located throughout the building related to the associated equipment (figure 5.44). Further investigation may be required to confirm if electrical distribution is adequate to meet the building needs, and to evaluate the code compliance of the electrical system.

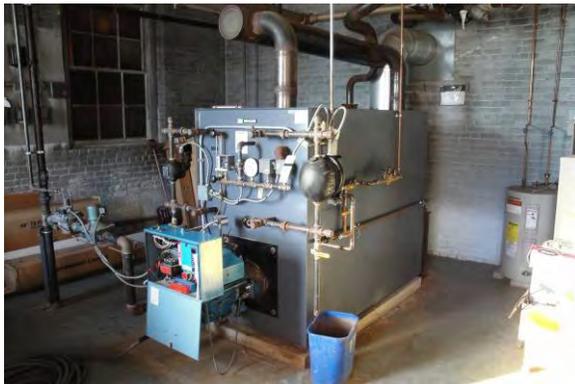
Figure 5.48 – Main Boiler

The boiler is approximately 10 years old, in good condition, and appears to be functioning. The capacity of the boiler could not be confirmed (figure 5.48). There are some minor rust spots on the piping and surface of the boiler. There are also some rust stains around the perimeter of the boiler pad; most likely from the general maintenance related to the piping system.

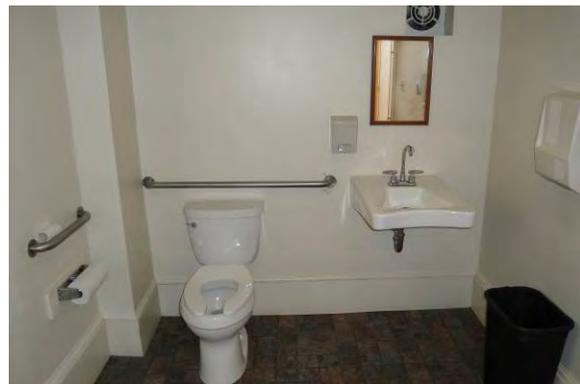
Figure 5.50 – First Floor Toilet Room

The building has three toilet rooms; one unisex toilet room on the first floor consisting of a toilet, sink, grab bars and accessories (figure 5.50); and two smaller toilet rooms on the second floor, one for men and one for women. The fixtures for the first floor appeared to be relatively new. The fixtures on the second floor appear old and likely not water-conserving fixtures, but appear to be functioning properly. The toilet rooms do not appear to be fully ADA compliant.

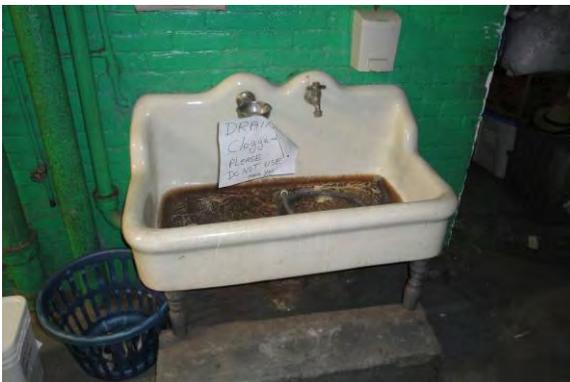
Figure 5.52 – Utility Sink

There are a few utility sinks located in the basement that appear to be old and are not currently functioning.

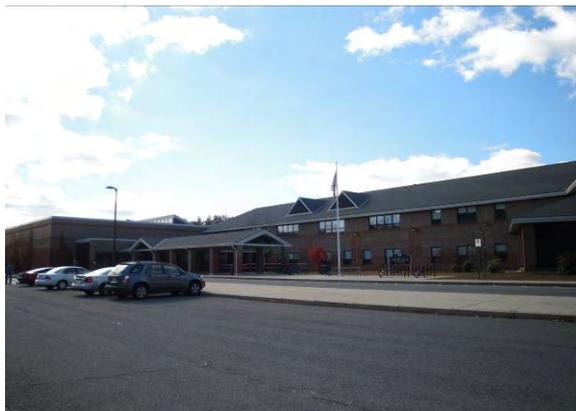
Figure 6.01 – Fowler Middle School

The Fowler Middle School is located at 3 Tiger Drive and was originally constructed in 2000 (figure 6.01).
