Town of Maynard, Massachusetts Building Observation Report

AECOM Technical Service Inc.
66 Long Wharf, 3rd Flr.
Boston, MA 02110
(617) 723-1700

December 2010

Executive Summary

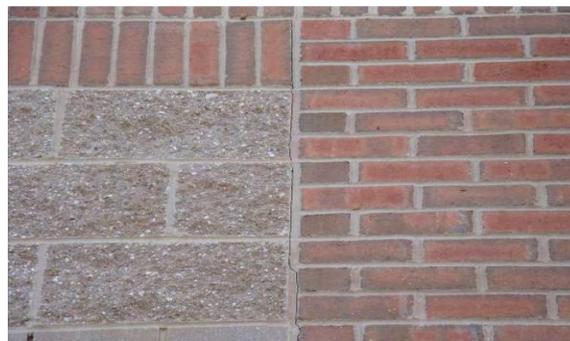
Figure 6.02 – Exterior Walls

The exterior walls are cavity wall construction of 4-inch thick standard brick and split-face concrete masonry units (CMU) over an 8-inch CMU backup, supported on a cast-in-place concrete foundation (figure 6.02).

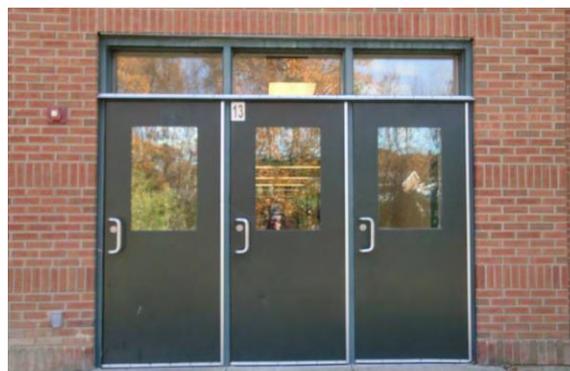
Figure 6.03 – Exterior Painted Metal Doors

The building has several types of exterior door systems. There are insulated painted metal doors within painted metal frames, some with glass sidelights and transoms above (figure 6.03).

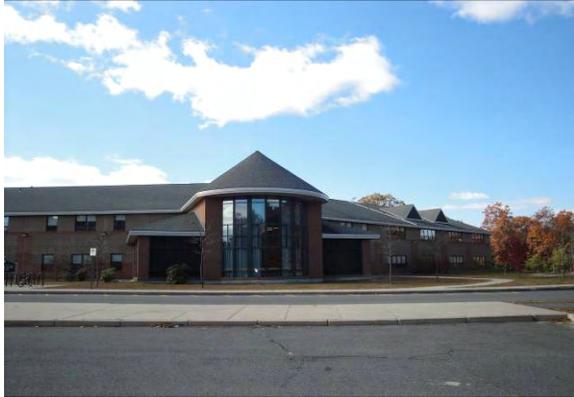
Figure 6.04 – Exterior Fenestration

The building has three different types of exterior window systems. There are insulated aluminum window assemblies with operable awning sashes in individual punched openings in the masonry wall. There are insulated aluminum and glass storefront windows with operable awning sashes in larger openings in the masonry wall. There is also a two-story high section of insulated aluminum and glass curtain wall located at the library section of the building (figure 6.04).

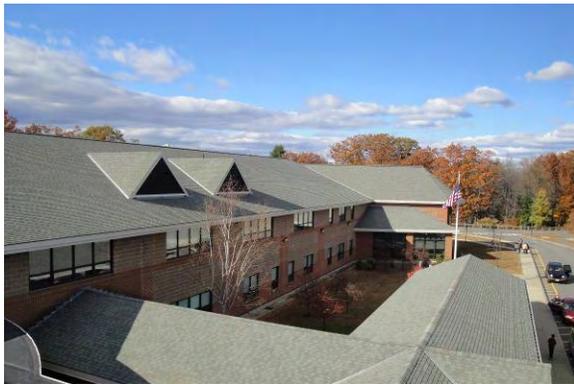
Figure 6.05 – Asphalt Shingles

The building has two different types of roof systems. The majority of the roof is a sloped asphalt shingle roof system with aluminum gutters and (figure 6.05).

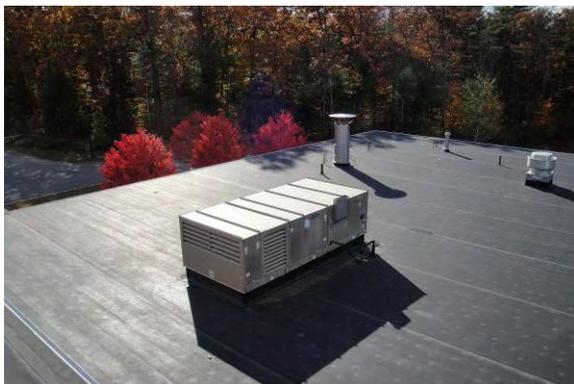
Figure 6.06 – EPDM Membrane Roof

There are other sections of the building that have an EPDM membrane roof system with some sections that are sloped and other sections that are flat. Roof drains are visible at the flat sections of roof (figure 6.06). Both roofing systems appear to be in very good condition and well maintained.

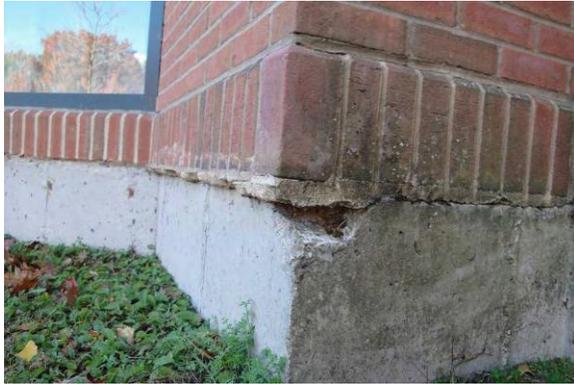
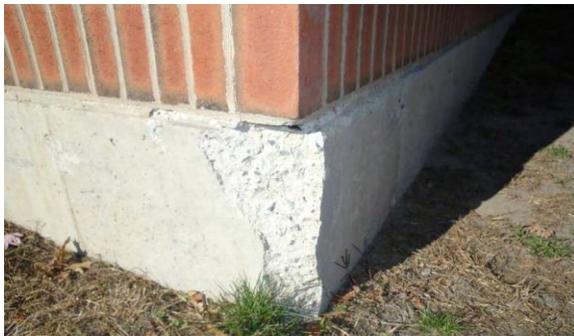
There are some corners of the building's foundation wall where the concrete is chipped off (figure 6.08 and 6.09).

Figure 6.08 – Chipped Foundation Corner

Figure 6.09 – Chipped Foundation Corner

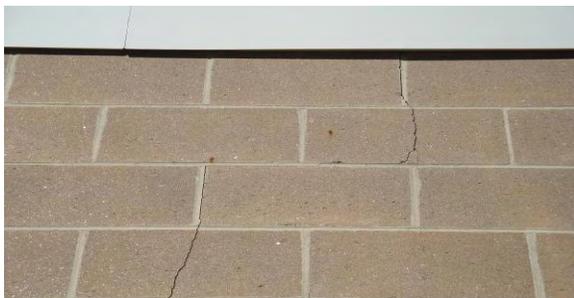
Figure 6.10 – Cracks in CMU Block

The exterior masonry walls are in overall good condition. There are a few areas where there is cracking in the block (figure 6.10). Further investigation may be required to confirm the cause of this cracking.

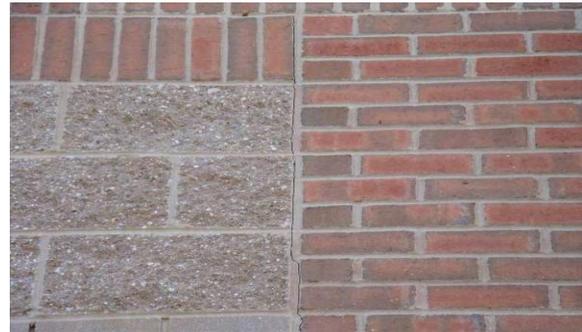
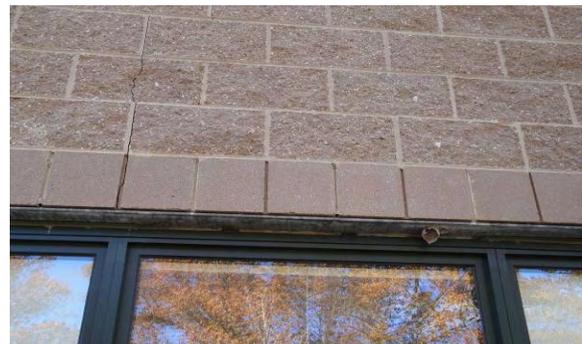
There are areas where the mortar joints appear to be cracked (figure 6.11 and 6.12).

Figure 6.11 – Cracks in Mortar Joints

Figure 6.12 – Cracks in Mortar Joints

Further investigation may be required to confirm the cause of the cracks.

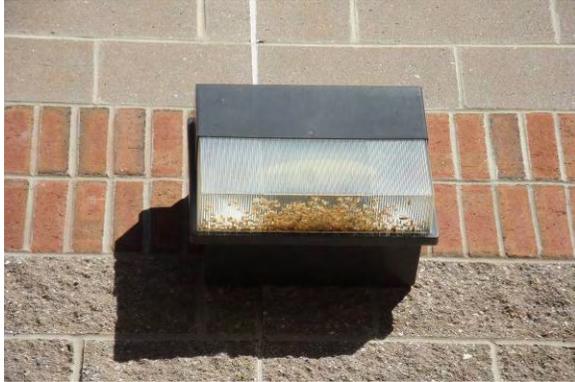
Figure 6.14 – Exterior Light

It is noted that at some of the exterior light fixtures, the lenses have captured dead insects (6.14). There was also evidence of the removal of old bee's nests at the exterior of the building.

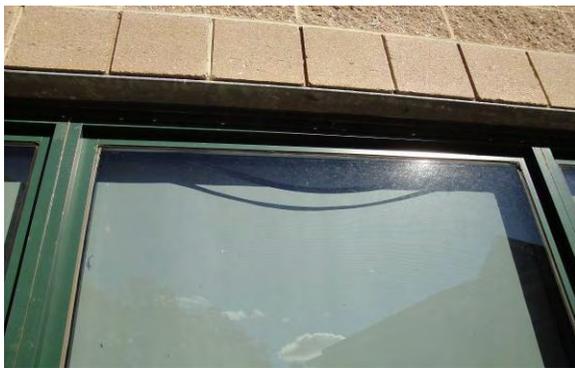
Figure 6.15 – Interior Window Gasket

There are several areas where the interior glazing gaskets appear to be loose and detached from the frame (figure 6.15).

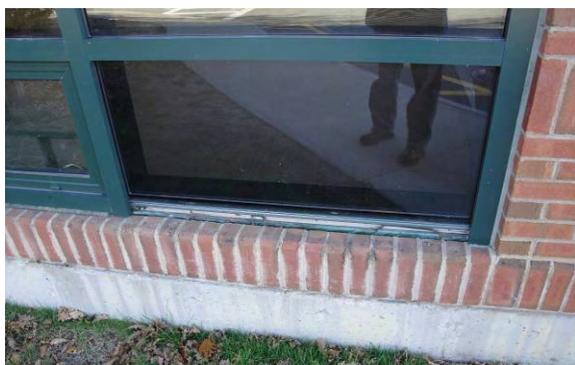
There are sections of storefront trim missing near the main entrance, which could allow water to penetrate into the wall cavity. Further investigation may be required (figure 6.16).

Figure 6.16 – Missing Storefront Trim

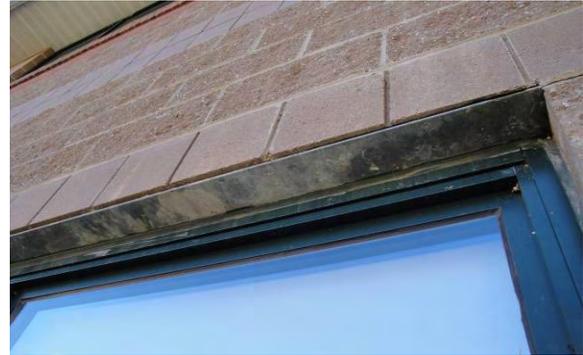
Figure 6.17 – Steel Lintel

The surface of some of the steel lintels above some of the windows had remnants of mortar which does not appear to have

been cleaned off during construction (figure 6.17).

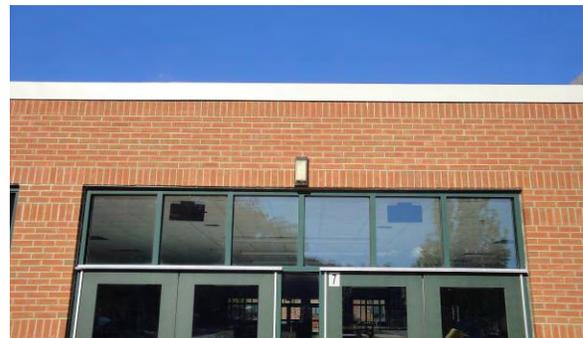
Some of the steel lintels over the larger storefront/windows openings appear to sag. Further investigation may be required to determine the structural capacity of the steel lintel (figure 6.18).

Figure 6.18 – Sagging Lintel

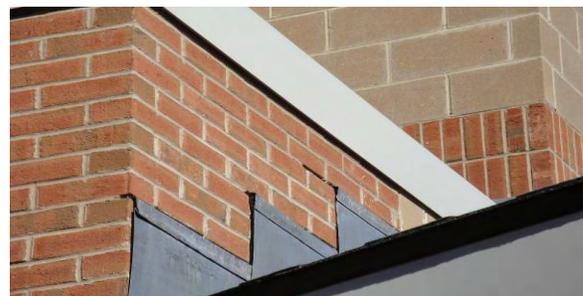
Figure 6.19 – Wall Flashing

There are sections of the wall flashing along the roof line where the mortar joints appear to be deteriorated and there are sections of the mortar missing. Further investigation may be required to confirm where/if water is penetrating into the wall cavity (figure 6.19).

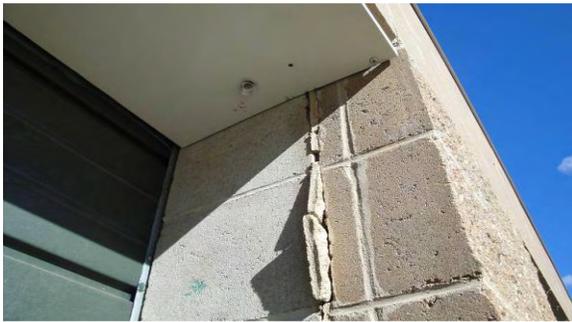
There are some mortar joints at the exterior wall openings where the mortar was loose and sections are missing. Further

investigation may be required to confirm where/if water is penetrating into the wall cavity (figure 6.20).

Figure 6.20 – Loose Mortar

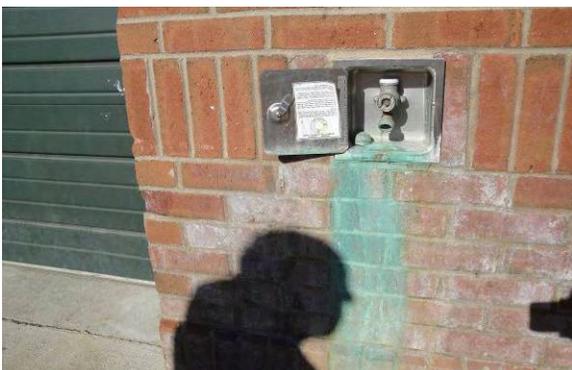
Figure 6.21 – Hose Bibb

There is a recessed frost proof wall hydrant (hose bib) at the rear of the building which displays evidence of staining on the brick veneer. The brick in that area also displays visible signs of efflorescence (white chalky patches) which indicates that water has penetrated behind the brick (figure 6.21). This may be related to the installation of this plumbing fixture. Further investigation may be required to confirm if water is penetrating into the wall cavity and damaging non-visible portions of the exterior wall.

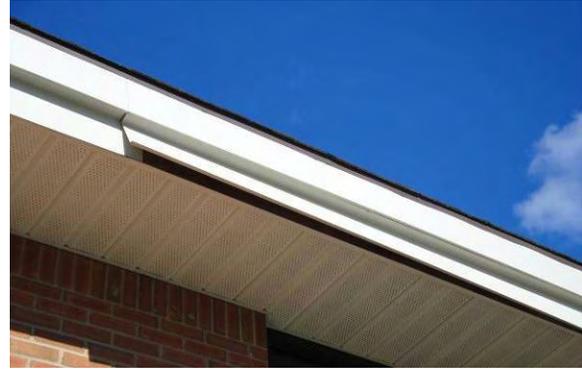
Figure 6.22 – Fascia Trim

There are sections of the metal fascia trim along the roof line that appear loose and detached (figure 6.22).

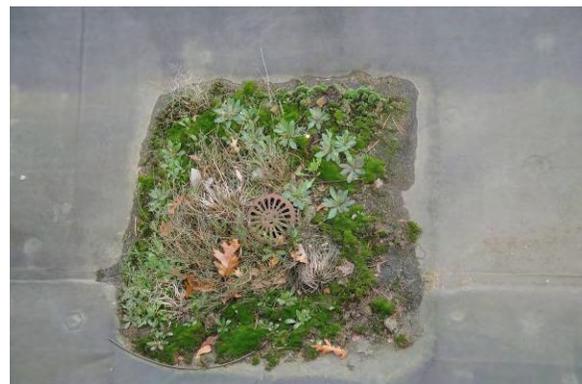
Figure 6.24 – Roof Drain

There are a few roof drains that displayed areas of vegetation and moss growth, which may be a sign that the roof drain is not functioning properly (figure 6.24).

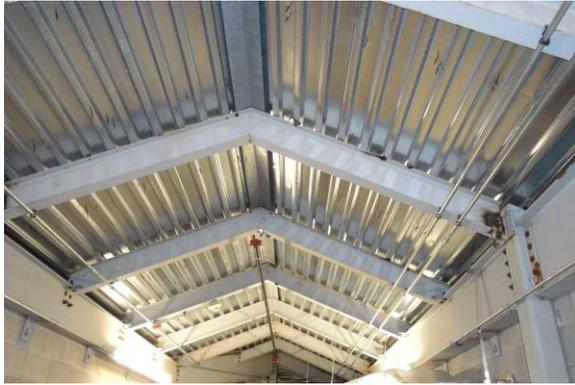
Figure 6.25 – Building Structure at Mechanical Mezz.

The superstructure of the building consists of steel tube and wide flange columns

supporting steel wide flange beams with open web steel floor and roof joists with metal roof deck. The gable roof over the mechanical mezzanine is framed with wide flange steel joists and metal deck (figure 6.25)

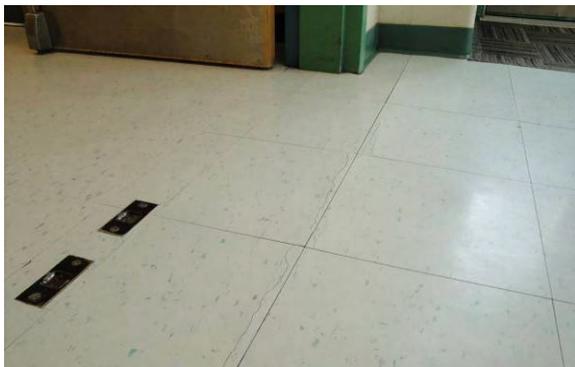
Figure 6.26 – VCT Tile Floor

The building has several different types of floor finish systems. There is 12"x12" vinyl composite tiles (VCT) located primarily in the corridors and cafeteria areas (figure 6.26)

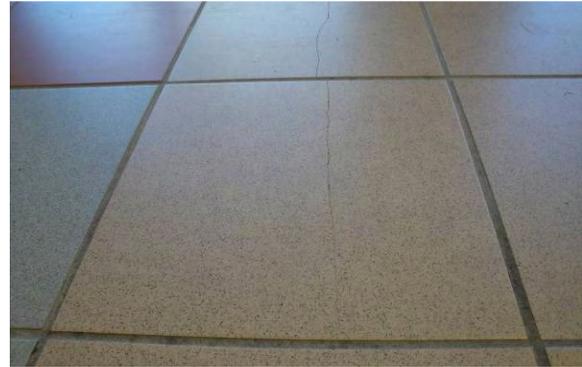
Figure 6.27 – Paver Tiles

There is carpet in the administration offices, auditorium, and library. There are paver tiles in the main entrance lobby (figure 6.27) and ceramic floor tiles in the toilet rooms and kitchen areas.

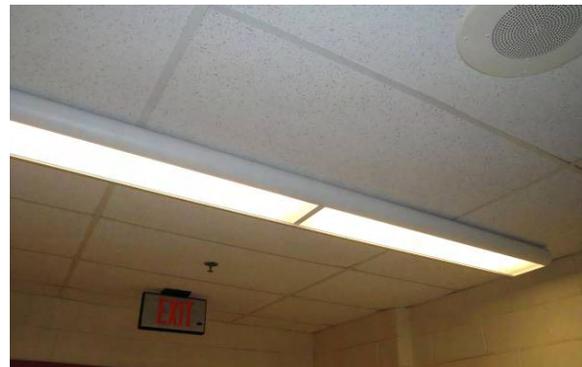
Figure 6.28 – Acoustic Ceilings

The building ceiling systems primarily consist of 2'x2' and 2'x4' acoustic ceiling tiles within a suspended metal grid system (figure 6.28).

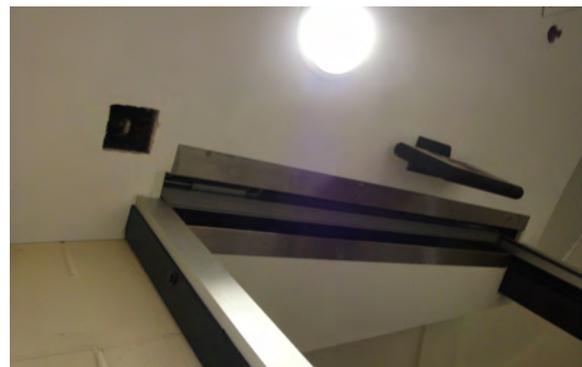
Figure 6.29 – Gypsum Board Ceilings

There are also sections of painted gypsum board ceilings located throughout the building, and at some of the stairs (figure 2.29).

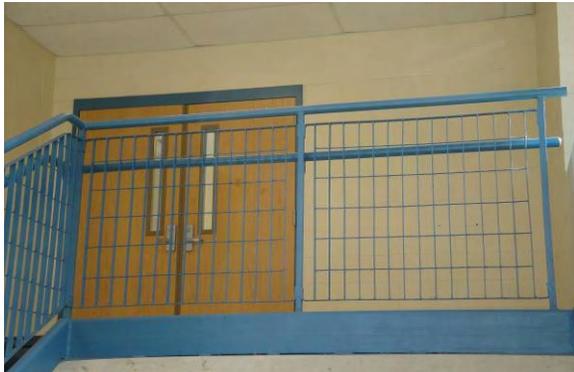
Figure 6.30 – Clear Finished Wood Doors

There are several types of interior doors throughout the building. There are clear finished flush wood doors within painted metal frames at most of the classrooms and office areas. Some of the doors have vision panels. The majority of the door hardware appears to be ADA compliant hardware (figure 6.30).

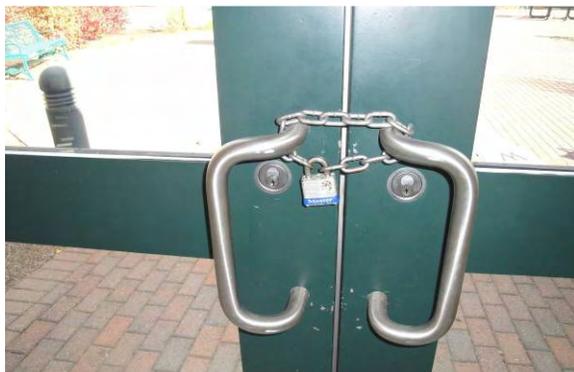
At the time of the site visit, the courtyard doors were chained and locked with a padlock on the inside of the building to prevent access to the building after hours from the courtyard. Further investigation / analysis may be required to provide an alternate method of securing the building since chaining doors typically is prohibited by the building code (figure 6.31)

Figure 6.31 – Chained Doors

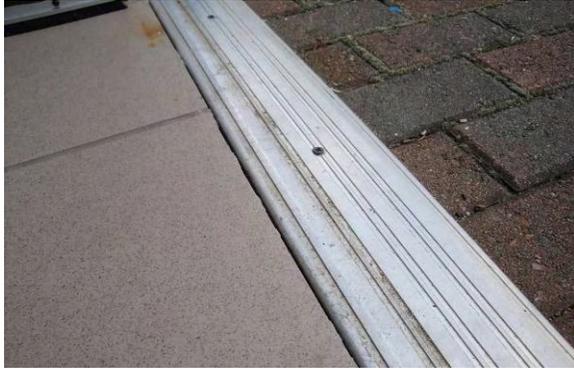
There are areas where the grout was missing between the ceramic tile joints and the exterior door thresholds, which may allow water to penetrate into the building below the tiles causing potential failure (figure 6.34).

Figure 6.34 – Missing Grout

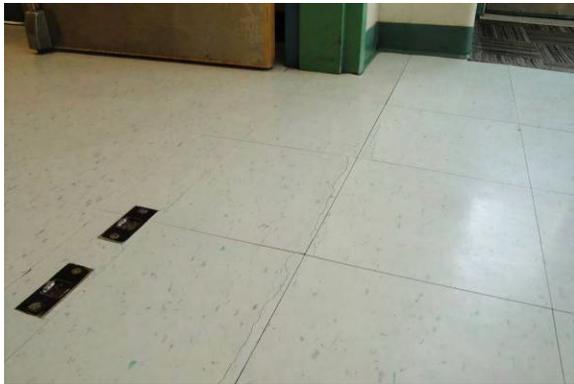
There are some areas where the VCT tiles are cracked and warped (figure 6.35).

Figure 6.35 – Cracked VCT Tile

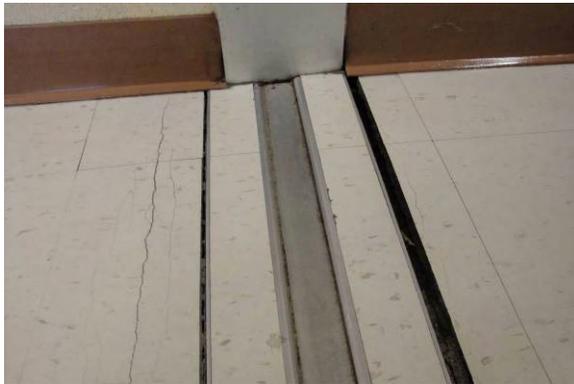
The VCT tiles at the floor expansion joints also appear to be cracked and warped (figure 6.36).

Figure 6.36 – VCT at Expansion Joint

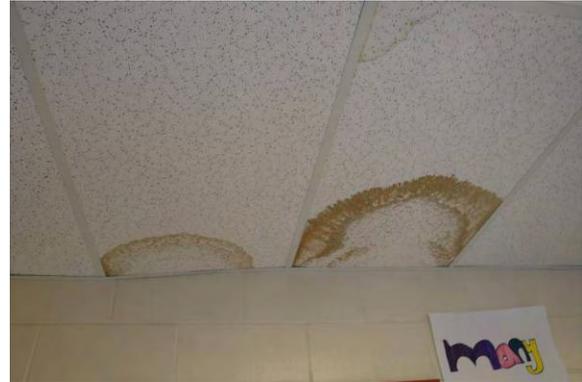
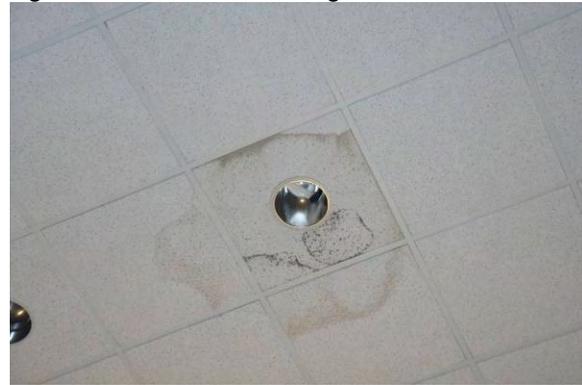
There are several areas where the acoustic ceilings were damaged, tiles missing, and tiles stained. The staining may be an indication of prior roof leaks. Further investigation may be required to determine the cause of the roof leaks and if there is

any further damage to the structure that is not visible (figure 6.37 and 6.38).

Figure 6.37 – Stained 2x4 Ceiling Tiles

Figure 6.38 – Stained 2x2 Ceiling Tiles

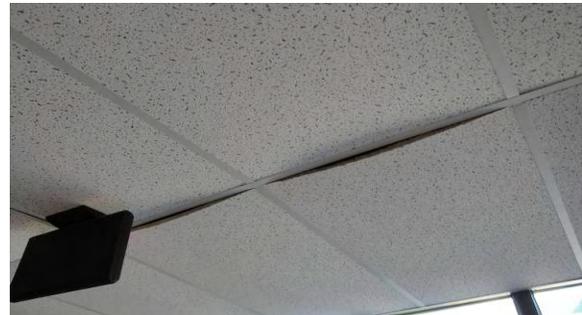
There are a few areas where cut ceiling tiles appear to have been improperly installed and are sagging from the grid (figure 6.39).

Figure 6.40 – Sagging Ceiling Tiles

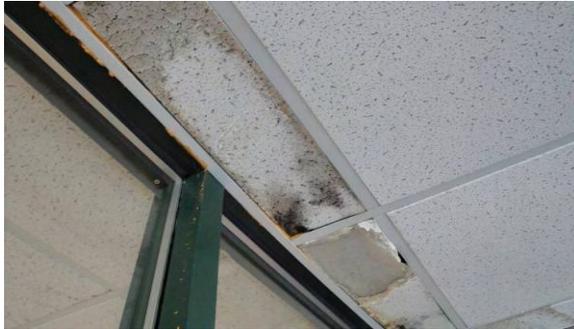
Figure 6.41 – Ceiling Tiles at Auditorium Entrance

There is an area adjacent to the main entrances where the ceiling tiles are stained and displaying areas of mold growth. Further investigation may be required to determine the cause and the extent of the mold growth (figure 6.41).

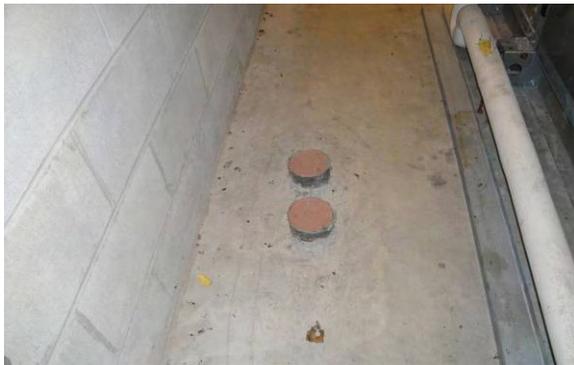
There are a few areas located at the Mechanical Mezzanine where empty conduit is capped and protruding from the floor creating a potential trip hazard (figure 6.42).

Figure 6.42 – Conduit in Floor

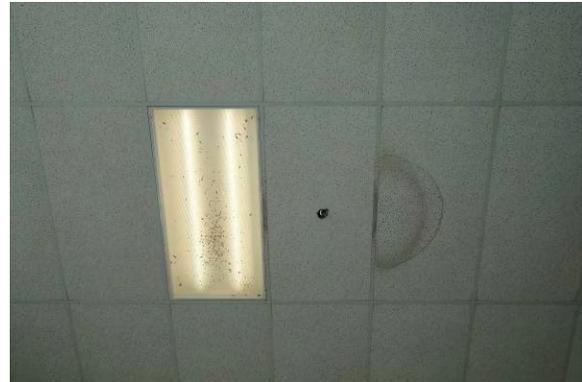
Figure 6.43 – 2x4 Recessed Fluorescent Light

The building has several different types of lighting fixtures. There are recessed 2'x4' fluorescent light fixtures with prismatic acrylic lenses within the suspended ceiling grids (figure 6.43). Several of the lenses have captured dead insects

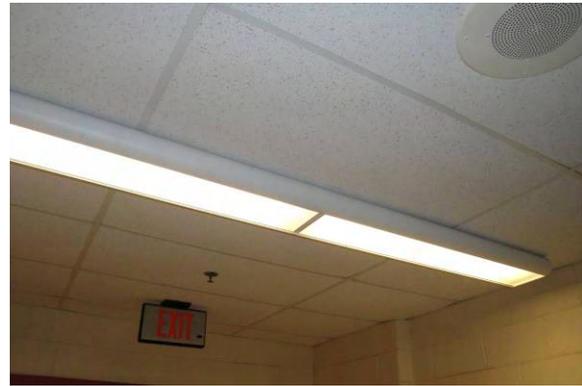
Figure 6.44 – 4' Fluorescent Strip Light

There are 4-foot dual lamp strip fluorescent lights, mounted to the underside of the suspended ceilings (figure 6.44).

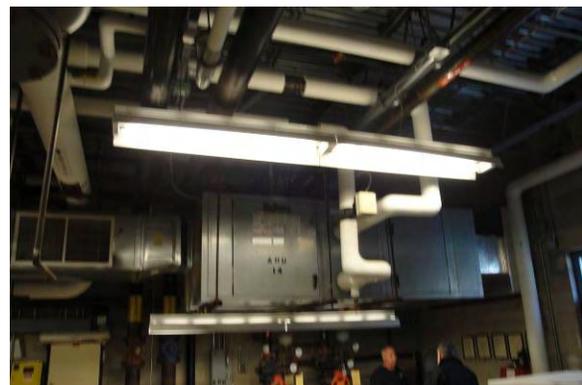
Figure 6.45 – Strip Fluorescent Lights in Utility Rooms

There are pendant mounted 4-foot strip fluorescent with exposed bulbs located in the utility rooms (figure 6.45).

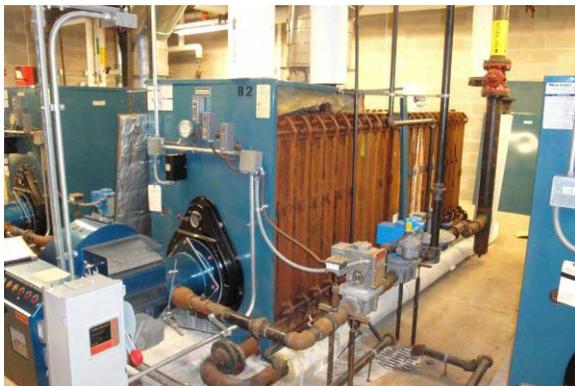
Figure 6.47 - Boilers

The HVAC system also includes three gas fired hot water boilers, which provide heat to fin tube radiators located throughout the building. The boilers appear to be approximately 10-years old. Two of the units are in good condition and functioning; the third boiler was leaking and did not appear to be functioning at the time of the visit (figure 6.47).

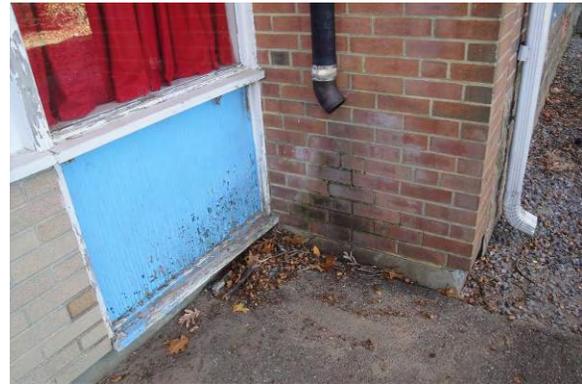
Figure 7.13 – Deteriorated Brick at Downspout

The concrete foundation and exterior walls were generally in overall good condition. There are areas where the brick mortar joints were deteriorated, which may be caused by the downspouts spraying excess water run-off onto the surface of the bricks (7.13).

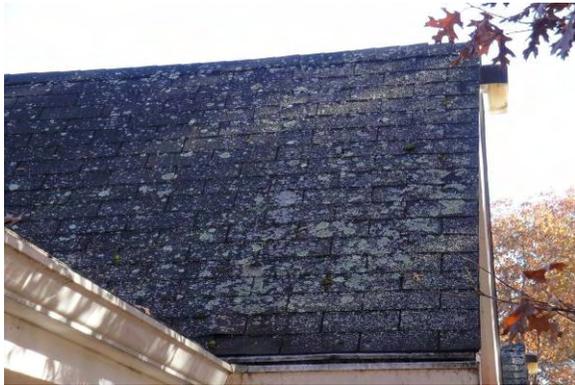
Figure 7.15– Asphalt Shingles

The asphalt shingle sections of the sloped roof system appear to be in good condition; however there are a few sections that display areas of moss/algae growth. Further investigation may be required to confirm the condition of the asphalt shingles at those areas (7.15).

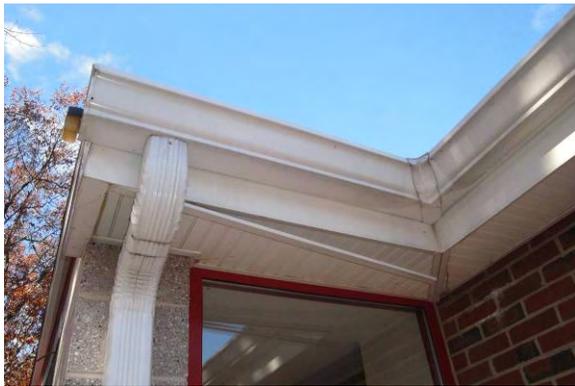
Figure 7.16 – Fascia Trim

There are sections of the metal fascia trim along the roof line that appear loose and detached (figure 7.16).

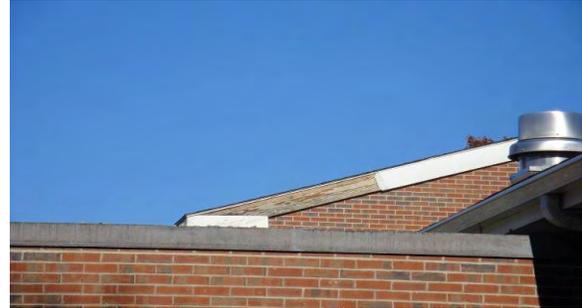
Figure 7.17 – Gable Trim

There are also sections of the metal gable trim along the roof line that appeared loose and detached, causing the wood below to be exposed to weather (figure 7.17).

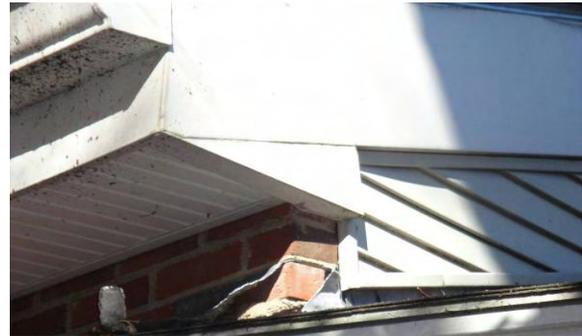
Figure 7.18 – Metal Flashing

There are sections of the wall flashing along the roof line where the flashing appears torn and some of the mortar joints are deteriorated. Further investigation may be required to confirm where/if water is currently penetrating the brick wall (figure 7.18).

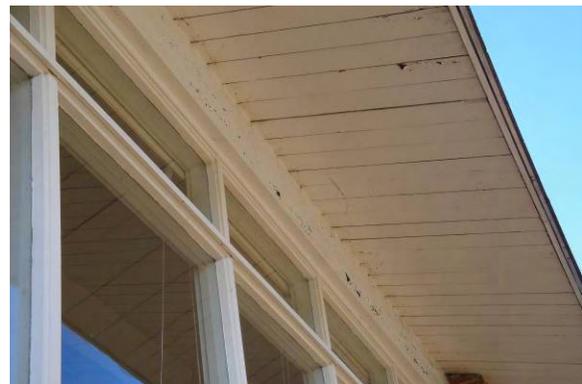
Figure 7.19 – Roof Overhang with Painted Wood Soffit

There are sections of the roof overhang with painted wood soffits; the paint finish appears to be weathered with sections of the paint peeling away and exposing the wood. Further investigation may be required to determine if there are any rotted and/or loose sections of wood, molding, and trim (figure 7.19).

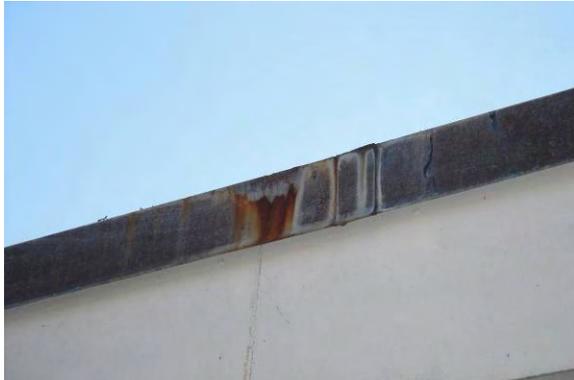
Figure 7.20 – Metal Roof Edge

There are sections of the metal roof edge fascia system that display areas of rust, and there are sections that appear to be loose and detached (figure 7.20).

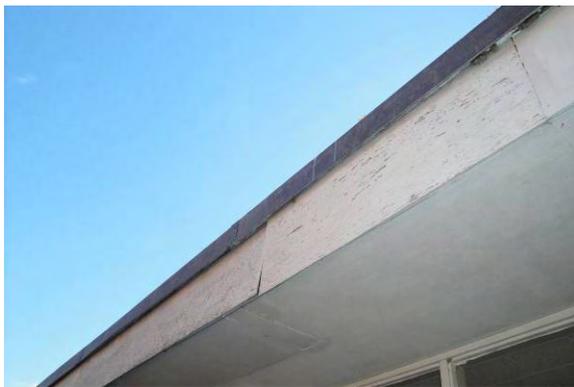
Figure 7.21 – Plywood Fascia Trim

There are sections of the plywood fascia board that appear warped, and sections where the paint finish appears to be weathered and faded (figure 7.21).

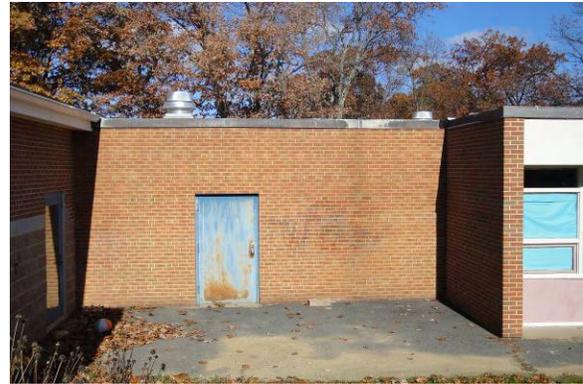
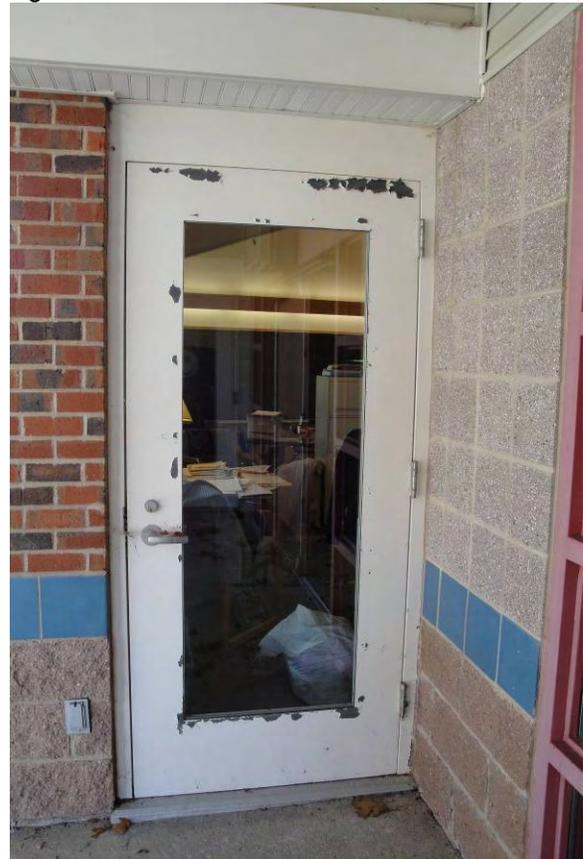
The paint on some of the exterior doors and frames appears weathered and faded. The frames display some areas of rust. At some doors there is daylight showing through the weatherstripping (figure 7.22 and 7.23).

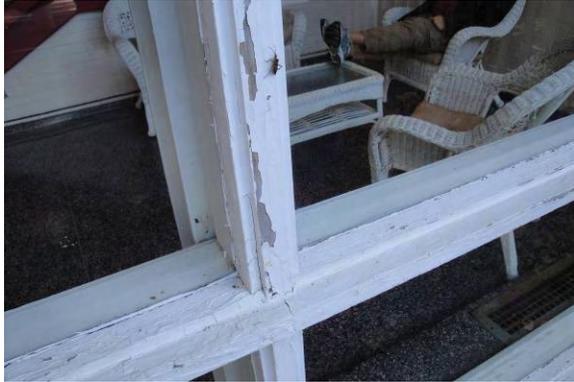
Figure 7.24 – Wood Storefront

The paint finish on the wood windows and wood storefront systems appears to be in poor condition. There are several areas where the paint has peeled off. There are a few areas where the glazing sealant was missing and sections of the wood appear to be deteriorated and rotting. Further investigation may be required to confirm if water is infiltrating into the building's interior (figure 7.24).

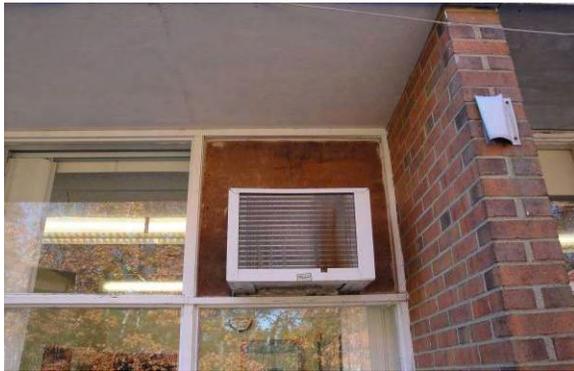
Figure 7.25 – AC unit in Plywood Panel

There are sections of the wood storefront glazing system that have been replaced with plywood panels and wall mounted AC (figure 7.25).

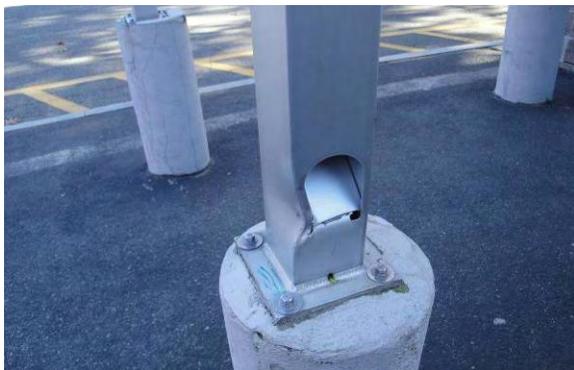
Figure 7.26 – Damaged Canopy Column

Some of the aluminum columns that support the entry canopy appear to be dented and damaged. Further investigation may be required to verify the structural integrity of the columns (figure 7.26).

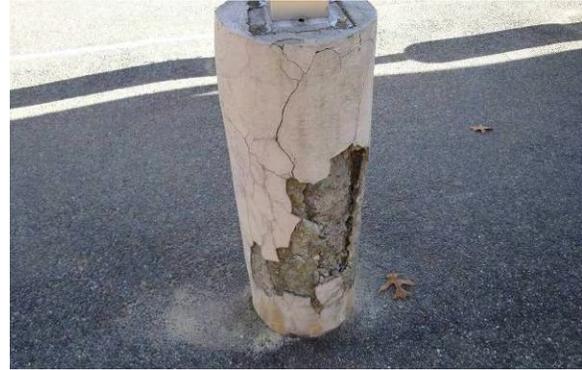
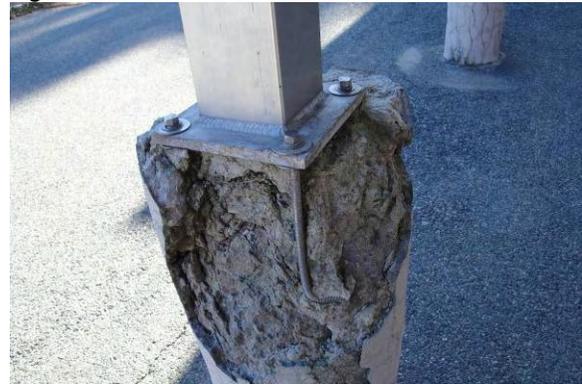
Several of the exposed concrete column bases at the canopy appear to be severely deteriorated. There are sections of the

metal rebar exposed and sections of concrete missing (figure 7.27 and 7.28).

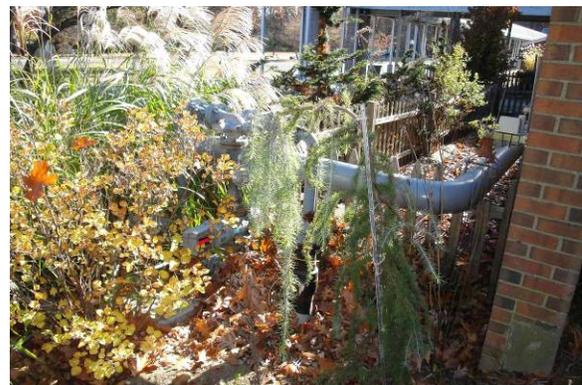
Figure 7.29 – Gas Main

The vegetation around the gas main appears to be overgrown (7.28)

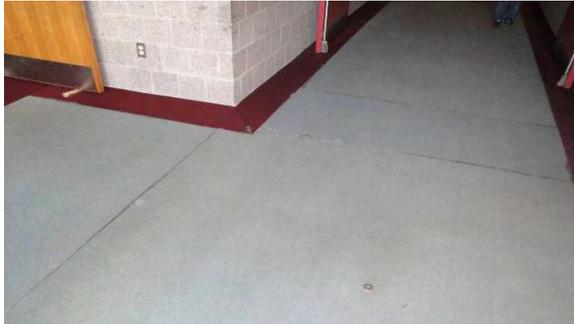
Figure 7.38 – Worn Carpet

The majority of the carpet appears to be worn and in overall poor condition. There are several areas where the seams are lifting and there are sections of the carpet

missing. It was reported that there are areas of the building where the carpet is installed over asbestos floor tiles (figure 7.38). Further investigation may be required to confirm locations and verify presence of asbestos containing materials.

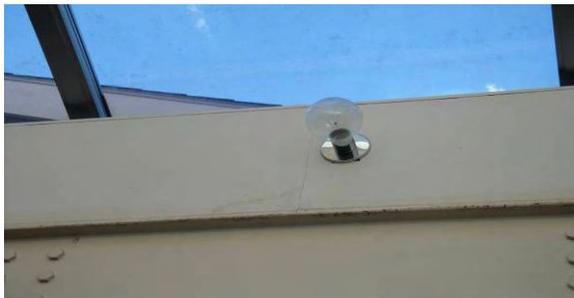
The gypsum board at the skylight shows evidence of water damage; which may be caused by leaks in the skylight on the roof. Further investigation may be required to determine the cause of the water damage (figure 7.39).

Figure 7.39 – Damaged Soffit at Skylight Opening

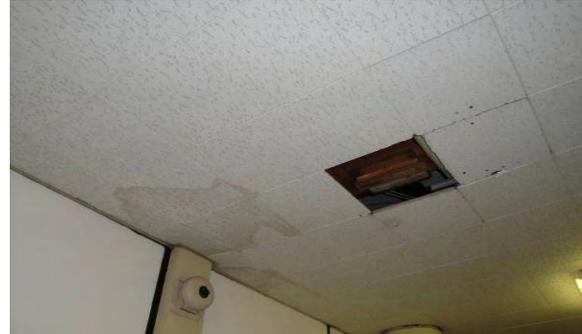
The majority of the suspended ceilings appear to be in generally good condition. There are a few areas where ceiling tiles display water staining, which may have been caused by roof leaks. Further investigation may be required to determine the cause of the leaks (figure 7.40).

Figure 7.40 – Damaged Ceiling Tiles

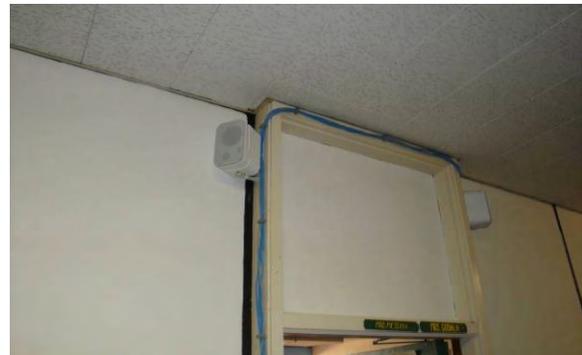
There are sections of exposed communication wiring and equipment in some of the corridors and classrooms (figure 7.41).

Figure 7.41 – Exposed Communication Wiring

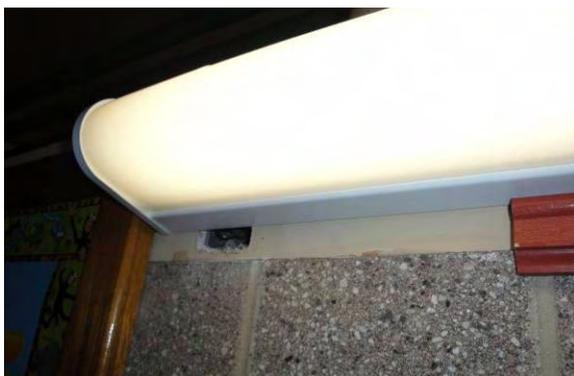
There are wall mounted strip fluorescent light fixtures located in the corridors (figure 7.44). The corridor lighting levels appear to be insufficient. Further investigation may be required to confirm current lighting levels.

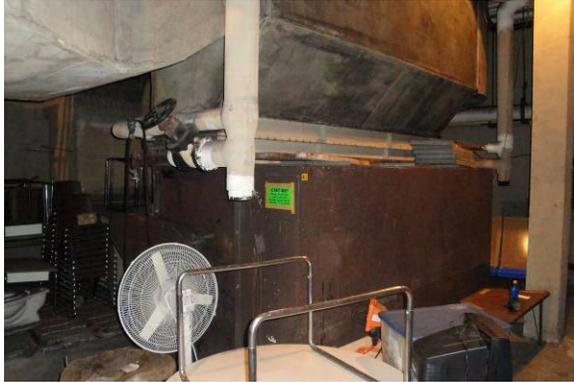
The building has a ventilation system located in the main boiler room, which appears old. The system type and capacity could not be confirmed at the time of this visit (figure 7.47).

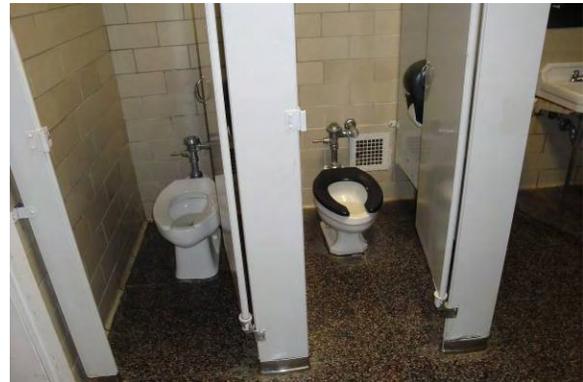
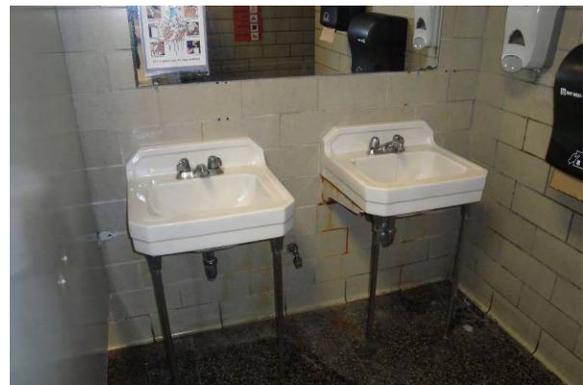
The building has several toilet rooms located on each floor which include separate student and faculty toilet rooms of multiple configurations and arrangements. Most of the toilet rooms appear to be old and are generally in poor condition. Some of the fixtures do not appear to be water-conserving or ADA compliant (figure 7.50 and 7.51)

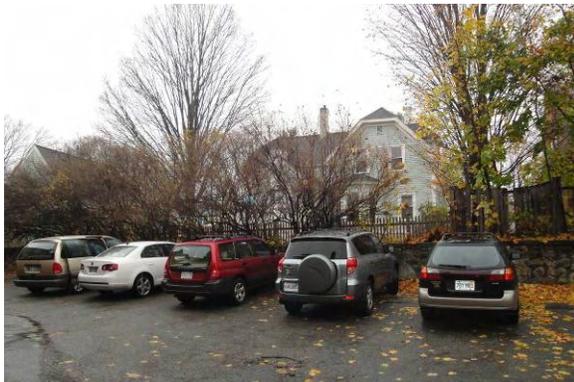
The landscape consists of primarily grass, which is in poor condition, and a few trees which are in need of trimming (figure 8.10). There are also a few sections of chain-link and wooden picket fence around the perimeter, which are in fair condition.

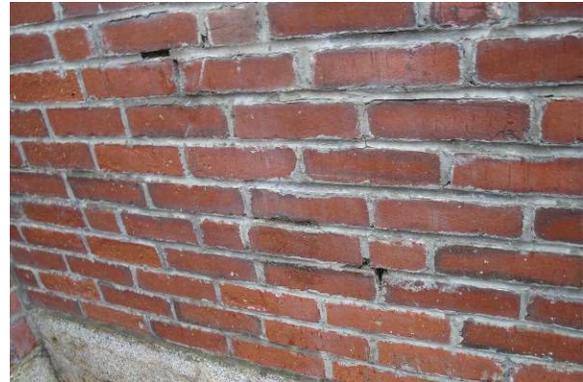
The exterior brick walls appear to be in fair condition. The mortar appears to be aging and weathered. There are several areas where the mortar appears deteriorated, loose, and cracked (figure 8.11).

Figure 8.11 – Brick Mortar Joints

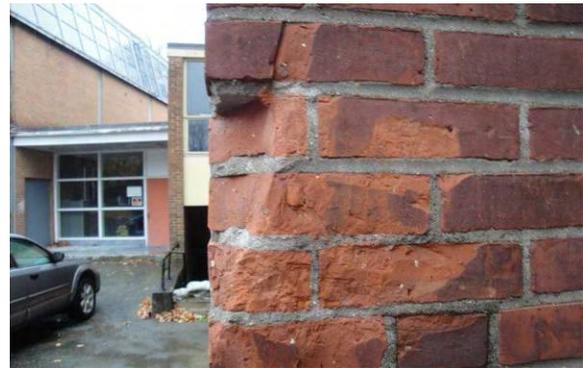
The brick at the corners displays a significant amount of deterioration as well. There are a few corners of the building where the brick is roughly chipped off (figure 8.12).

Figure 8.12 – Chipped Brick Corner

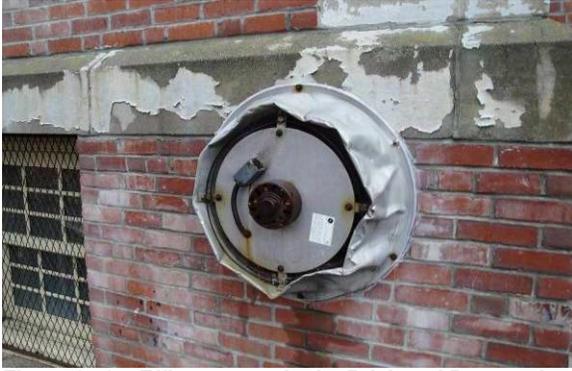
There are also areas in the brick that displayed efflorescence (chalky white patches), which indicates that water has penetrated behind the brick. Further investigation is required to confirm where water is penetrating the wall.

The cover to one of the exhaust vents is also in poor condition and the fan is exposed (figure 8.13).

Figure 8.13 – Efflorescence in the Brick and Damaged Exhaust

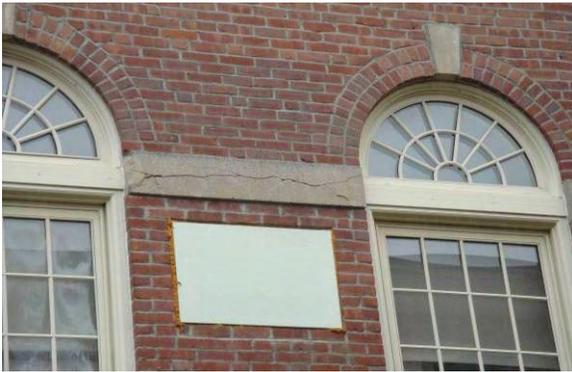
There are several sections of cast stone accent bands in the exterior walls that display signs of deterioration with surface spalling (Figure 8.14).

Figure 8.14 – Cast Stone Accent Band

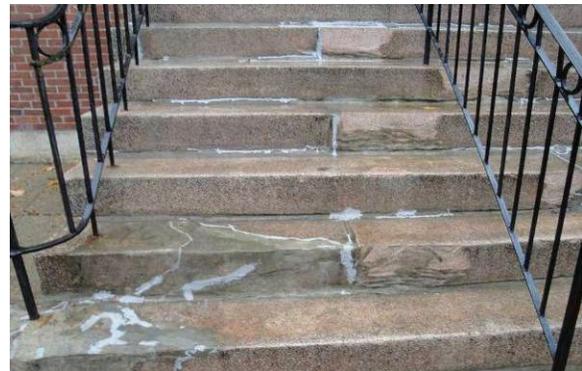
The mortar joints at the main entrance stairs are in poor condition. There are several areas where the mortar is cracked or missing. Further investigation is required (figure 8.16).

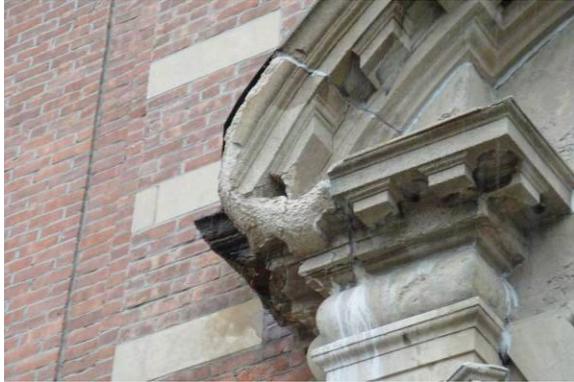
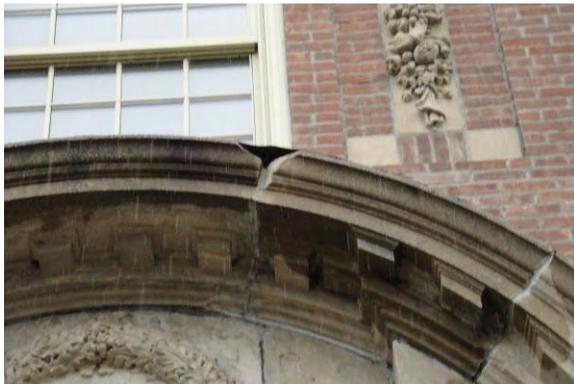
The stone pediment assemblies over the main entrance doors are in poor condition. There are sections where the stone has deteriorated and some of the mortar joints are cracked (figure 8.17 and 8.18).

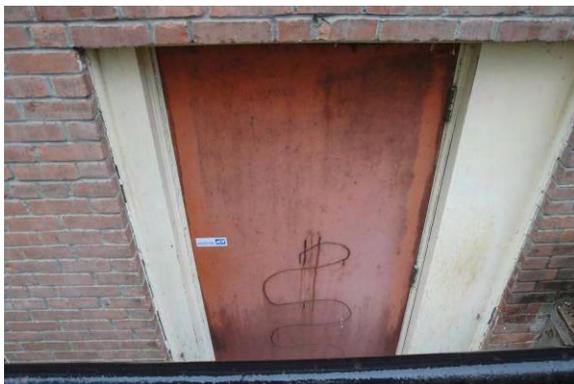
The paint finish on most of the exterior doors and frames appears weathered and faded. There is also daylight showing through the weather stripping. The majority of the door hardware appears to be ADA compliant (figure 8.19).

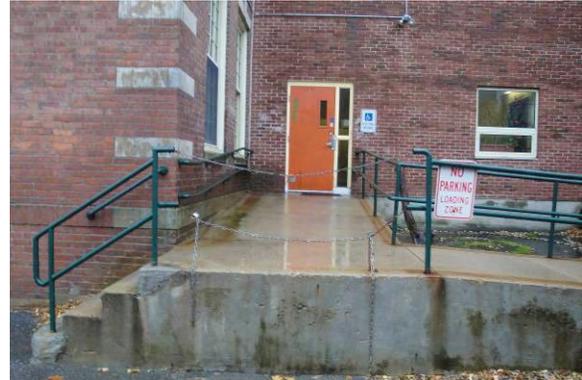
The guardrails at the rear entrance are in fair condition. There is a section of guardrail that appears to have been removed and replaced with a chain to create a loading dock. The paint finish on

the guardrails is weathered and peeling (figure 8.20).

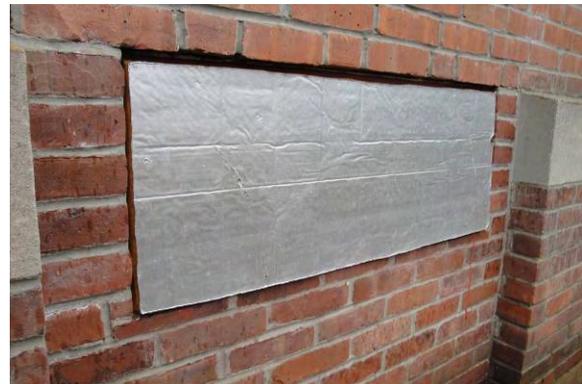
There are a few locations located on the exterior brick walls where it appears that louvers have been removed and replaced with sections of foil faced rigid insulation, which may not be an acceptable application. The perimeter of the insulation is also not sealed, which may allow water to penetrate into the wall. Further investigation may be required (figure 8.21).

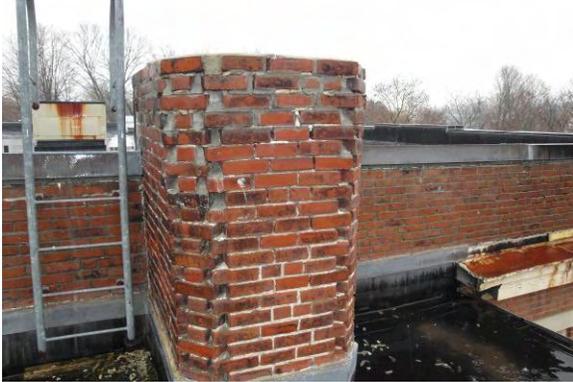
The chimney located at the roof is in poor condition. The mortar is severely deteriorated and several of the bricks are loose (figure 8.22).

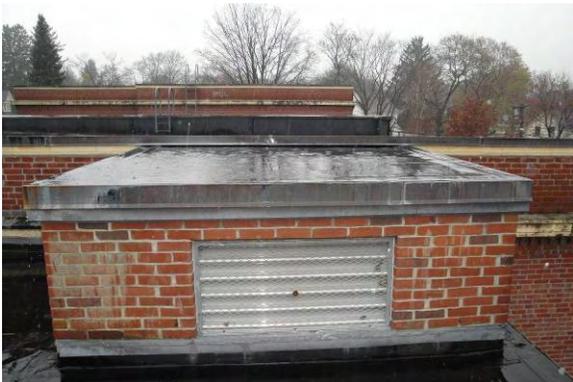
The membrane roof at the elevator penthouse appears to have insufficient slope, with water ponding observed on the roof at the time of the site visit, and no overflow scupper provided (figure 8.23).

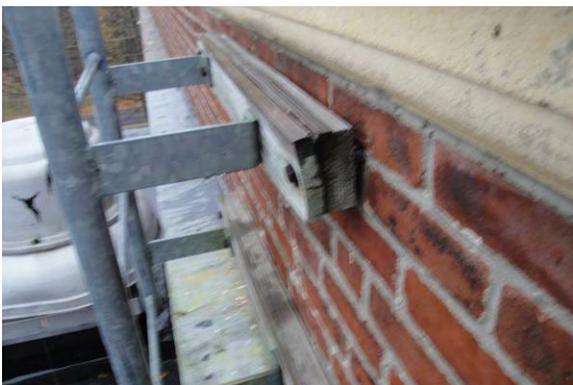
The bolts that attach one of the roof access ladders are loose, making the ladder unstable (figure 8.24)

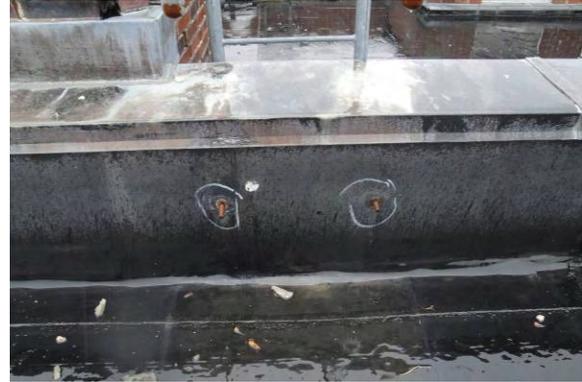
There is another roof access ladder where a section of the ladder is missing, also making the ladder unstable (figure 8.25).

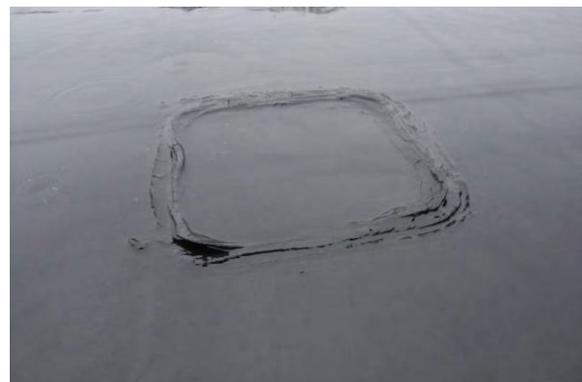
There are also patches that were installed where the seams were starting to separate, which may allow water to penetrate into the building (figure 8.27).

Figure 8.27 – Membrane Roof Patch

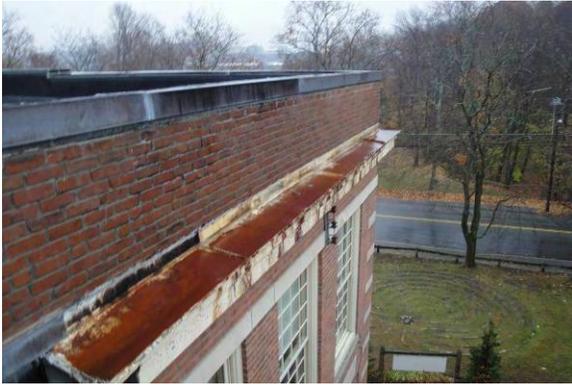
Figure 8.28 – Metal Flashing

The metal flashing at the cornice trim is in poor condition. There are several areas where the flashing is rusted and the seam separated, which may allow water to penetrate into the wall. Further investigation is required (figure 8.28).

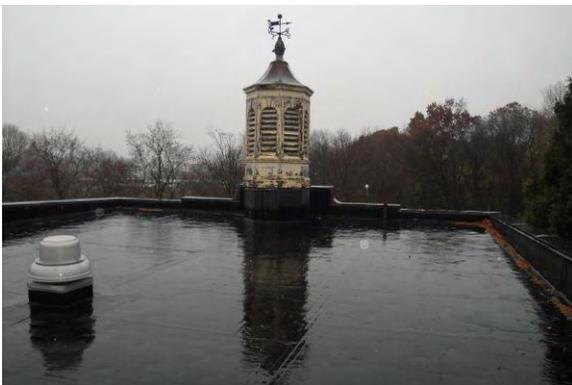
Figure 8.29 – Cupola

The wooden roof cupola is in poor condition. The paint finish is weathered and peeling and some of the wood is exposed. Further investigation is required to determine if there are any rotted or loose sections of wood or molding (figure 8.29).
