Town of Maynard, Massachusetts Building Observation Report

AECOM Technical Service Inc.
66 Long Wharf, 3rd Flr.
Boston, MA 02110
(617) 723-1700

December 2010

Executive Summary

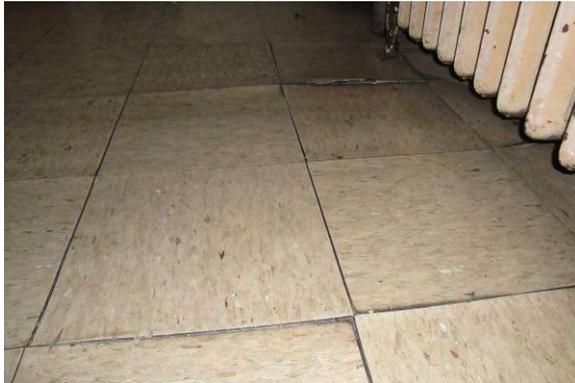
Figure 8.41 – VCT Floor Tiles

The majority of the VCT throughout the building is in poor condition. The tiles are worn and peeling up in several areas (figure 8.41).

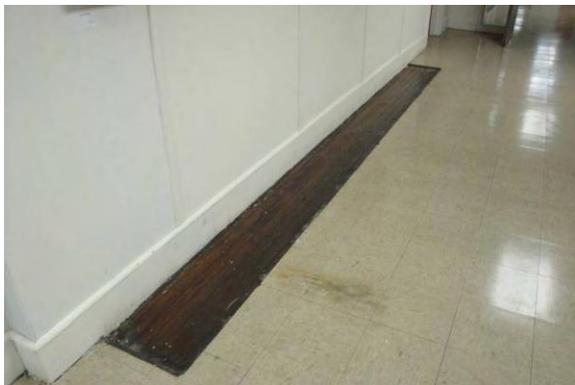
Figure 8.42 – Missing VCT Floor Tiles

There are sections of VCT floor missing in several of the corridors where the lockers were removed, and the original hardwood flooring is exposed (figure 8.42).

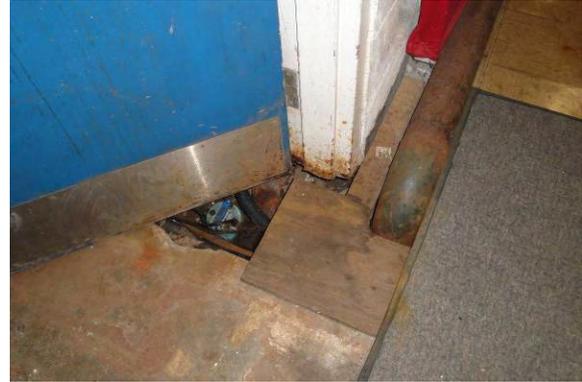
Figure 8.43 – Plywood at Concrete Slab

There is a section of the basement floor where the concrete slab was removed and a section of steam pipe installed and covered by a piece of plywood (figure 8.43).

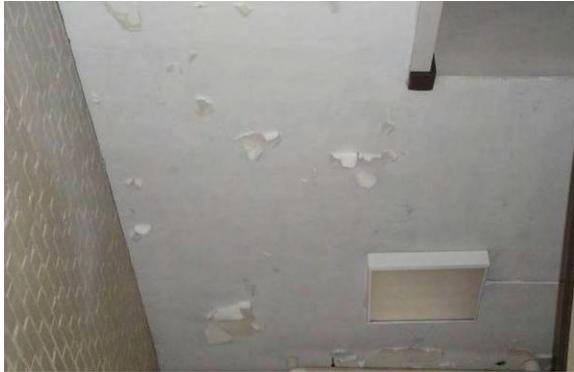
Figure 8.46 – Plaster Ceilings

The painted plaster ceilings are in overall fair condition. There are several areas where the paint finish is missing or peeling

off, which may be caused by roof leaks. Further investigation is required to determine the cause of the leaks (figure 8.46).

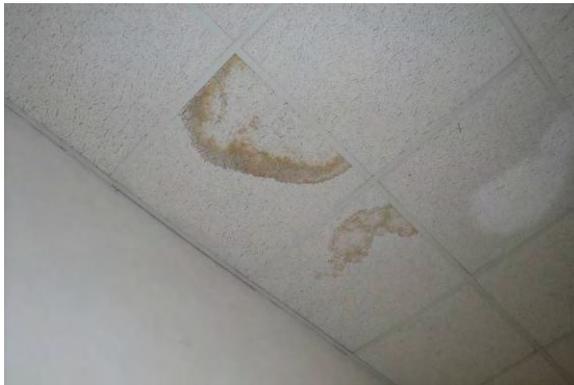
Figure 8.47 – Damaged Ceiling Tiles

The majority of the suspended ceilings appear to be in good condition. There are a few areas where ceiling tiles appear water stained, which may have been caused by roof leaks. Further investigation is required to determine the cause of the water damage (figure 8.47).

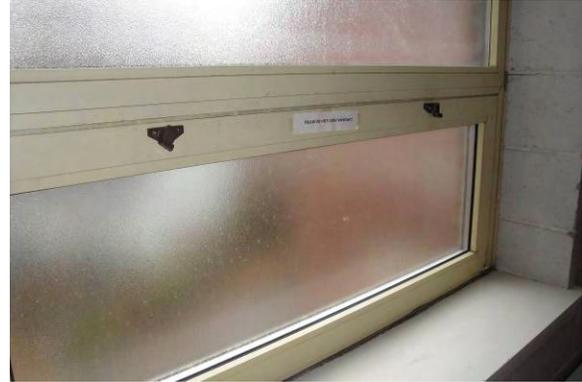
Figure 8.48 – Broken Window Hardware

The hardware at some of the awning windows is broken and the windows are difficult to open (figure 8.48).

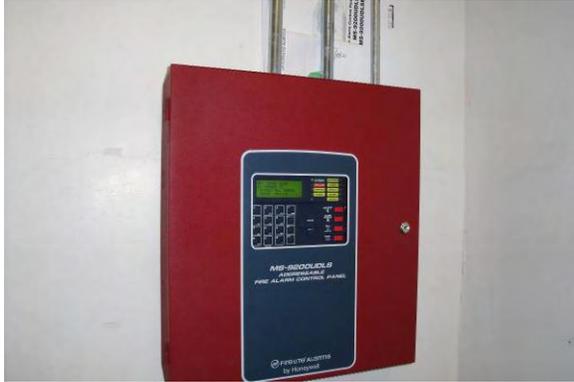
Figure 8.55 – Fire Alarm Panel

The building has a fire alarm system, which consists of control panels, exit signs, emergency lights, pull stations, and horn/strobe devices. The system components appear to be in good condition and functioning, but there are a few devices that appear to be old and likely not code compliant (figure 8.55).

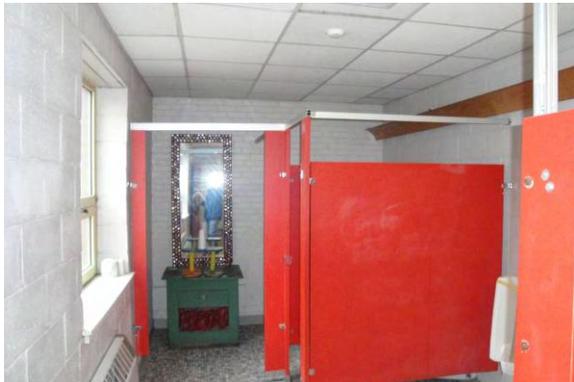
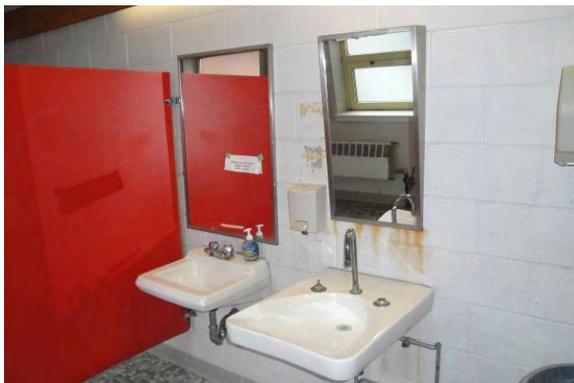
The building has several toilet rooms located on each floor, which include previous student and faculty toilet rooms of multiple configurations. Most of the toilet rooms appear to be old and in poor condition. Some of the fixtures are likely not water-conserving or ADA compliant (figure 8.56 and 8.57)

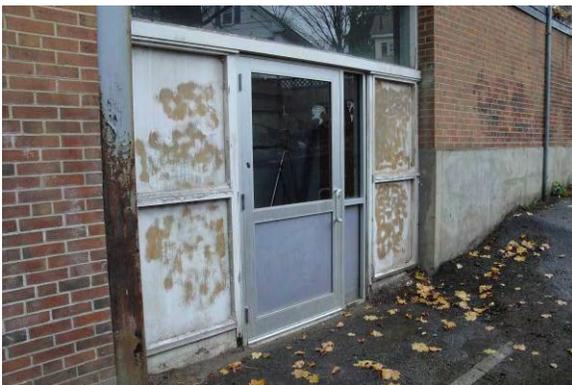
Figure 8.60 – Office Exterior Doors

There are two different types of exterior doors and frames. The office area entrance doors are aluminum and glass storefront assemblies, which appear to have replaced the original painted wood framing system. The doors have glass sidelights and transoms above, however the sidelight glass has been removed and replaced with painted plywood (figure 8.60).

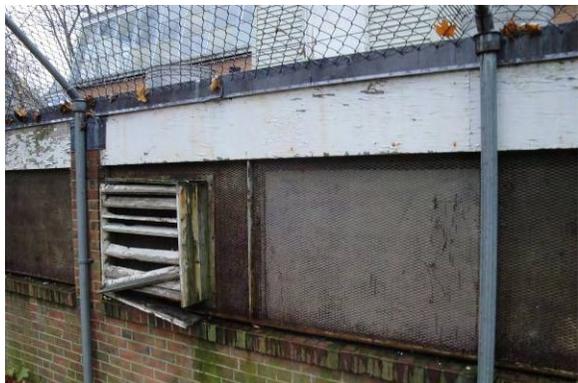
Figure 8.63 – Strip Windows

The office area exterior windows appear to be a painted metal strip window assembly; however the glass panels have been removed and replaced with painted plywood (figure 8.63).

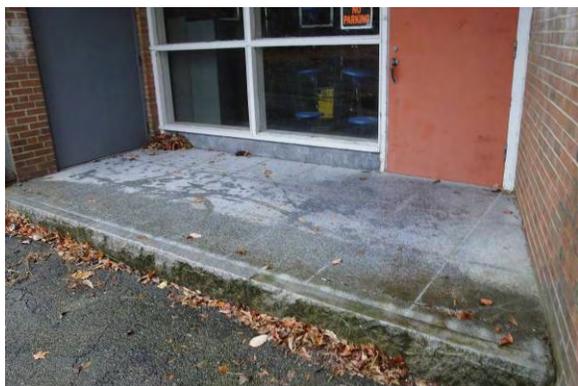
Figure 8.65 – Raised Entrance Platform

The building entrances have raised concrete platforms approximately 6-inches high. There are no accessible entrances present (figure 8.65).

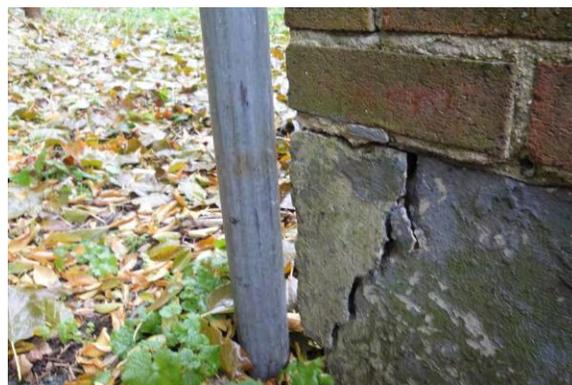
Figure 8.67 – Chipped Foundation Corner

The exterior brick walls appear to be in good condition. There are some areas where the mortar appears to be aging and weathered. There are a few corners of the foundation wall where the concrete is cracked or chipped off (figure 8.67).

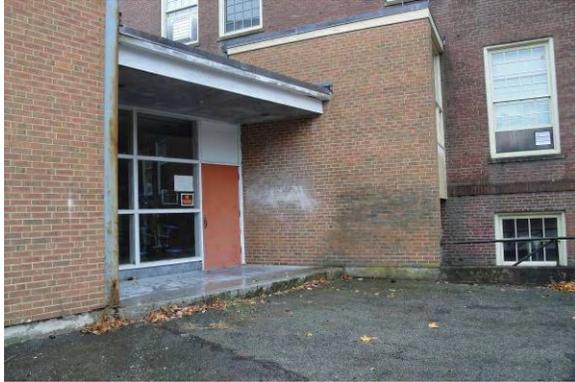
Figure 8.68 – Efflorescence in the Brick

There are also areas in the brick that display efflorescence (chalky white patches), which indicate that water has penetrated behind the brick. Further investigation is required to confirm where water is penetrating the wall cavity (figure 8.68).

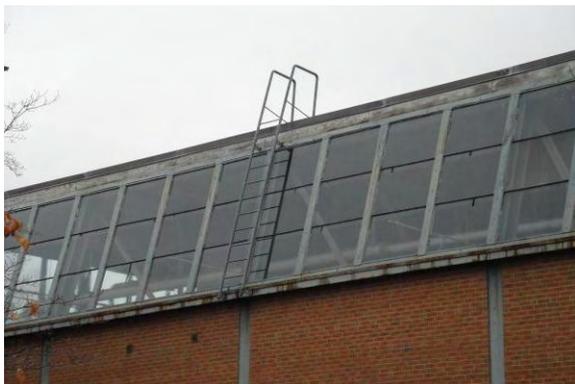
Figure 8.70 – Exterior Glazing

The gaskets at some of the exterior glazing are failing and some of the lexan replacement window panels are frosted (8.70).

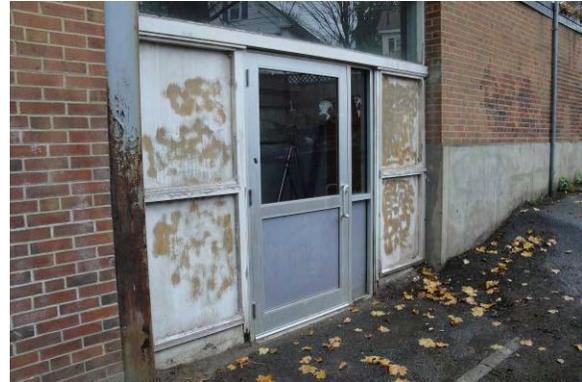
Figure 8.71 – Wood Storefront Assembly

The wood frames at the entrance doors and storefront are in poor condition. The paint finish is weathered and peeling and some of

the wood is exposed. Further investigation is required to determine if there are any rotted or loose sections of wood or molding (figure 8.71 and 8.72).

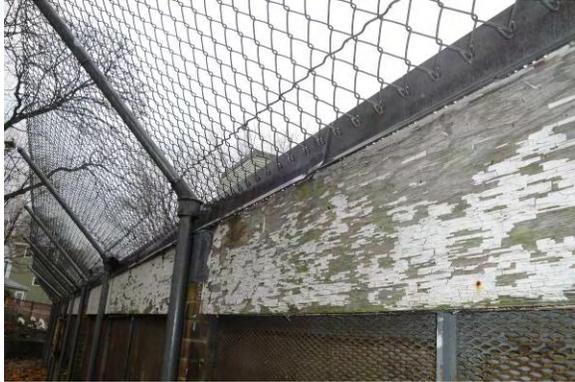
Figure 8.74 – Plywood Fascia Trim at Rear Roof

There are sections of the metal roof edge that display areas of rust and sections that appear loose and detached. There are also sections of the plywood fascia board that appear warped and sections where the paint finish appears weathered and faded (figure 8.73 and 8.74).

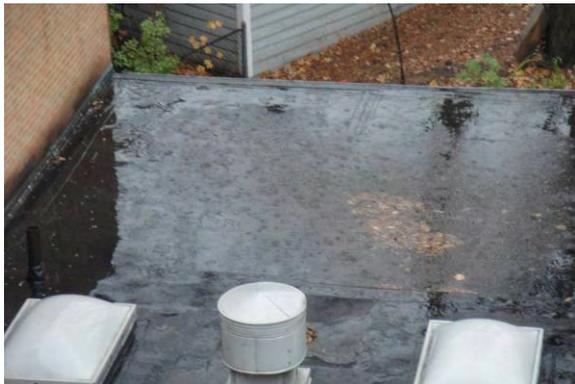
Figure 8.75 – Roof Drain

There is a roof drain at the gym vestibule roof that does not appear to be functioning. Further investigation is required to determine the cause of the malfunction (figure 8.75).

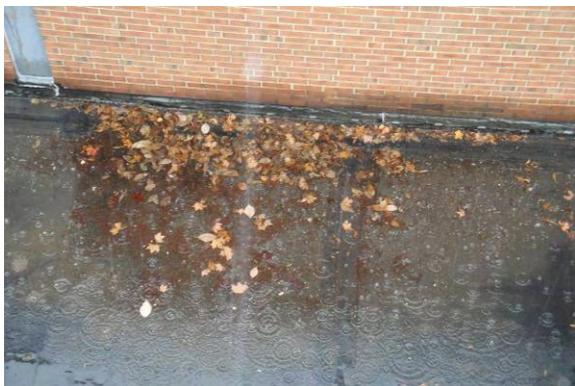
There are a few other areas on the lower roofs where water was observed ponding, and there are no overflow scuppers (figure 8.76 and 8.77).

Figure 8.76 – Gym Vestibule Roof

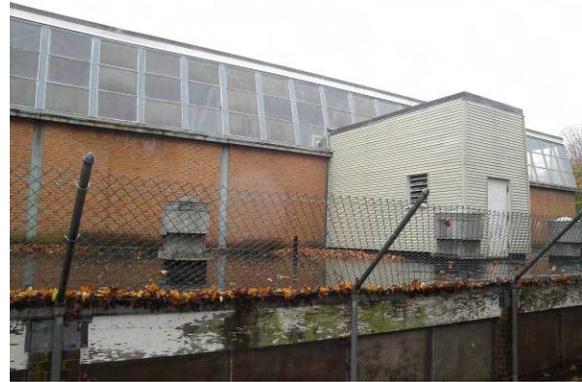
Figure 8.77 – Office Area Roof

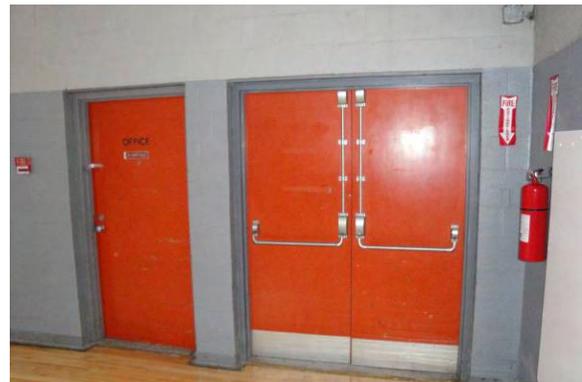
The interior doors are painted flush wood doors within painted metal frames. The door hardware does not appear to be ADA compliant (figure 8.84).

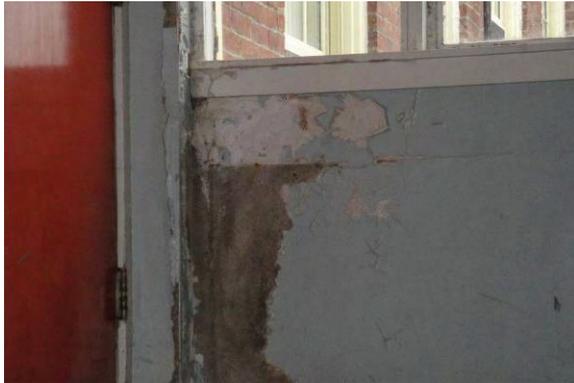
There is a section of the interior wall at the gym vestibule section where the plaster finish is damaged, which may have been caused by window leaks above. Further investigation is required to confirm if water is penetrating the wall cavity (figure 8.85).

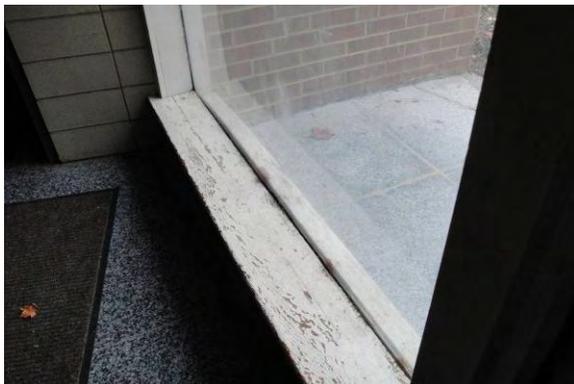
The paint finish on the interior wood window sills is faded and peeling and some of the wood is exposed. Further investigation is required to confirm if water is penetrating the wall system (figure 8.86).

Figure 8.86 – Wood Sills

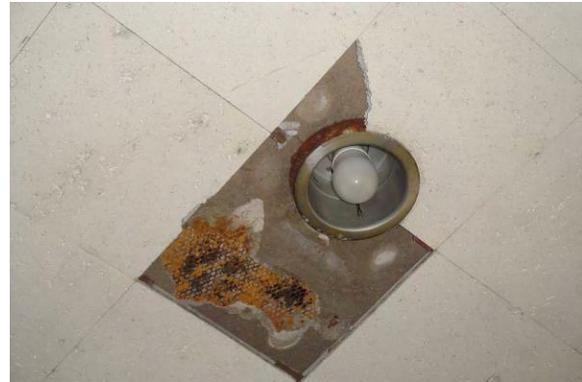
There are several areas where sections of the 1'x1' acoustic ceiling tiles are missing and display evidence of water damage, which may be caused by roof leaks above (figure 8.87). Further investigation is required to confirm the cause of the roof leaks and if there is any further damage to the structure.

Figure 8.87 – Damaged 1x1 Acoustic Ceiling Tiles

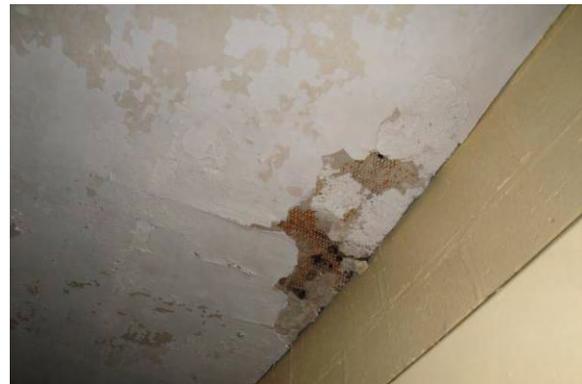
The plaster ceilings also include several areas that appear damaged from roof leaks. There are a few areas where ceilings are water stained, plaster is missing or deteriorated, and sections of the paint is peeling off (figure 8.88).

Figure 8.88 – Damaged Plaster Ceilings

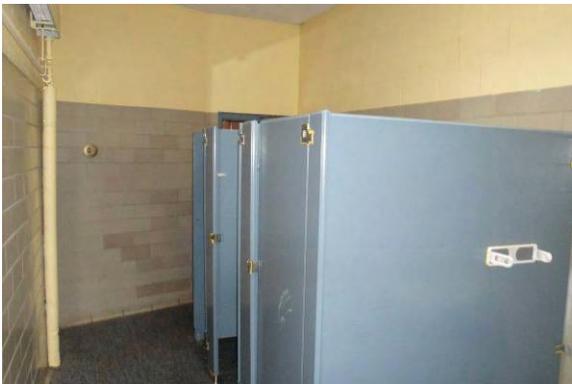
The building has two toilet rooms: a men's room that has 2 toilets, 2 urinals, 2 lavatories, and accessories; and a women's room that has 3 toilets, 2 lavatories, and accessories (figure 8.90).

The fixtures appear to be original to the building and are in fair condition and functioning. The toilet rooms do not appear to be ADA compliant.

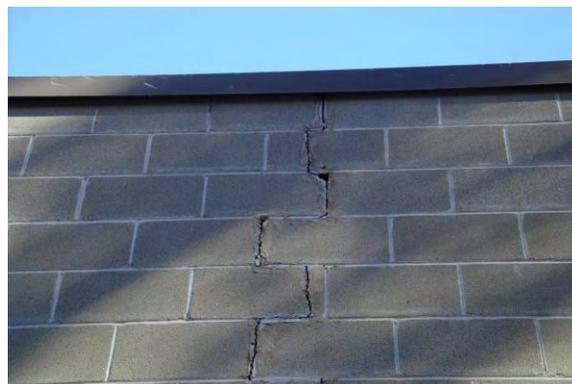
There are a few areas where the exterior CMU walls are cracked at the mortar joints and through some of the blocks (figure 9.5). Further investigation is required to determine if these cracks are stress cracks or settlement cracks, and to verify if water is penetrating into the wall.

Figure 9.5 – Wall Cracks

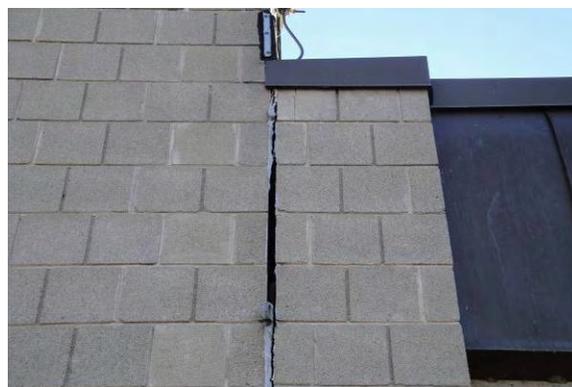
There are a few locations where the sealant at the joints is cracked and missing. Further investigation is required to verify if the joint separation is due to building settling or sealant failure, and also to verify if water is penetrating the wall (figure 9.6).

Figure 9.6 – Open Exterior Joint

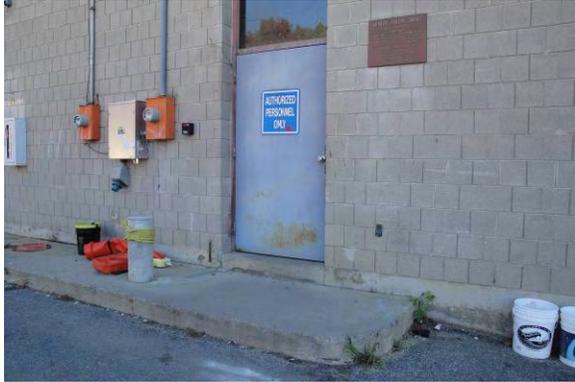
The paint finish on the exterior doors and frames appears weathered and there are areas of rust.

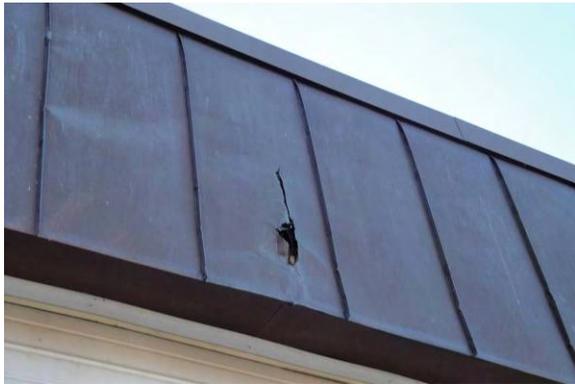
There are sections of the aluminum wall panels that are damaged. Some of the siding panels appear torn, and others loose, warped, or detached (figures 9.8 and 9.9).

Figure 9.8 – Damaged Aluminum Siding

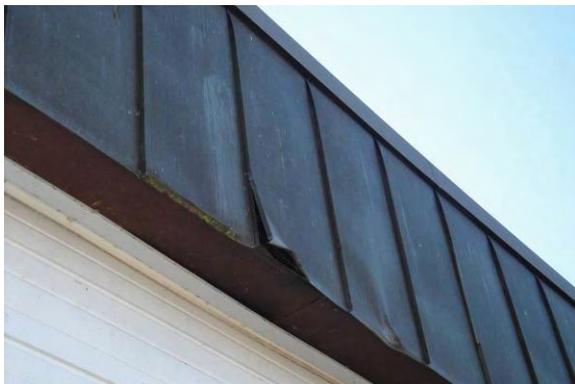
Figure 9.9 – Detached Aluminum Siding

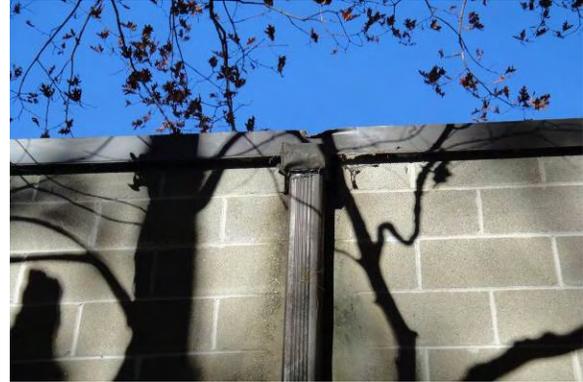
The aluminum scuppers and downspouts appear to be old and in fair condition. The CMU wall behind the downspouts appears water damaged (figure 9.10). Further investigation is required to determine if the CMU wall needs repair.

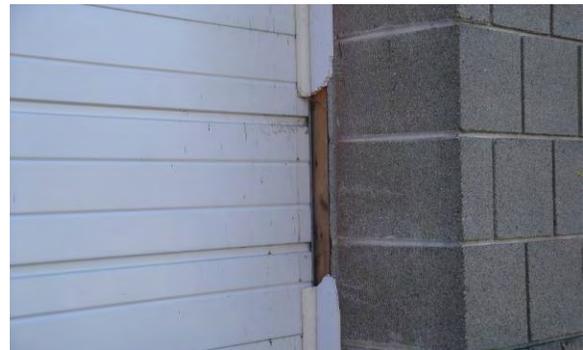
The weatherstripping at the overhead doors is deteriorated, with some sections loose and other sections missing (figure 9.11). Further investigation is required to determine if the damaged weatherstripping is allowing water infiltration.

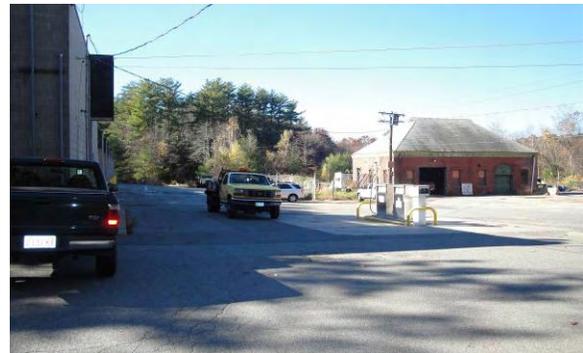
The paving surfaces appear to have been patched over the years and are uneven in several areas with significant cracking. The paving appears to have sufficient pitch to allow for proper drainage (figure 9.12).

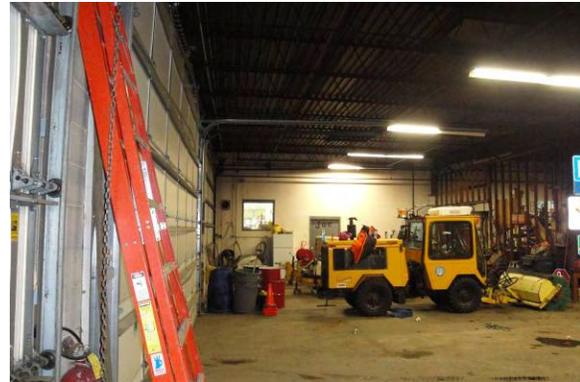
The concrete floor slab has several areas where the slab appears to be stained and chipped, most likely due to maintenance to the adjacent vehicles and equipment. The slab has a few areas with isolated cracks, but overall it appears to be in good condition (figure 9.14).

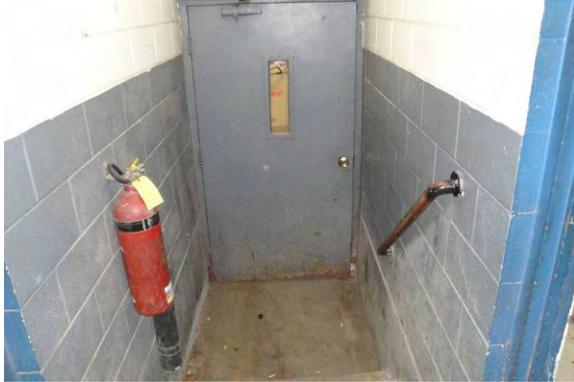
The interior doors are old and appear to be original to the building, but are in overall fair condition. The door hardware is old but functioning. Some of the doors display areas of rust and corrosion (figure 9.16).

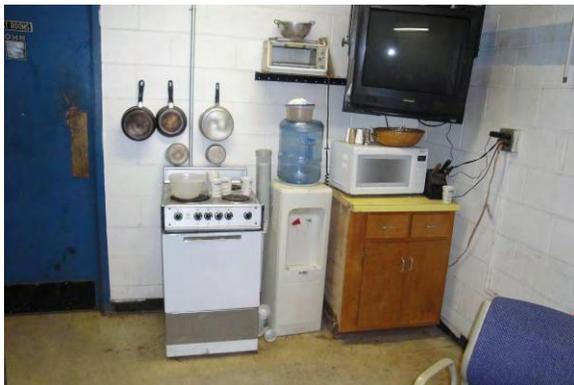
There is a small section of built-in casework located in the lunchroom with a plastic laminate countertop and wood cabinets. The countertop height cabinet door hardware and cooktop are not ADA compliant (figure 9.17). The casework is old and in overall poor condition.

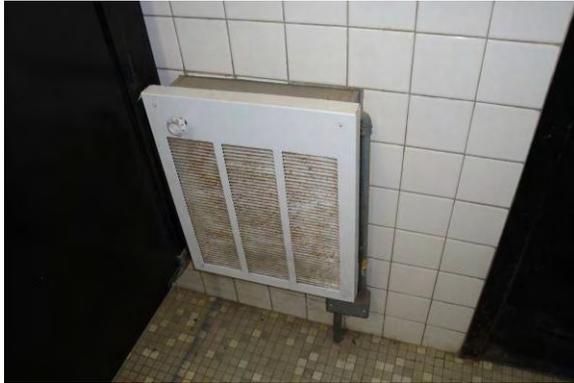
The office and toilet room have supplemental heating provided by wall mounted electrical unit heaters (figure 9.21). The units appear to be original to the building and are rusted, but appear to be functioning.

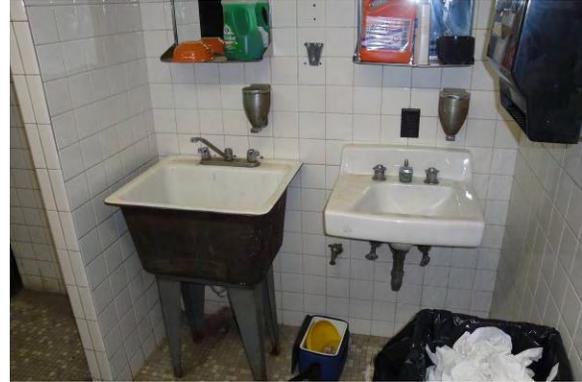
The building has one toilet room, which consists of two toilets, a urinal, lavatory, utility sink, and a shower. The fixtures appear original to the building and are likely not water-conserving, but appear to be functioning (figure 9.22). The toilet room does not appear to be ADA compliant. Current plumbing codes would likely require separate toilet room facilities for men and women.

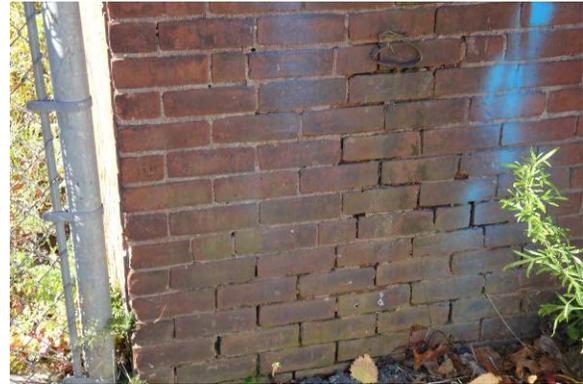
Figure 9.30 – Brick Wall at Grade

The exterior brick walls appear to be in very poor condition. The mortar appears to be aging and weathered. There are several areas where the mortar is deteriorated, missing, loose, or cracked (figure 9.30).

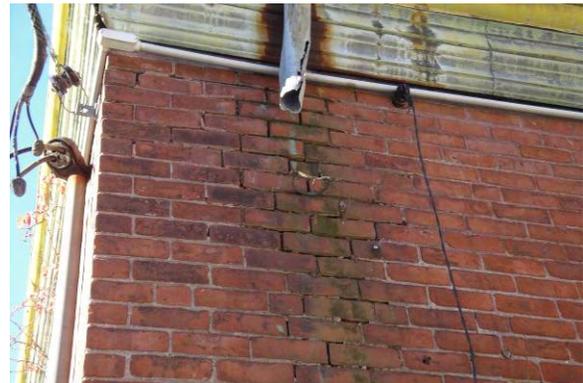
Figure 9.31 – Water Damage at Brick

There is a section of brick that appears to be water-damaged at a location of a missing downspout (figure 9.31).

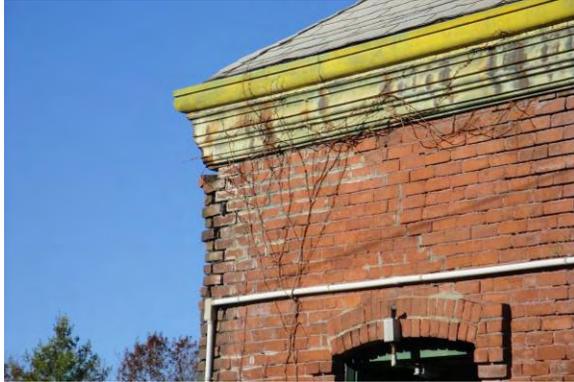
Figure 9.32 – Brick at Corner

The brick at the corners displays a significant amount of deterioration as well. Several bricks appear loose and some bricks are missing (figure 9.32).

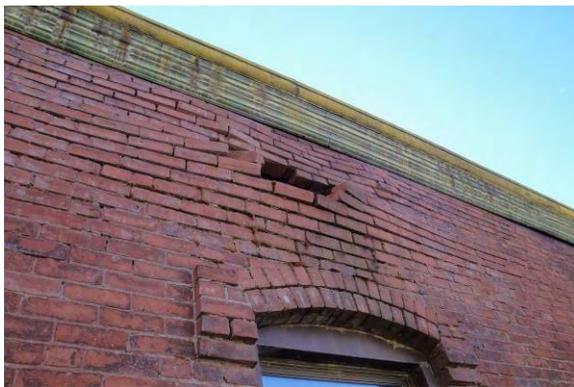
Figure 9.33 – Brick over Windows

The brick over the windows also displays a significant amount of deterioration. The brick is bowing out, and several bricks are loose or missing (figure 9.32).

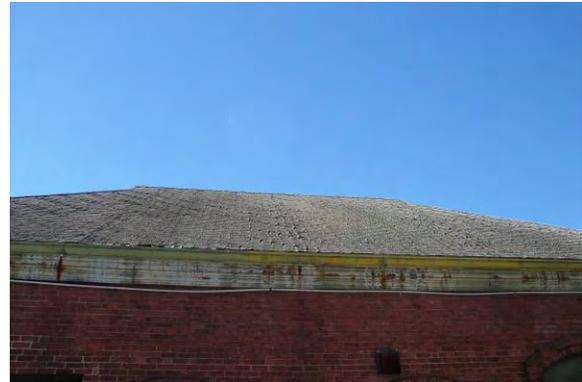
Figure 9.35 – Roof Shingles

The asphalt roof shingles appear to be in very poor condition. The shingles display areas of tearing and warping. The granular surface of the shingles appears to have worn off, and the shingles appear brittle (figure 9.35).

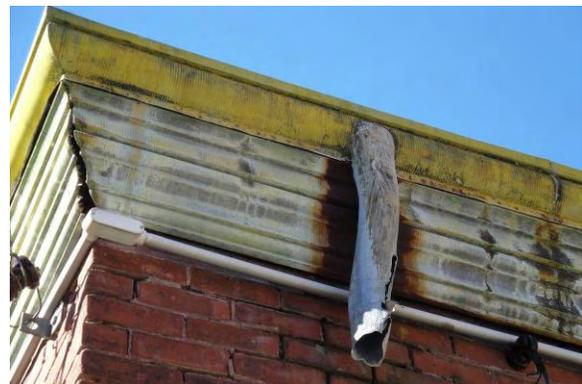
Figure 9.36 – Gutter and Cornice at Roof

The metal gutter and downspouts appear to be in poor condition. There are several downspouts missing causing rain water to run down the face of the brick wall. Some of the joints between the metal cornice sections are open, which might allow water to penetrate into the wall. Further investigation is required (figure 9.36).

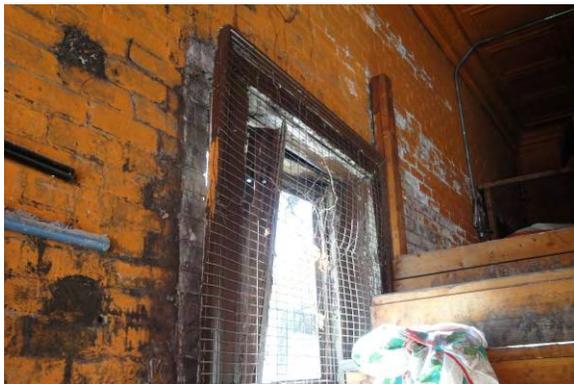
Figure 9.44 – Dislodged Window Assembly

The windows are in poor condition. In the vehicle maintenance area, the window assembly appears to be separated from the masonry wall and is tipping into the building (figure 9.44).

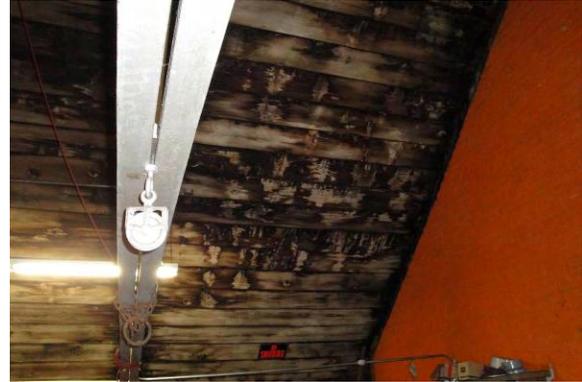
Figure 9.45 – Roof Decking

The roof decking appears to be wet and displays areas of water damage (figure 9.45). Further investigation is required.

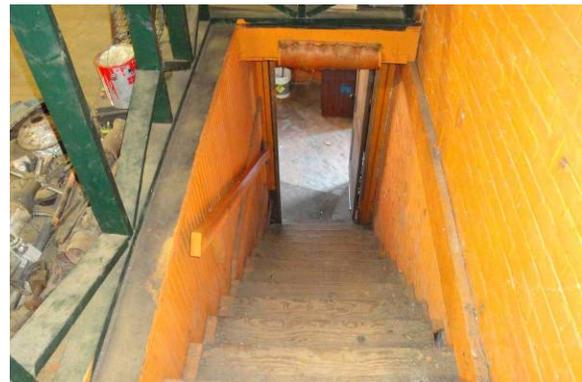
Figure 9.46 – Mezzanine Stair

There is a single interior wood stair to the storage loft, which does not appear to conform to current building code or ADA requirements. The guardrail and handrail heights appear lower than the heights allowable by code (figure 5.46), and they do not extend beyond the top and bottom nosing as required by code. Further investigation is required to determine other code deficiencies (figure 5.47).

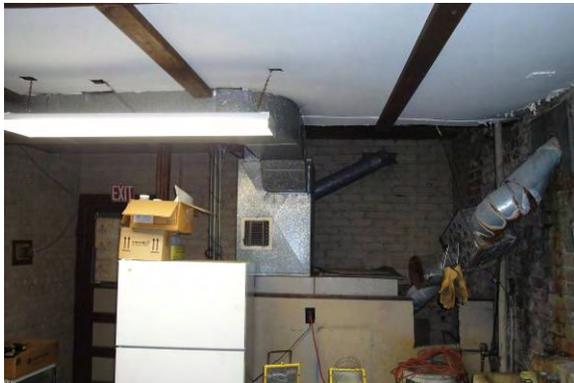
Figure 9.48 – Oil Fired Furnace

The building has an oil fired forced hot air heating system with exposed ductwork that provides heat and ventilation to the office and storage rooms (figure 9.49). The ductwork appears to be original to the installation and is severely rusted. Further investigation is required to verify if the heating system is adequate and code compliant.

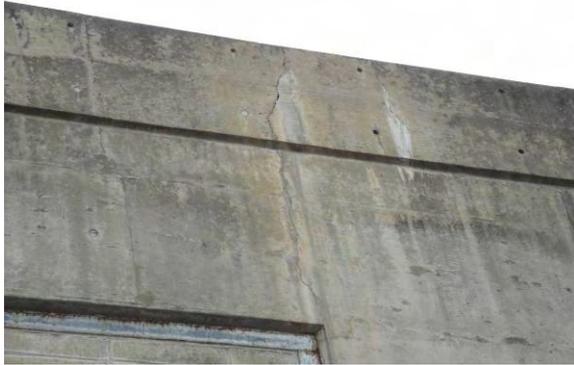
Figure 10.15 – Pre-cast Concrete Walls

The exterior concrete walls have some minor surface cracks. Further investigation is required to confirm if the cracking is due to the building settling, and also to verify if water is penetrating into the wall (figure 10.15).

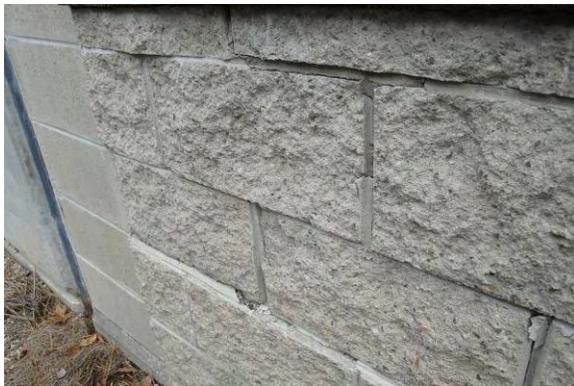
Figure 10.16 – Damaged CMU Wall

There is a section of the split-face CMU wall to the left of the front entrance that appears to have been damaged by a vehicle. Further investigation is required to verify if water is penetrating the wall at this area (figure 10.16).

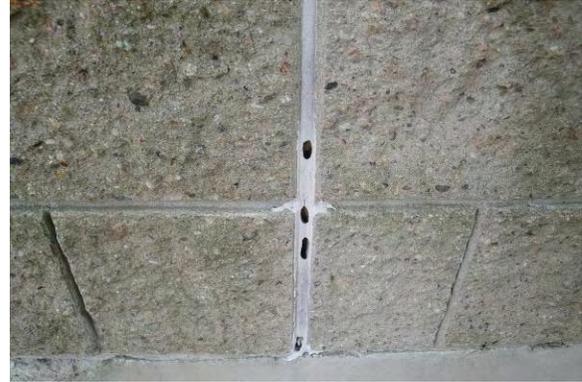
Figure 10.17 – Exterior Joint

The sealant at the exterior joints is cracked and the backer rod exposed. Further investigation is required to verify if the joint separation is due to building settling or sealant failure, and also to verify if water is penetrating the wall (figure 10.17).

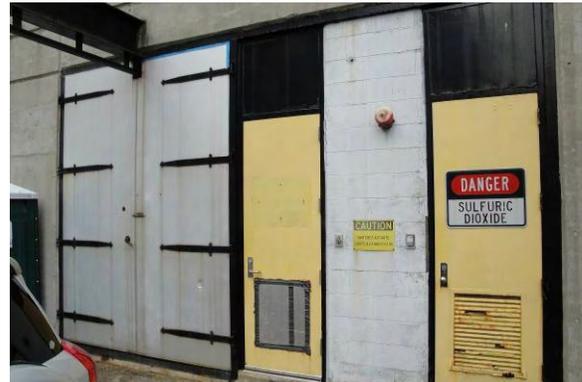
Figure 10.18 – Exterior Doors at Rear of Building

The painted metal doors are in poor condition. The paint finish on the doors and frames appears weathered and faded, with areas of rust visible. The caulking around the perimeter of the door frames is missing in some areas and in overall poor condition. There is also daylight showing through the weather stripping at some of the doors. The door hardware appears old and not ADA compliant (figure 10.18).

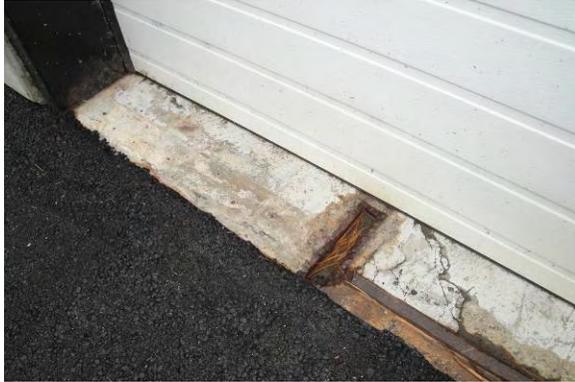
Figure 10.19 – Exterior Doors at Rear of Building

There is a rusted piece of former steel framing embedded into the concrete slab at one of the overhead door openings at the vehicle storage bays. The steel piece is rusty and there are several concrete cracks around it (figure 10.19).

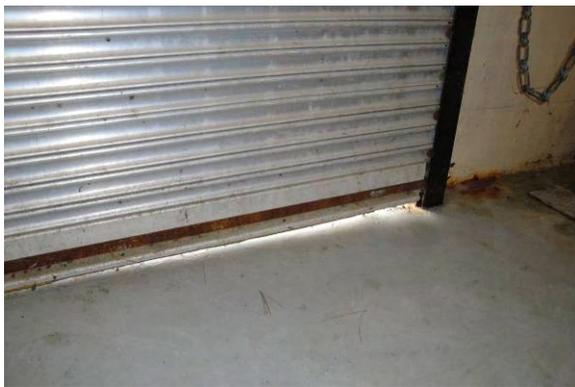
Figure 10.20 – Overhead Sill Seal

There is daylight showing at the sill seal of one of the overhead doors, which could allow water to infiltrate the building (figure 10.20).

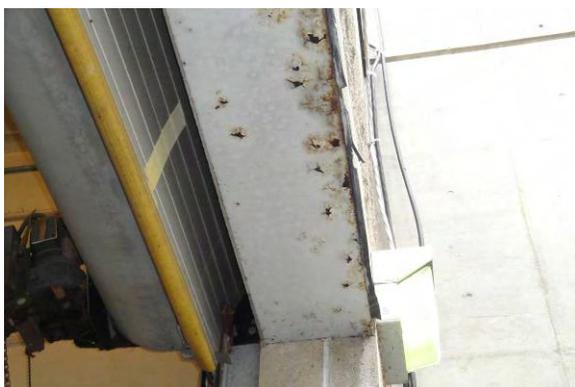
Figure 10.21 – Overhead Door Header

The paint finish on the pump truck garage overhead door frame is in poor condition. The paint is peeling and the frame displays areas of rust (figure 10.21).

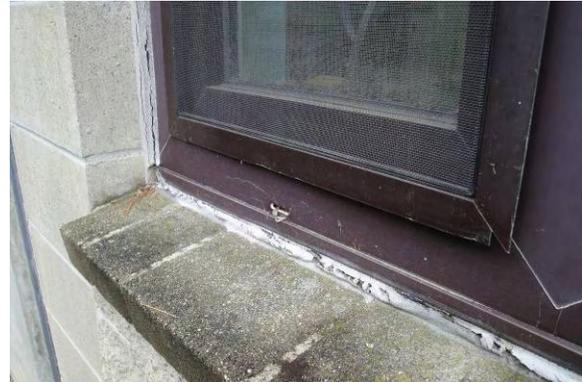
Figure 10.22 – Sill Seal

The caulking around the windows is missing in some areas and in overall poor condition (figure 10.22).

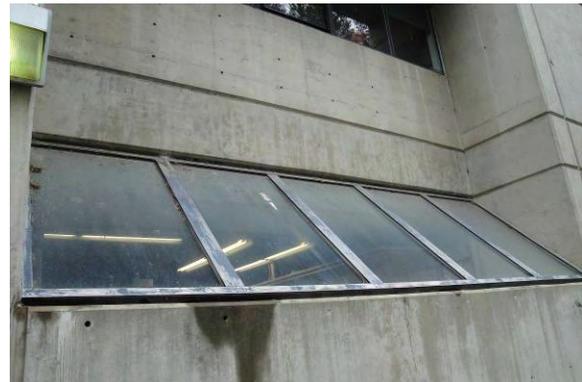
Figure 10.23 – Sloped Glazing

The sloped glazing windows appear to be in fair condition. The finish on the framing is worn and the sealant around the perimeter is in poor condition (figure 10.23).

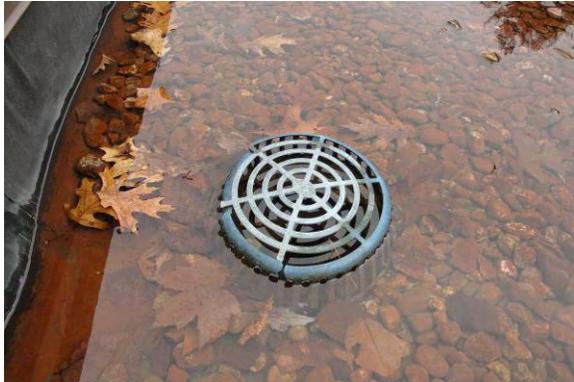
Figure 10.25 – Roof Drain

There is one roof drain that does not appear to be functioning; at the time of the site visit,

ponding water and accumulated debris was observed at the drain. Further investigation is required to determine cause of the malfunction (figure 10.25).

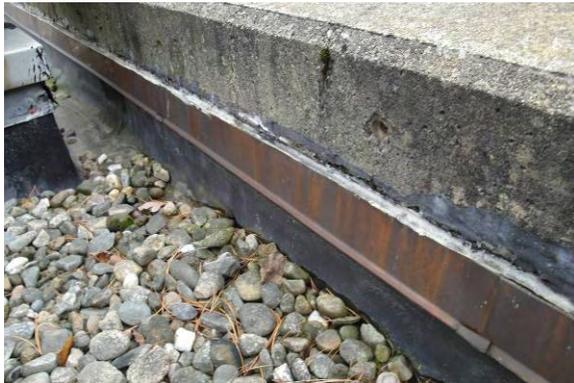
Figure 10.26 – Counter Flashing

The sealant at the counter flashing along the roof is in poor condition. There are areas where the sealant is cracked, which may allow water to penetrate behind the membrane. Further investigation is required (figure 10.26).

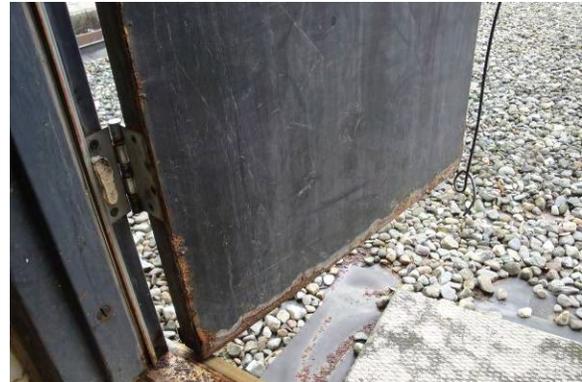
Figure 10.27 – Roof Access Door

The roof access door is in poor condition. The paint finish appears weathered and faded, and there is a significant amount of rust visible on the door and the frame. The door hardware is also in poor condition, and the door was being held shut with a wire (figure 10.27).

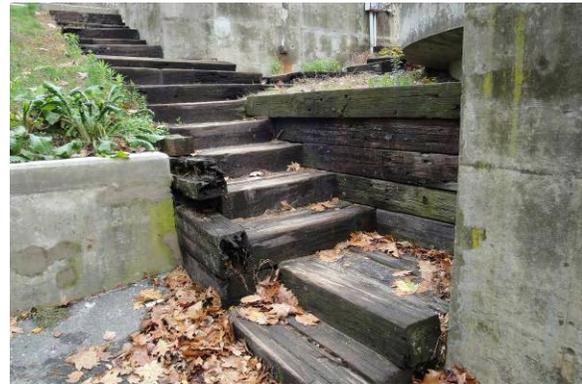
Figure 10.28 – Railroad Tie Stair

The railroad tie stairs at the rear of the building are in poor condition. The ties are loose and several appear rotted (figure 10.28).

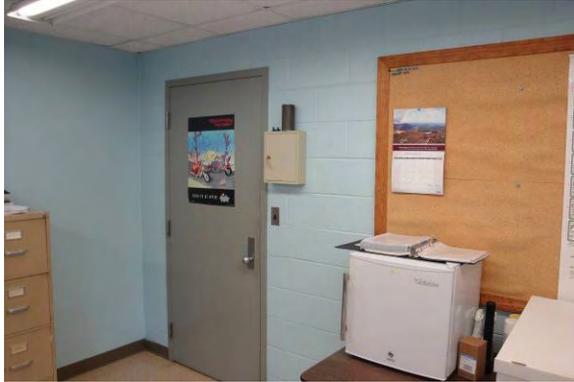
Figure 10.35 –Interior Doors

The interior doors are painted metal doors within painted metal frames. The doors do not have ADA compliant hardware (figure 10.35).

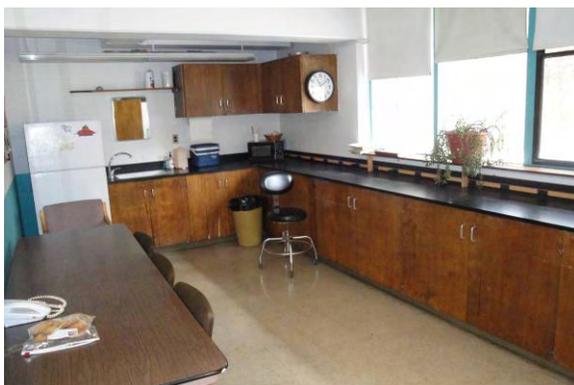
Figure 10.36 – Lunchroom Casework

There are sections of built-in casework located in the lunchroom and lab areas, with wood cabinets, a solid surface countertop, and a sink. The countertop height and sink configuration are not ADA compliant (figure 10.36).

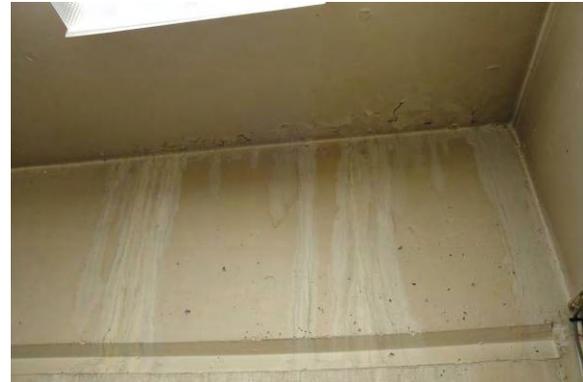
Figure 10.37 – Damaged Paint at Ceiling

There are areas where the paint on the exposed structure appears water damaged (figure 10.37).

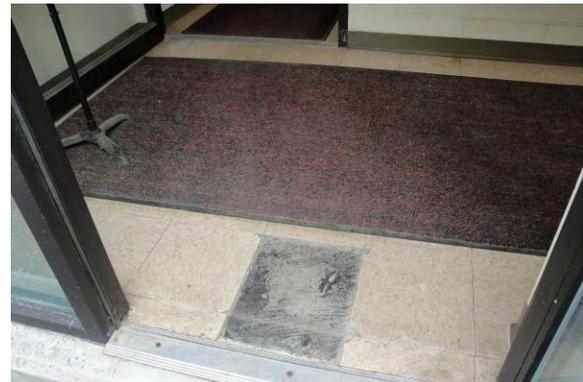
Figure 10.38 – VCT at Front Vestibule

The VCT floors appear to be original to the building and are in poor condition. Several areas are stained and worn, with a few tiles missing in some areas (figure 10.38).

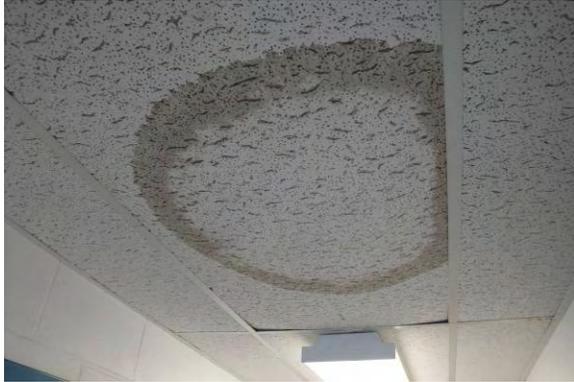
Figure 10.39 – Damaged 2'x4' Tiles

There are several areas where the acoustic ceiling tiles are water stained, which may have been caused by roof leaks above. Further investigation is required to determine the cause of the water damage (figure 10.39).

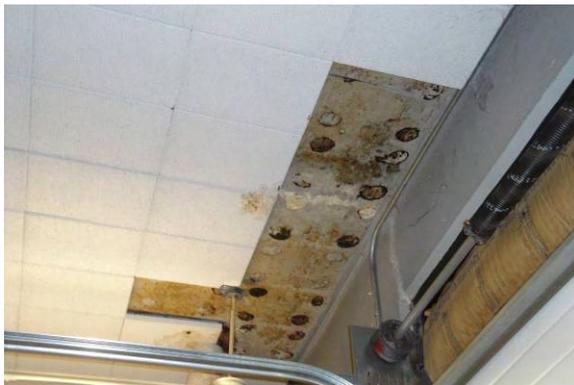
Figure 10.40 – Damaged 12"x12" Tiles

The 12"x12" ceiling tiles in one of the vehicle storage bays appear to be water damaged and several of the tiles are missing (figure 10.40).

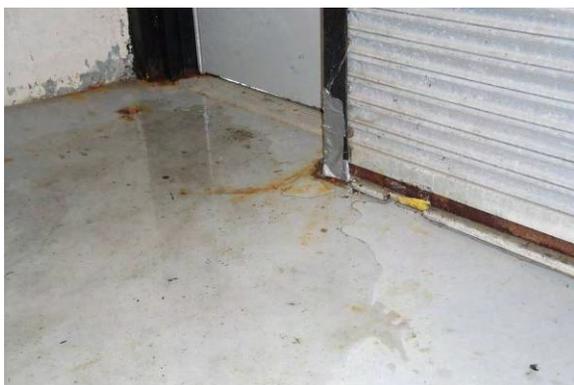
Figure 10.41 – Puddle of Water

At the time of the site visit, there was a puddle of water below the damaged ceiling tiles, which appears to be caused by a leaking roof drain above. Further investigation is required to determine the cause of the leaks (figure 10.41).

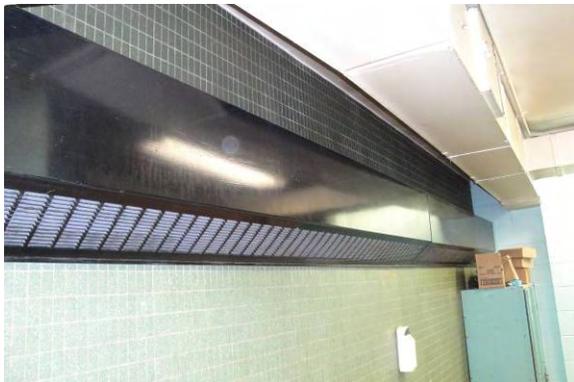
Figure 10.45 – Fin Tube Radiation

The building heating system is comprised of fin tube radiators mounted high on the wall, connected to a gas fired hot water boiler (figure 10.45). Further investigation is required to verify if the high wall installation meets ADA requirements for protruding objects.

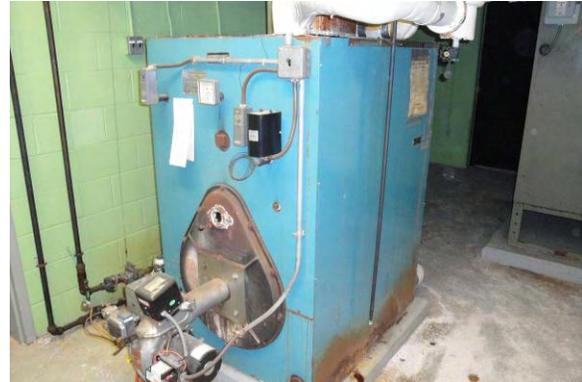
Figure 10.47 – Main Boiler

The boiler is approximately 25 years old, and appears to be in good condition and functioning. The capacity of the boiler could not be confirmed. There is some rust on the piping and surface of the boiler. There are also some rust stains around the perimeter of the boiler pad, most likely from maintenance of the piping (figure 10.47).

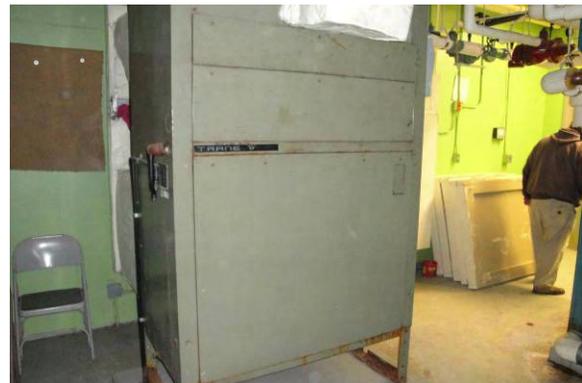
Figure 10.48 – AC Unit

The building also has an air conditioning system, which appears to be original to the building. The AC unit is old and in poor condition (figure 10.48).

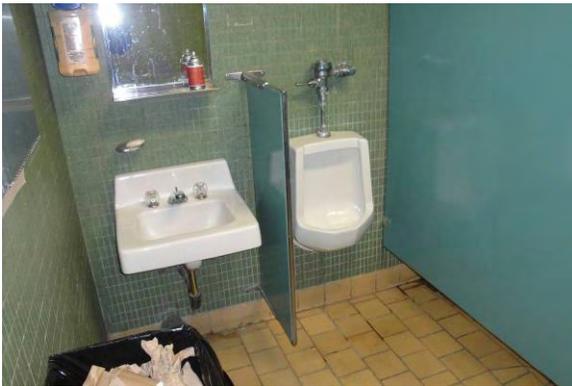
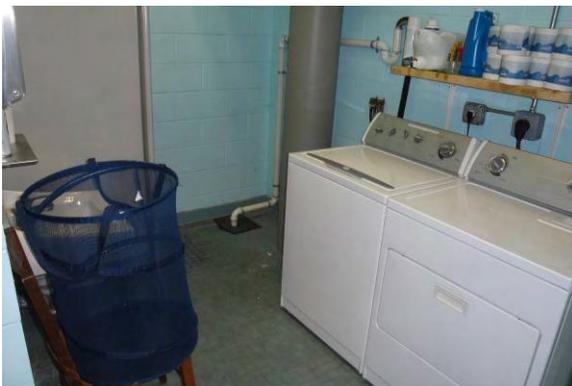
The building has two toilet rooms on the first floor; a men's room that has a toilet, urinal, lavatory, shower, and accessories (figure 10.50); and a women's room that has a toilet, lavatory, and accessories (figure 10.51). The women's room also has a washer and dryer. The fixtures appear to be in good condition and functioning. The toilet rooms do not appear to be ADA compliant.

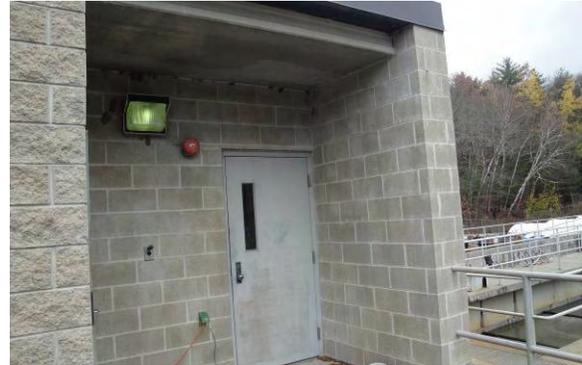
Figure 10.55 – Exterior Doors

The building has two painted insulated metal doors within painted metal frames with stainless steel hardware. One door provides access to the inside of the main building, and the other door provides access to the stair that leads to the equipment below. The building entrances share a raised concrete platform that is approximately 4-inches high. There are no accessible entrances present (figure 10.55).

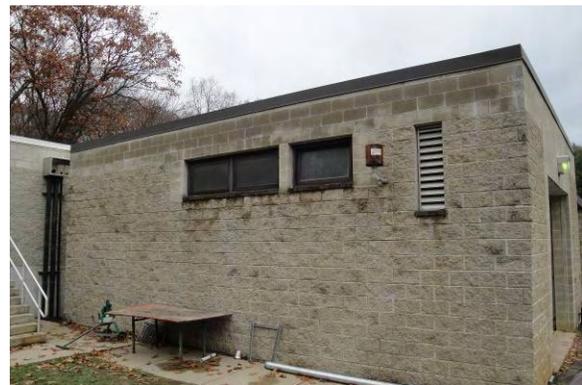
Figure 10.57 – Exterior Windows

There are several aluminum windows with insulated glass and operable awning sash in punched wall openings (figure 10.57).

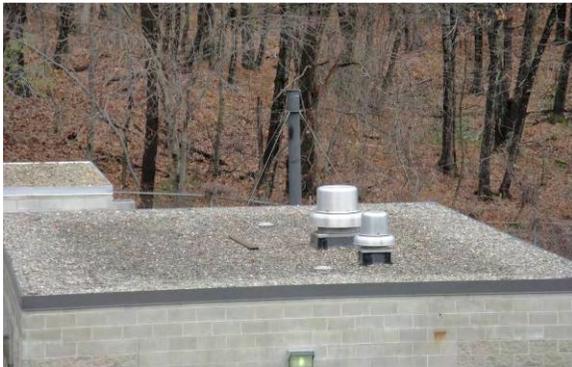
Figure 10.57 – Stone Ballasted Membrane Roof

The roof could not be observed at the time of the visit due to access limitations. However, the roof was observed from the Administration Building and it appears to be a stone ballasted membrane roof, likely original to the building. The roof has an aluminum gravel stop around the perimeter. There is no evidence on the interior of the building of any roof leaks. Further investigation is required to verify the exact type and condition of the roof (figure 10.57).

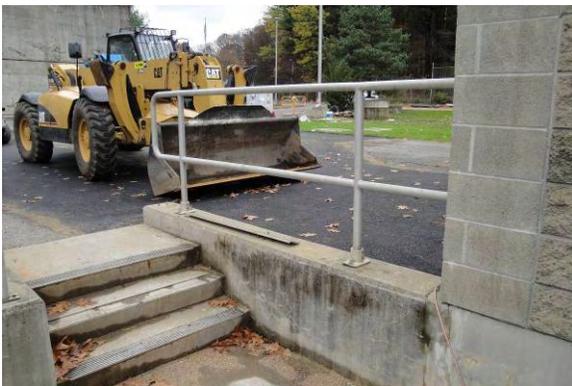
Figure 10.59 – Exterior Stair

The building has two sets of stairs. There is an exterior concrete stair adjacent to the building entrance (figure 10.59). The other stair extends down to the equipment located below grade (figure 10.60).

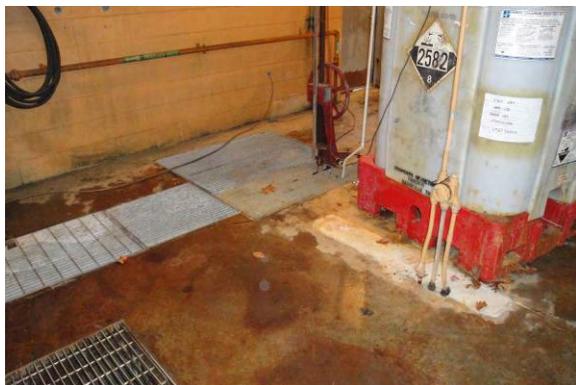
Figure 10.68 – Stained Concrete

The exposed concrete slab is severely stained from the water treatment process (figure 10.68), but otherwise appears to be in good condition.
