Town of Maynard, Massachusetts Building Observation Report

AECOM Technical Service Inc.
66 Long Wharf, 3rd Flr.
Boston, MA 02110
(617) 723-1700

December 2010

Executive Summary

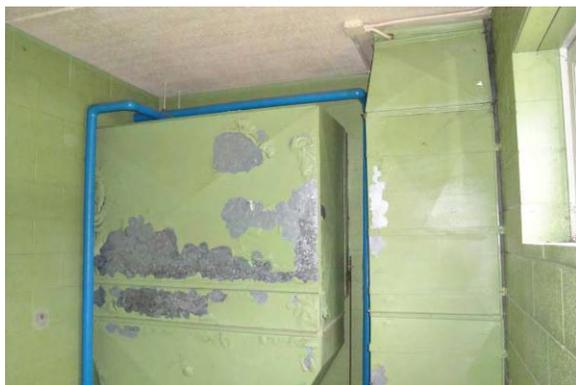
Figure 10.69 – Peeling Paint

The paint finish on a section of HVAC ductwork in the stair leading to the equipment below is deteriorated and peeling off (figure 10.69).

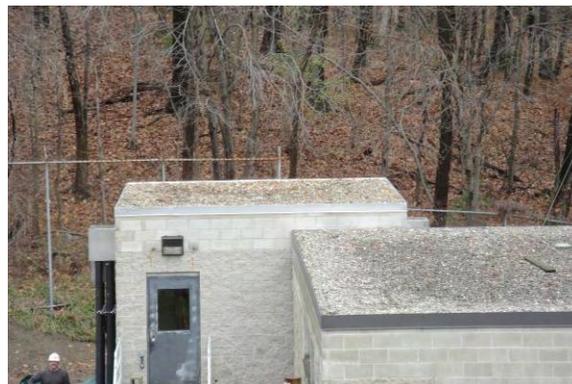
Figure 10.74 – Stone Ballasted Membrane Roof

The roof could not be observed at the time of the visit due to access limitations. However, the roof was observed from the Administration Building and it appears to be a stone ballasted membrane roof, likely

original to the building. The roof has an aluminum gravel stop around the perimeter. There is no evidence on the interior of the building of any roof leaks. Further investigation is required to verify the exact type and condition of the roof (figure 10.74).

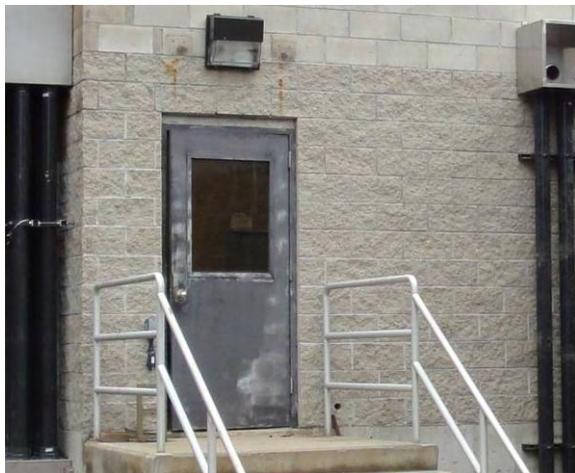
Figure 10.76 – Exterior Door

The paint finish on the exterior door and frame appears weathered and faded (figure 10.76).

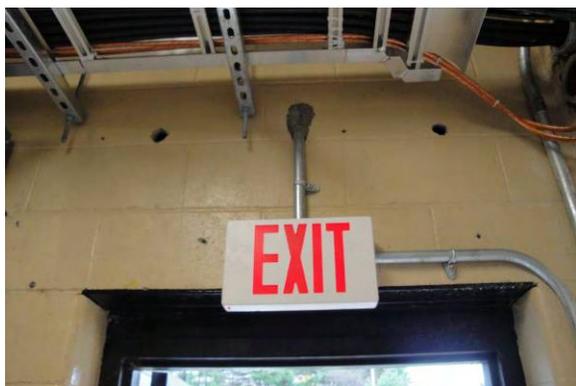
Figure 10.81 – Exit Sign

The building fire alarm system consists of an exit sign and an emergency light unit. Further investigation is required to confirm if the fire alarm system is adequate and code compliant (figure 10.81).

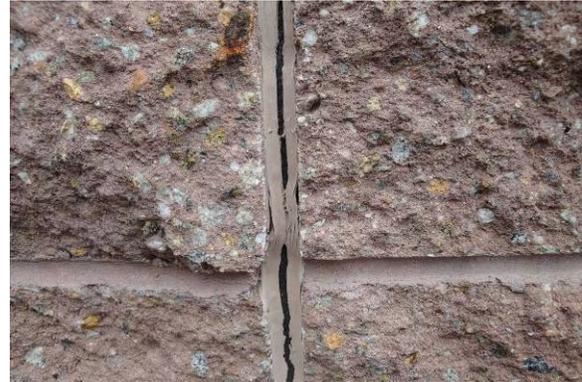
Figure 11.7 – Exterior Joint

The sealant at the exterior joints is cracked and the backer rod exposed. Further investigation is required to verify if the joint separation is due to building settling or

sealant failure, and also to verify if water is penetrating into the wall (figure 11.7).

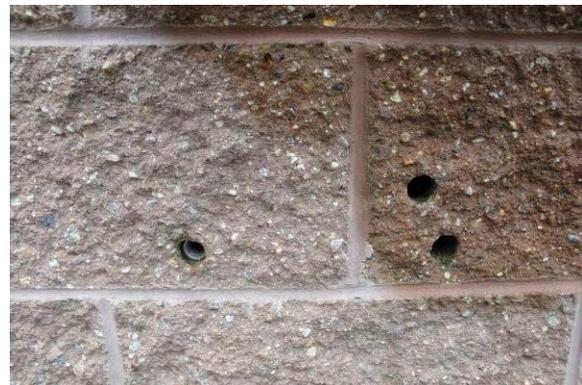
Figure 11.8 – Holes in the Brick

There are several holes in the exterior block walls that appear to be from abandoned conduit (figure 11.8). Further investigation is required to verify if water is penetrating into the wall.

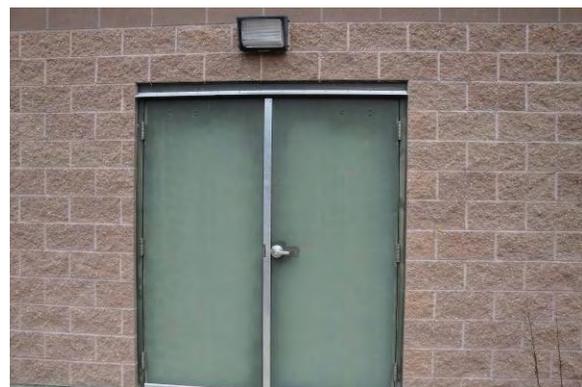
Figure 11.9 – Exterior Doors

The paint finish on the exterior doors and frames appears weathered and faded. There is also daylight showing through the weather stripping (figure 11.9).

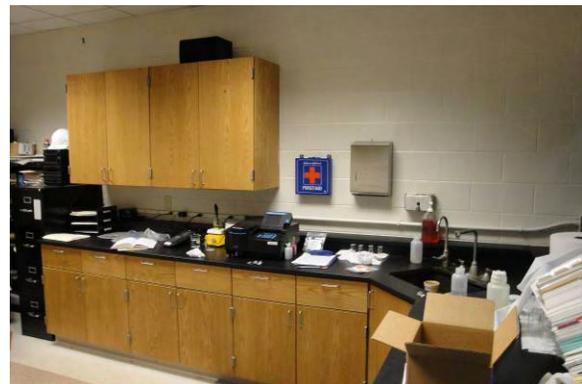
Figure 11.14 – Casework

There is a section of built-in casework located in the office with wood cabinets and a solid surface countertop. The casework has a corner sink. The countertop height and cabinet door hardware appear to be ADA compliant, although the sink configuration is non-compliant (figure 11.14).

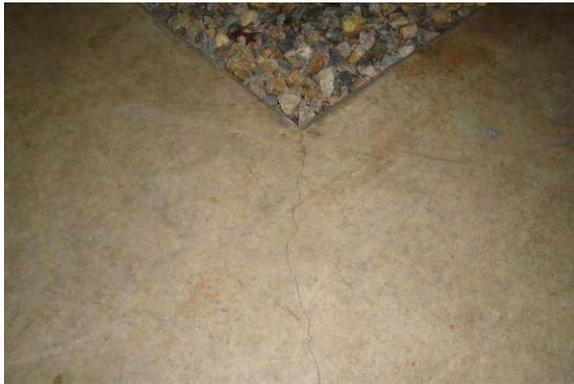
Figure 11.15 – Cracks in Concrete Slab

The concrete slab has several cracks located near the center CMU wall, and extending towards the treatment equipment. Further investigation is required to verify if the cracks are due building settling or if they are shrinkage cracks from the concrete curing process (figure 11.15).

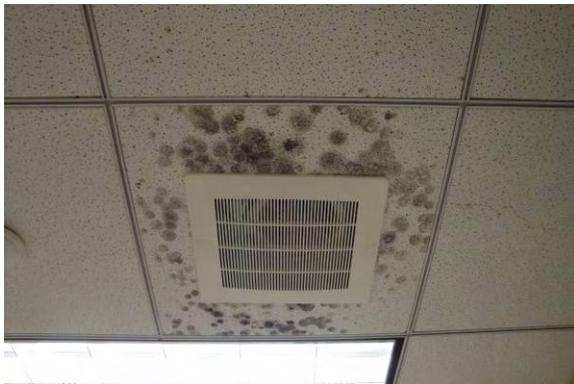
Figure 11.16 – Moldy Ceiling Tiles

The acoustic ceiling in the toilet room displays areas of mold. Further investigation is required to determine the cause and type of the mold (figure 11.16).

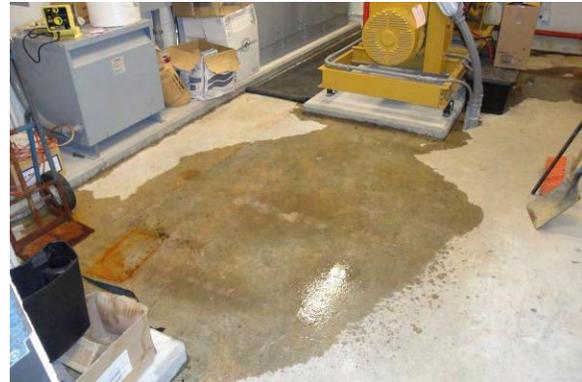
Figure 11.17 – Water in Boiler Room

At the time of the site visit, there was standing water on the floor of the Boiler Room, likely infiltrating the building through the make-up air vent in the roof. Further investigation is required to determine the exact cause of the water infiltration (figure 11.17).

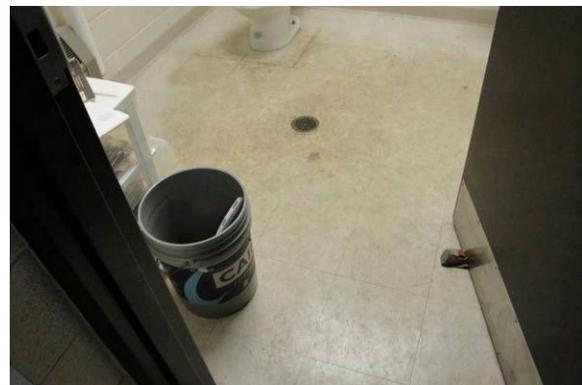
Figure 11.18 – VCT Floor in Toilet Room

The VCT floors in the office and toilet room are stained and worn (figure 11.18).

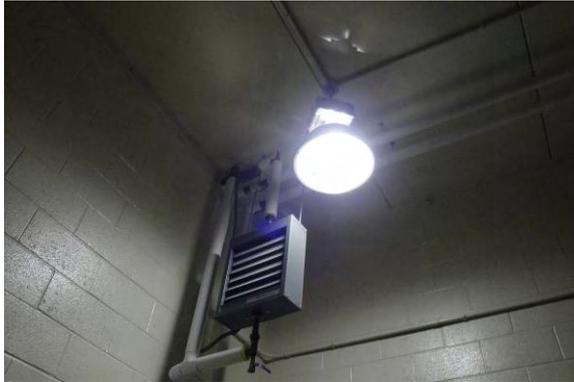
Figure 11.20 – HID Light Fixtures

The building has three different types of light fixtures. There are high bay style HID fixtures pendant mounted to the underside

of the pre-cast concrete roof panels (figure 11.20).

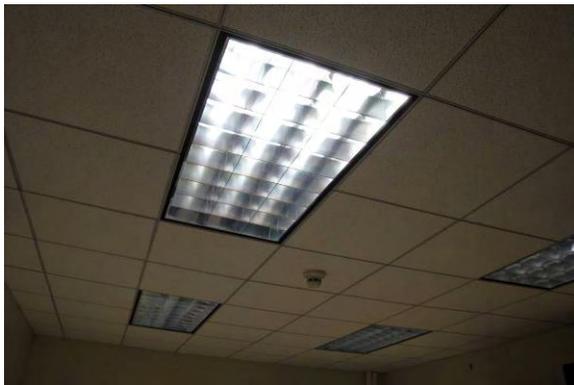
Figure 11.21 – Recessed Parabolic Light Fixture

The office and toilet room areas have recessed 2'x4' triple lamp fluorescent light fixtures with parabolic lens (figure 11.21).

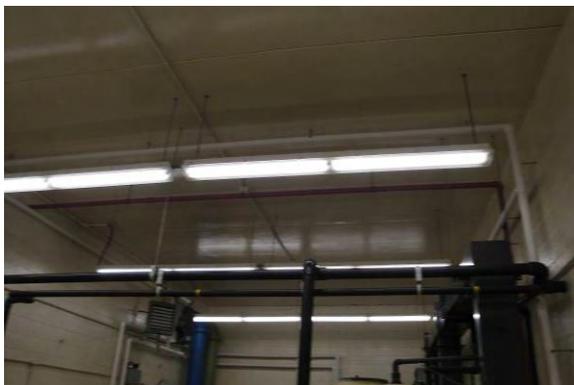
Figure 11.22 – Strip Fluorescent Lights

There are also 4-foot dual lamp strip fluorescent lights, pendant mounted to the underside of the pre-cast concrete roof panels (figure 11.22).

Most of the lights appear to be in good condition and functioning. There are a few fixtures with burned out lamps.

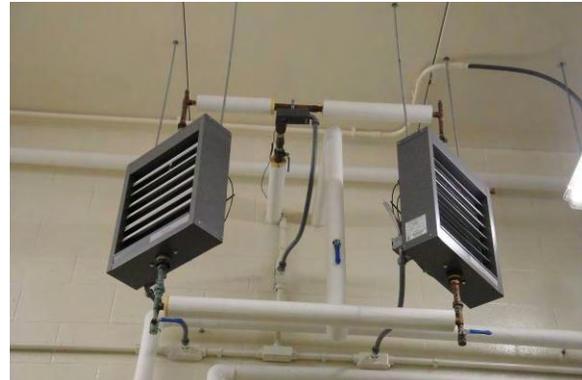
Figure 11.23 – Hot Water Unit Heaters

The building heating system is comprised of pendant mounted hot water unit heaters throughout the building, connected to a gas fired hot water boiler (figure 11.23). There are also fin tube radiators located the in the office and toilet room.

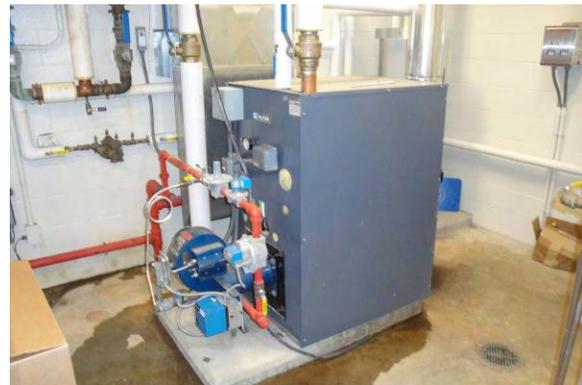
Figure 11.24 – Main Boiler

The boiler appears original to the building and is approximately 8 years old; it appears to be in good condition and functioning. The capacity of the boiler could not be confirmed (figure 11.24).

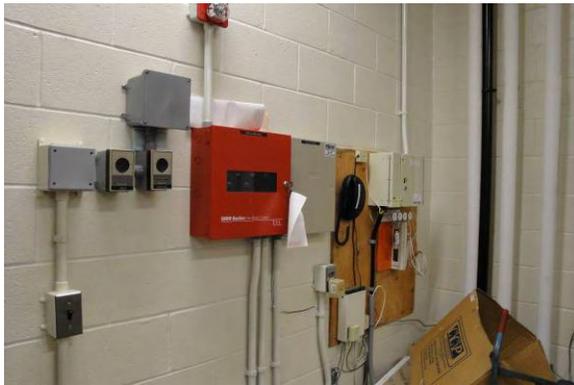
Figure 11.25 – Main Fire Alarm Panel

The building fire alarm system consists of control panels, exit signs, emergency lights, pull stations, and horn/strobe devices. The system components appear modern and in good condition (figure 11.25).

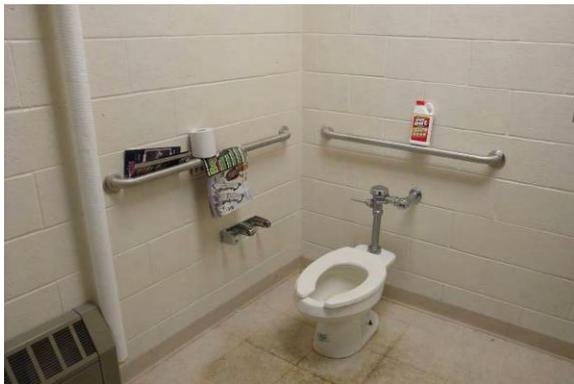
Figure 11.26 – Toilet Room

The building has one toilet room, which consists of a toilet and lavatory. The fixtures appear to be original to the building and functioning (figure 11.26). The toilet room appears to be ADA compliant. Current plumbing codes would likely require separate toilet rooms for men and women.

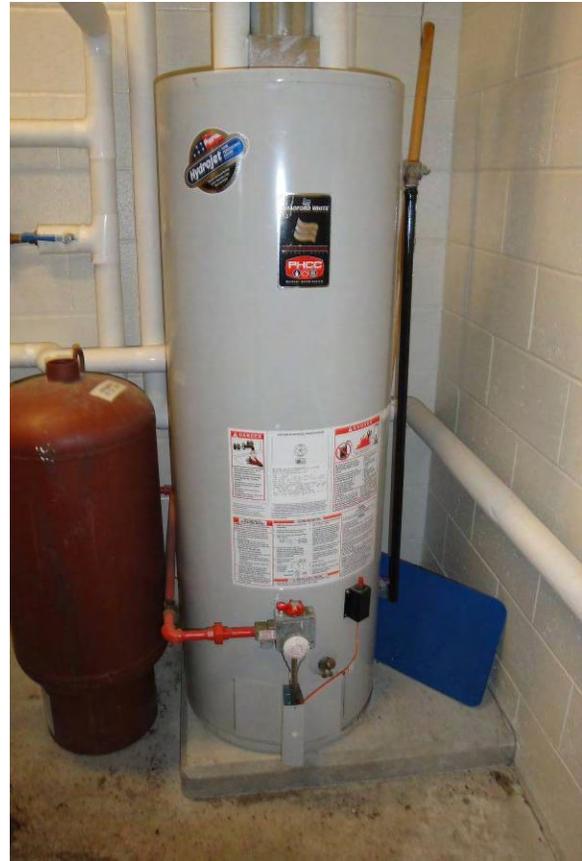
Figure 11.27 – Hot Water Heater

The building hot water is provided by a gas fired water heater (capacity could not be confirmed) located in the boiler room. The water heater appears to be original to the building and functioning (figure 11.27).

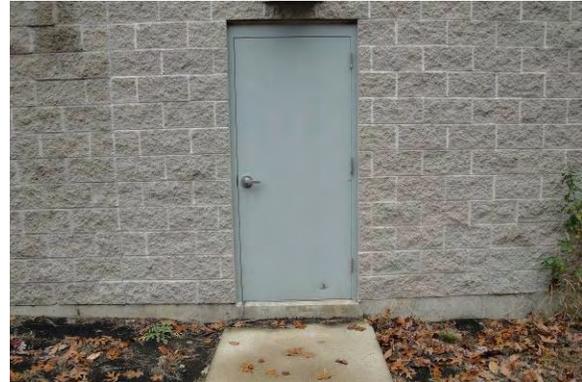
Figure 11.30 – Exterior Doors

The building has painted insulated metal doors within painted hollow metal frames with stainless steel hardware. There is a single door located at the front of the building, a pair of doors located on the left side near the rear of the building, and another single door on the right side also

near the rear of the building (figure 11.30). The building entrances have raised concrete platforms varying in height from 6 to 8-inches high. There are no accessible entrances present.

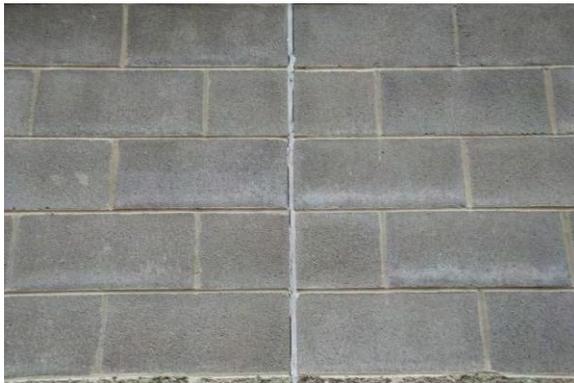
Figure 11.32 – Exterior Joint

The sealant at the exterior joints is cracked and the backer rod exposed. Further investigation is required to verify if the expansion joint separation is due to building settling or sealant failure, and also to verify if water is penetrating into the wall (figure 11.32).

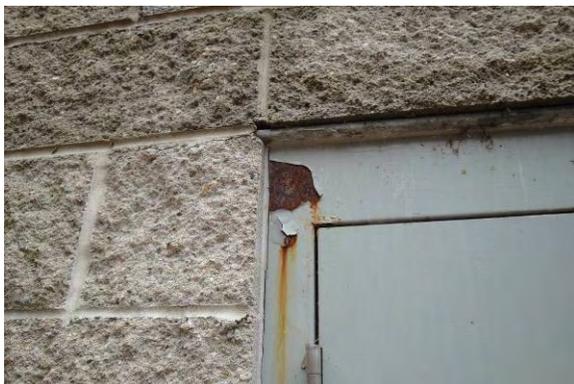
Figure 11.33 – Exterior Doors

The paint finish on the exterior doors and frames appears weathered and faded. The frames also display areas of rust. There is also daylight showing through the weather stripping (figure 11.33).

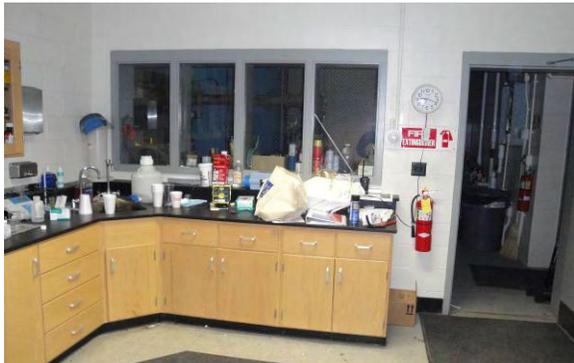
Figure 11.37 – Casework

There is a section of built-in casework located in the office with a wood cabinets and a solid surface countertop. The casework had a corner sink. The countertop height and the cabinet hardware appear to be ADA compliant; however the sink configuration is non-compliant (figure 11.37).

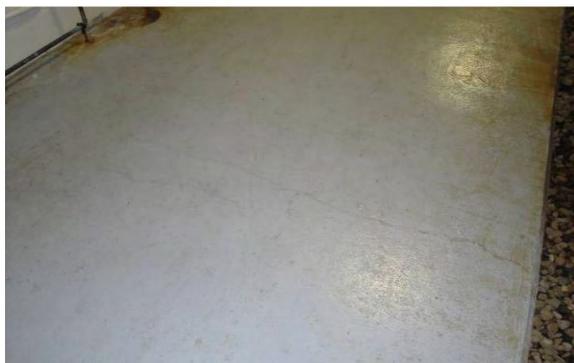
Figure 11.38 – Cracks in Concrete Slab

The concrete slab has several cracks located near the center CMU wall, and extending towards the treatment equipment. Further investigation is required to confirm if the cracks are due to building settling or if they are shrinkage cracks from the concrete curing process (figure 11.38).

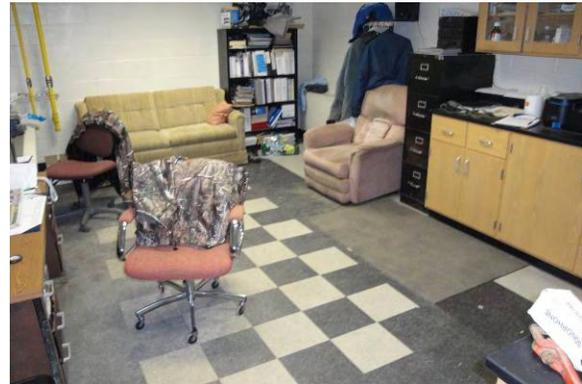
Figure 11.39 – VCT Floor in Office

The VCT floors in the office and toilet room are stained and worn (figure 11.39).

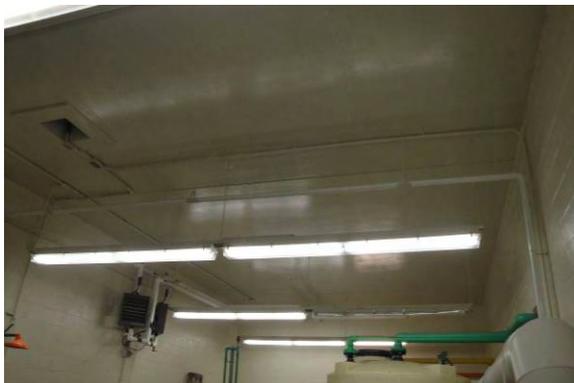
Figure 11.42 – Strip Fluorescent Lights

There are also 4-foot dual lamp strip fluorescent lights, pendant mounted to the underside of the pre-cast concrete roof panels (figure 11.42).

Most of the lights appear to be in good condition and functioning. There are a few fixtures with burned out lamps.

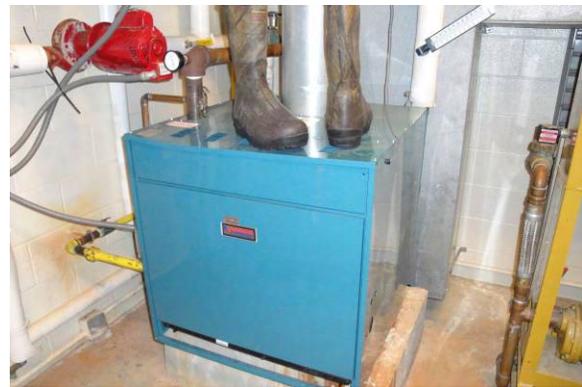
Figure 11.44 – Main Boiler

The boiler appears original to the building, is approximately 12 years old, in good condition, and appears to be functioning. The capacity of the boiler could not be confirmed (figure 11.44). There is also a large pendant mounted dehumidifier adjacent to the treatment equipment.

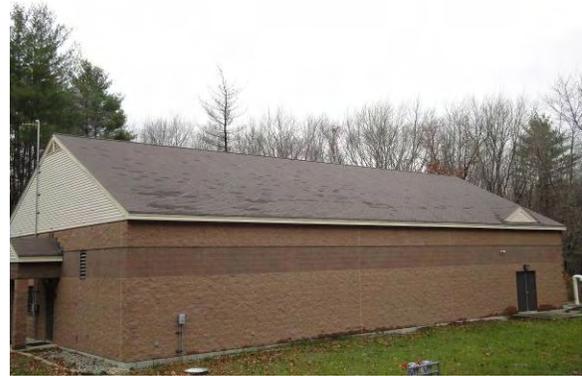
Figure 11.50 – Asphalt Shingles

The sloped roof has asphalt shingles without any gutters or downspouts (figure 11.50). There are two dormers on the left side and a small canopy roof at the main entrance supported by brick piers. The shingle roof appears to be in good condition and there is no evidence of leaks on the inside of the building.

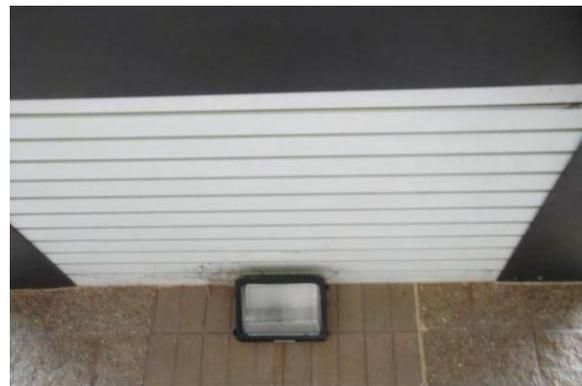
Figure 11.51 –Exterior Lighting

The exterior lighting for the building entrances and parking lot is provided by wall mounted fluorescent lights and appears to be adequate. The light levels could not be observed at the time of visit. Further investigation is required to confirm if the lights are functioning and if the light levels are adequate (figure 11.51).

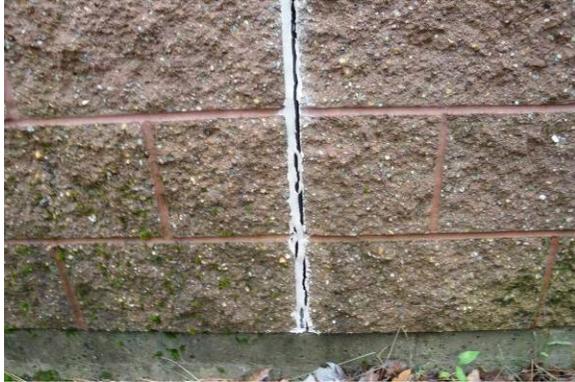
Figure 11.52 – Exterior Joint

The sealant at the exterior joints is cracked and the backer rod exposed. Further investigation is required to verify if the joint separation is due to building settling or sealant failure, and also to verify if water is penetrating into the wall (figure 11.52).

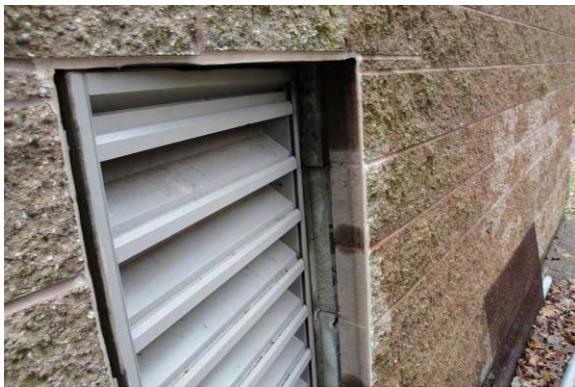
Figure 11.53 – Exterior Louver

There is an exterior louver at the rear of the building adjacent to radon silo, which appears to be detached from the CMU wall and exposing the wall cavity. Further investigation is required to verify if water is penetrating into the wall cavity (figure 11.53).

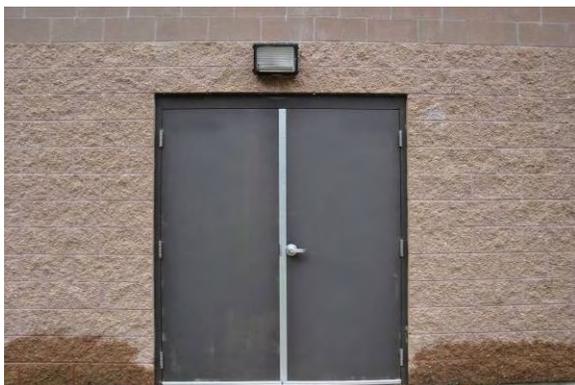
Figure 11.54 – Exterior Doors

The paint finish on the exterior doors and frames appears weathered and faded. There is also daylight showing through the weather stripping (figure 11.54).

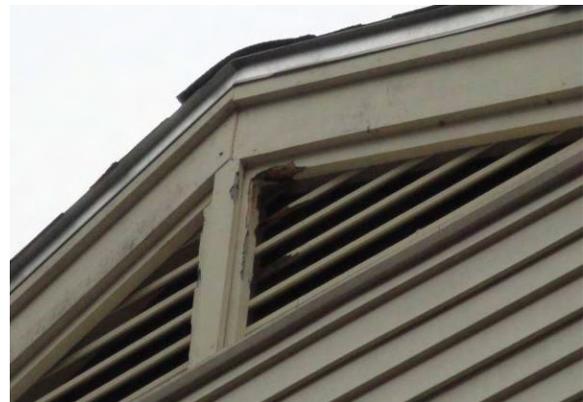
Figure 11.56 – Gable Louvers and Trim

There is a section of the wooden gable vent that appears to be damaged, and may be allowing vermin to enter the building (figure 11.56).

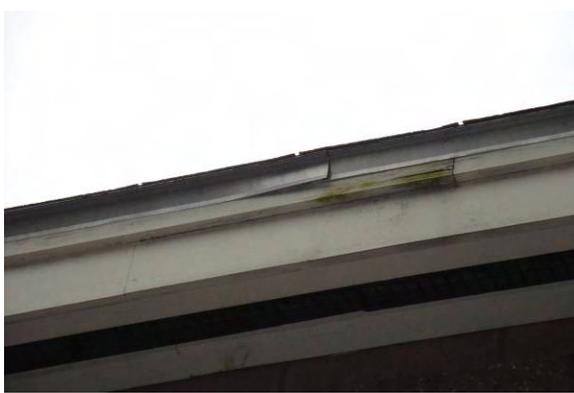
Figure 11.57 – Roof Edge Trim

There are a few sections of the roof trim that appear rotted with the metal drip edge detached (figure 11.57).

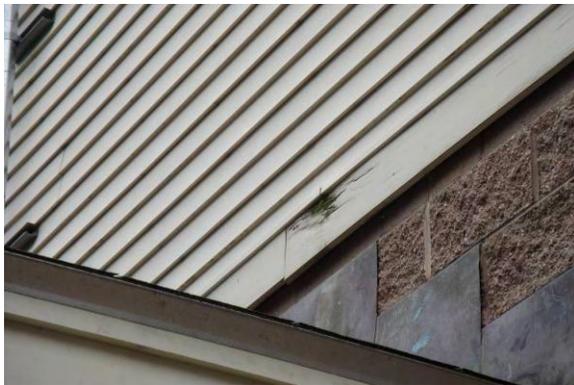
Figure 11.58 – Wood Trim

There are a few other sections where the wood trim appears rotted (figure 11.58).

The condition of the painted wood trim appears to be good overall, but the paint is weathered and faded.

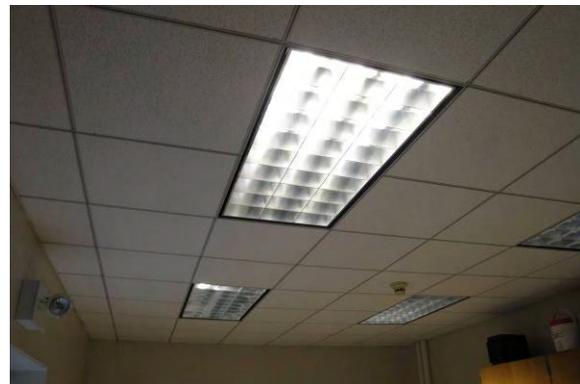
Figure 11.61 – Suspended Ceilings

The majority of the building has exposed structure with no ceilings. The toilet room and office have 2'x4' acoustic ceiling tiles with a metal grid system (figure 11.61).

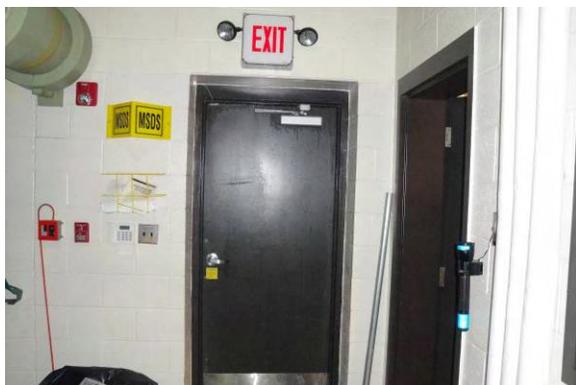
Figure 11.62 – Interior Doors

The interior doors are painted metal doors within painted metal frames. The doors appear to have ADA compliant hardware (figure 11.62).

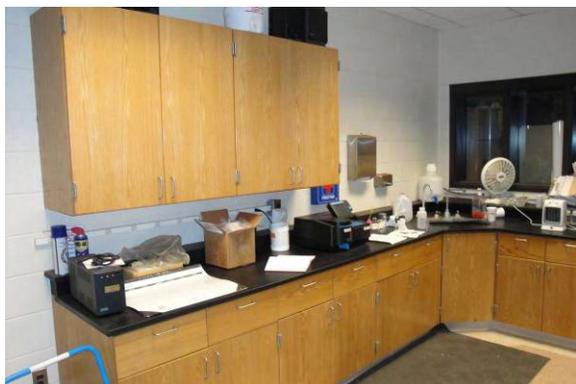
Figure 11.63 – Casework

There is a section of built-in casework located in the office with a wood cabinets and a solid surface countertop. The casework has a corner sink. The countertop height and the door hardware appear to be ADA compliant; however the sink configuration is non-compliant (figure 11.63).

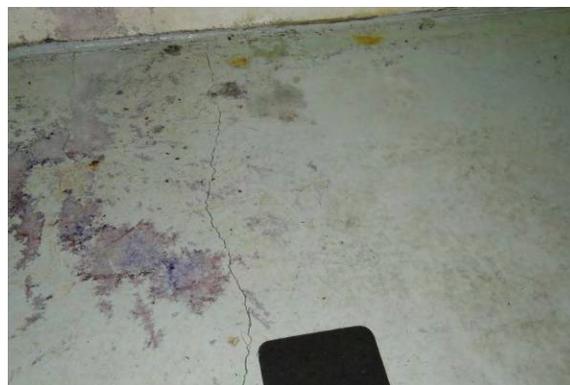
Figure 11.64 – Cracks in Concrete Slab

The concrete slab has several cracks located near the center CMU wall, extending towards the treatment equipment. Further investigation is required to verify if the cracks are due to building settling or if they are shrinkage cracks from the concrete curing process (figure 11.64).

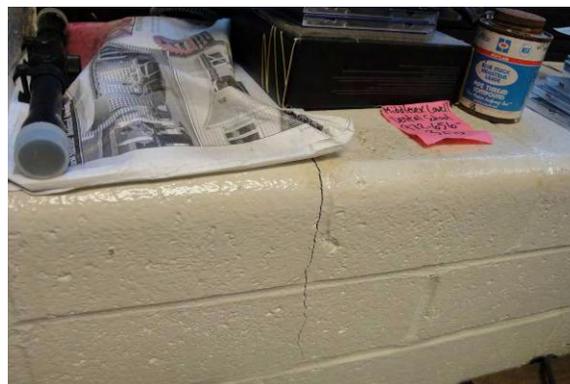
Figure 11.65 – Crack in CMU Window Sill

There is also a crack in the CMU wall at the office window sill. Further investigation is required (figure 11.65).

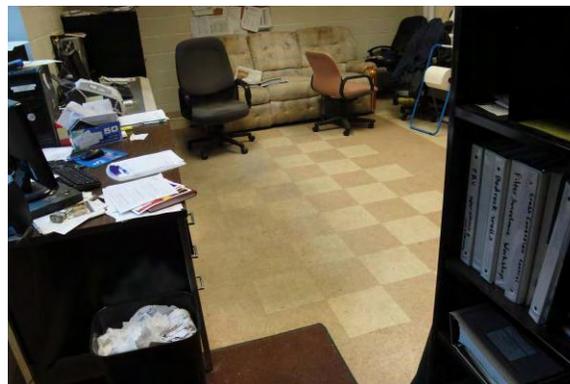
Figure 11.66 – VCT Floor in Office

The VCT floor in the office area is stained and worn (figure 11.66).

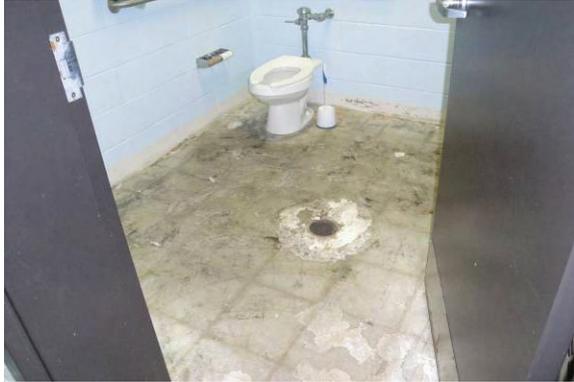
Figure 11.67 – Missing VCT Floor in Toilet Room

The building floor finishes consist of painted and exposed concrete throughout, with vinyl composite tiles (VCT) in the in office. The toilet room appears to have formerly included a VCT floor finish that has been removed (figure 11.67).

The VCT floor in the toilet room appears to have been removed and currently there is no floor finish (figure 11.67).

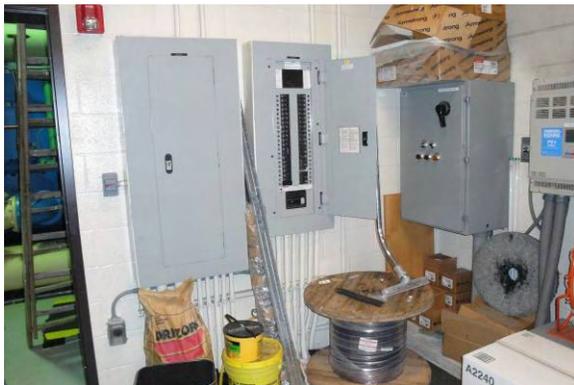
Figure 11.68 – Main Electrical Panel

The electrical service appears to be provided by underground wires. The main electrical panel indicates 250A/208V/three phase power (figure 11.68).

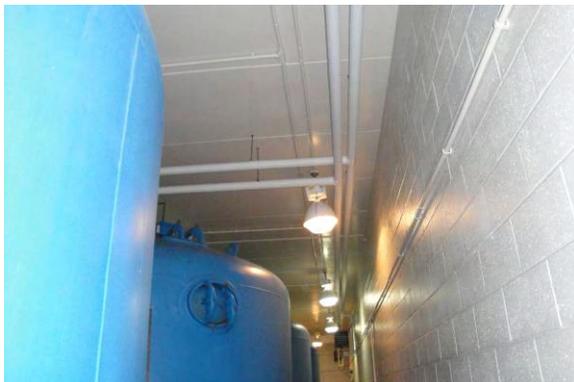
Figure 11.69 – HID Light Fixtures

The building has three different types of light fixtures. There are high bay style HID fixtures pendant mounted to the underside of the pre-cast concrete roof panels (figure 11.69).

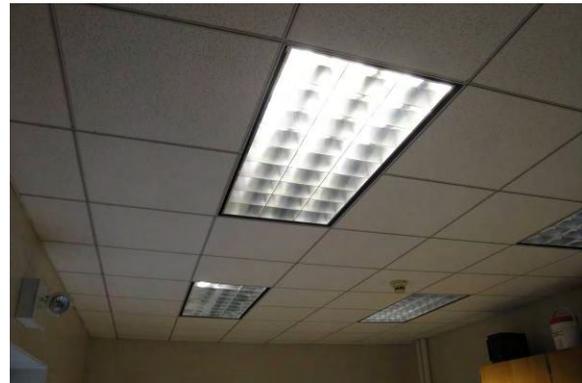
Figure 11.70 – Parabolic Light Fixture

The office and toilet room areas have recessed 2'x4' triple lamp fluorescent light fixtures with parabolic lens (figure 11.70).

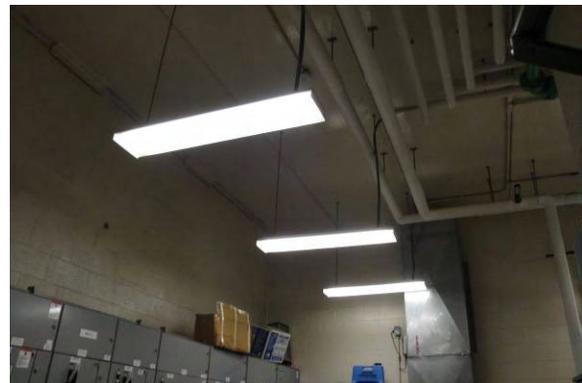
Figure 11.71 – Strip Fluorescent Lights

There are also 4-foot dual lamp strip fluorescent lights, pendant mounted to the underside of the pre-cast concrete roof panels (figure 11.71).

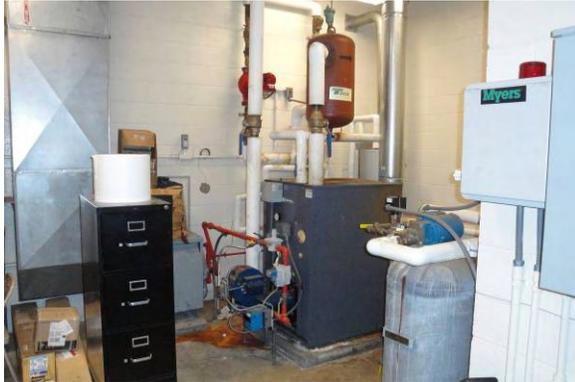
Figure 11.72 – Main Boiler

The boiler appears original to the building, approximately 8 years old, and appears to be in good condition and functioning. The capacity of the boiler could not be confirmed (figure 11.72). There is also a large

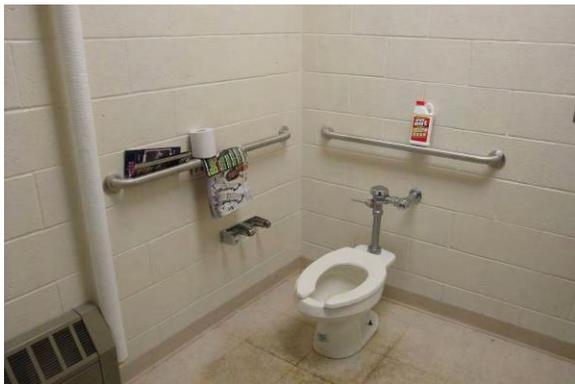
Figure 11.73 – Toilet Room

The building has one toilet room, which consists of a toilet and lavatory. The fixtures appear to be original to the building and functioning (figure 11.73). The toilet room appears to be ADA compliant. Current plumbing codes would likely require separate toilet rooms for men and women.

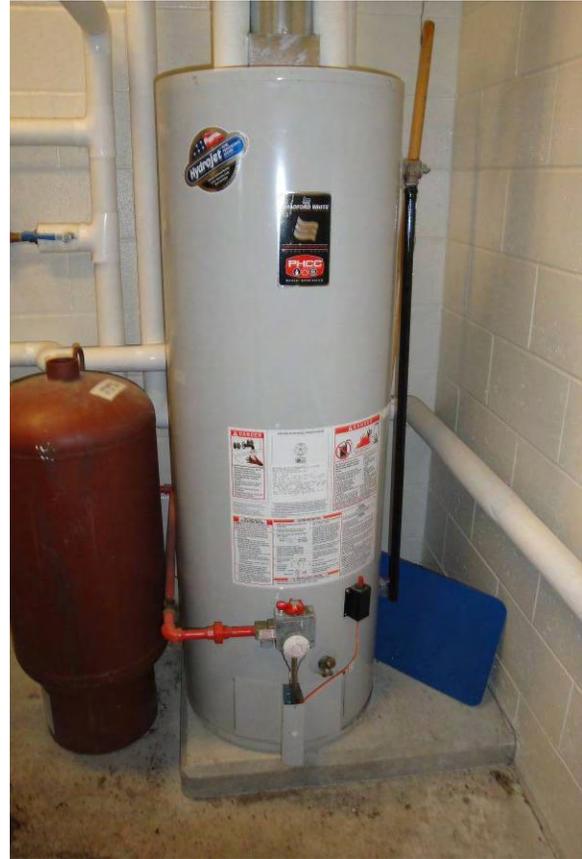
Figure 11.74 – Hot Water Heater

water heater appears to be original to the building and functioning (figure 11.74).

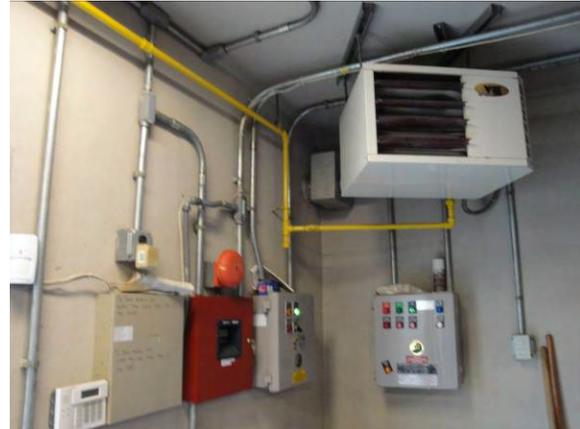
Figure 12.2 – Gas Fired Unit Heater

The building has one gas fired ceiling mounted unit heater which is used to provide heat for the building (capacity was not observed). The unit was not operating at the time of the visit (figure 12.2).

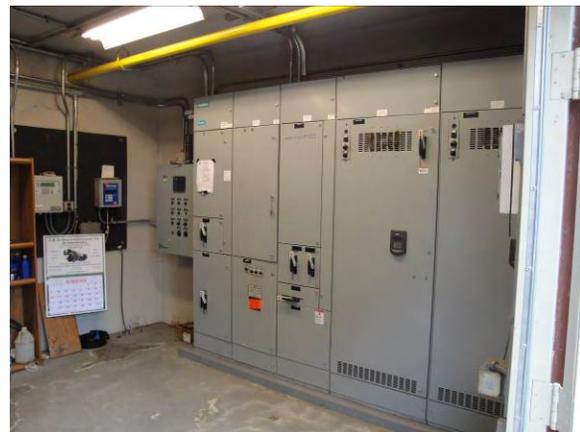
Figure 12.3 – Switchgear

There is electrical switchgear located on one side of the building that provides power for the building, pumping equipment, and other systems. The building power panel indicates that the building has 600V/600A/3P power (figure 12.3).

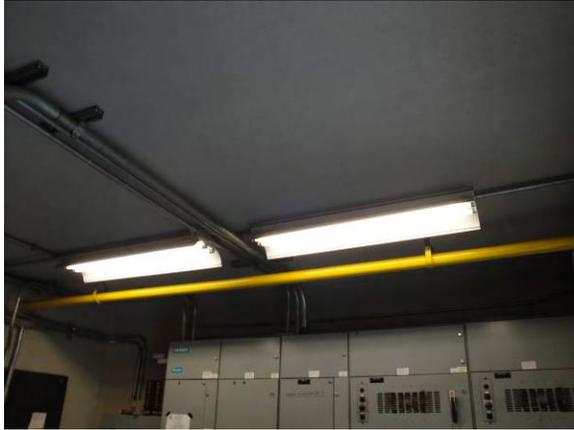
Figure 12.4 – Interior Lighting

The lighting consists of two ceiling mounted 4-foot dual lamp fluorescent fixtures that appear to provide sufficient light levels for the building. These light fixtures appear to be in good condition and functioning properly (figure 12.4).

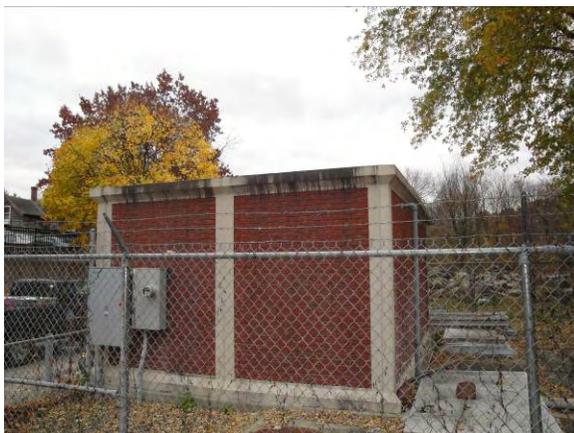
Figure 12.5 – Exterior Fence

The site consists of an asphalt driveway that leads from the building back to Powder Hill Road including parking spaces for a few vehicles. The area around the building is enclosed with a 6-foot high galvanized chain-link fence system with an access gate and barbed-wire to prevent unauthorized access to the pump house and related equipment. The driveway and fence are both in good condition (figure 12.5).

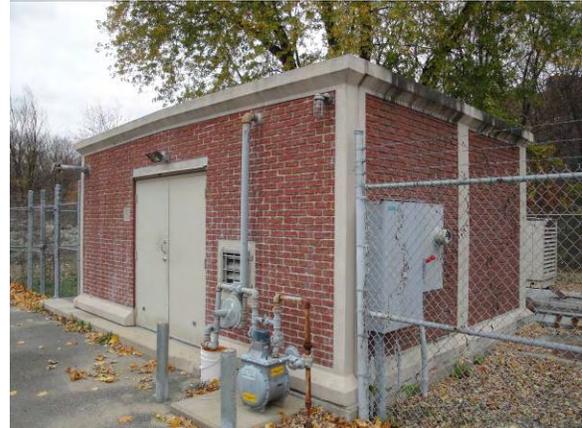
Figure 12.6 – Exterior Brick Veneer

The brick veneer appears to be in generally good condition overall with no signs of cracking and/or loose mortar. It is noted that the brick appears to have an excessive

amount of staining from the roof run-off of the concrete roof above (figure 12.6).

The staining does not appear to be the result of efflorescence; however, further investigation may be required to determine if there is any water infiltration into the wall.

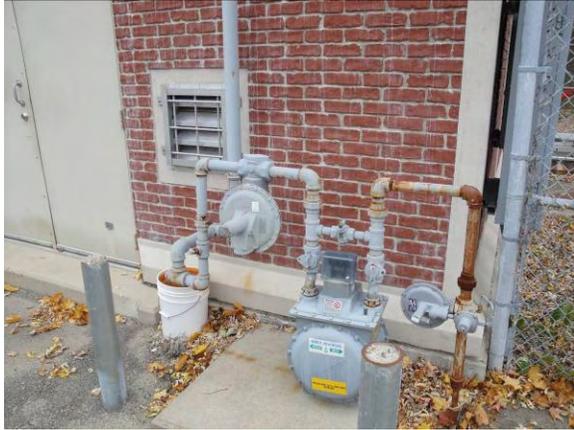
Figure 12.8 – Gas Meter Piping

The gas meter is located to the right of the entrance doors and is protected by two 4-inch concrete filled galvanized steel bollards. Some of the gas meter piping appears to be rusting (figure 12.8).

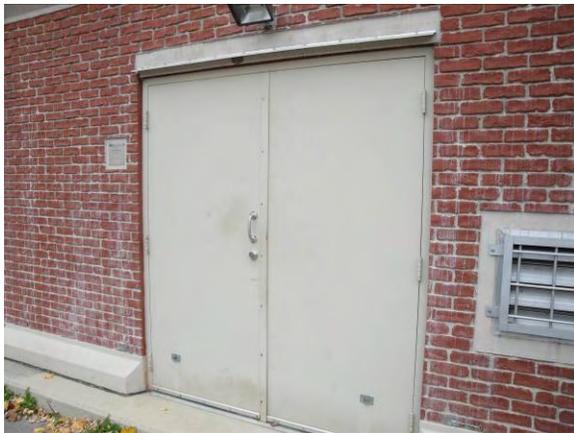
Figure 12.9 – Entrance Door Assembly

The paint finish on the entrance doors and frame appears to be weathered and worn. The rain deflector located over the double door appears to be directing the run-off from the roof onto the adjacent brick wall panels (figure 12.9).

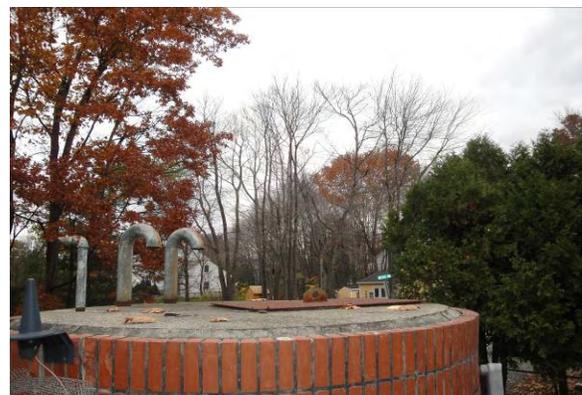
Figure 12.11 – Exposed Concrete Roof

The roof appears to be an exposed cast-in-place concrete slab with no apparent flashing of the roof to wall transition (figure 12.11).

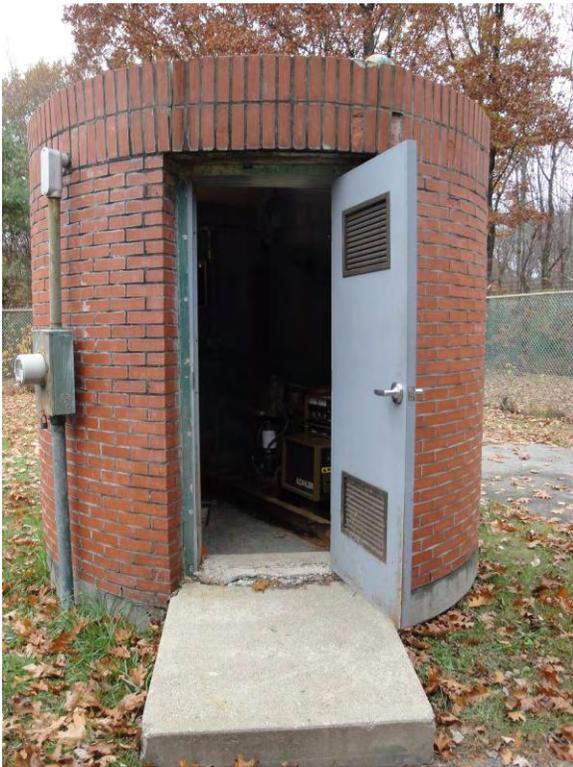
Figure 12.12 – Entrance Door

The building has a single painted insulated metal door within a painted metal frame and has stainless steel door hardware. The door and hardware appear to be functioning. The door has two metal louvers; one at the top of the door and the other at the bottom of the door (figure 12.12).

There are no electrical panels or switchgear present at the building. The only electrical devices observed were a few wall mounted disconnects for the pumping equipment. The electric meter is located on the exterior of the building (figure 12.12).

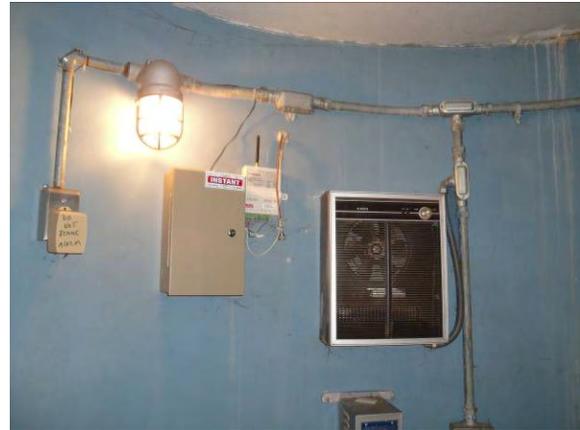
Figure 12.13 – Wall Light and Unit Heater

The building has one wall mounted electric unit heater to provide heat for the building (capacity was not observed). The unit was not operating at the time of the visit (figure 12.13).

The lighting consists of a single wall mounted incandescent light fixture with a metal safety cage, which was functioning at the time of visit. There is no exterior lighting present (figure 12.13).

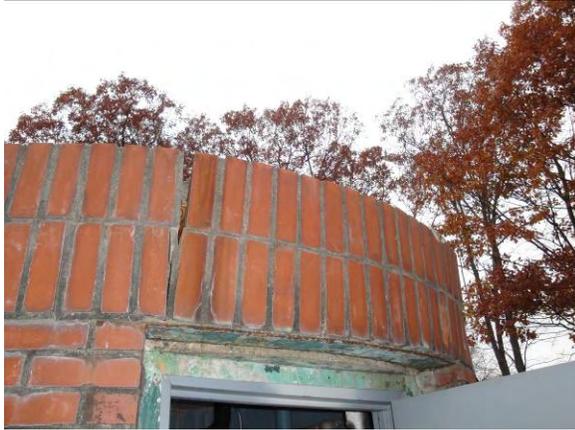
Figure 12.14 – Brick over Door

The brick veneer in general is in poor condition. There are several areas where the mortar has deteriorated and the bricks are on the verge of separating from and falling off the back-up wall (figure 12.14 and 12.15).

The absence of top wall flashing between the veneer brick and the concrete roof may have allowed water to collect at the joint along the top of the wall between the concrete and the brick, forcing the brick outwards through freeze/thaw cycles. Further investigation is required.

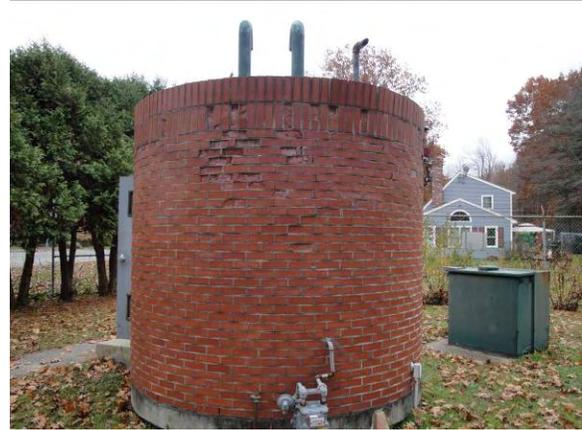
Figure 12.16 – Brick Veneer at Rear

There are also several areas where the brick has deteriorated and sections of the bricks appear chipped off (figure 12.16).

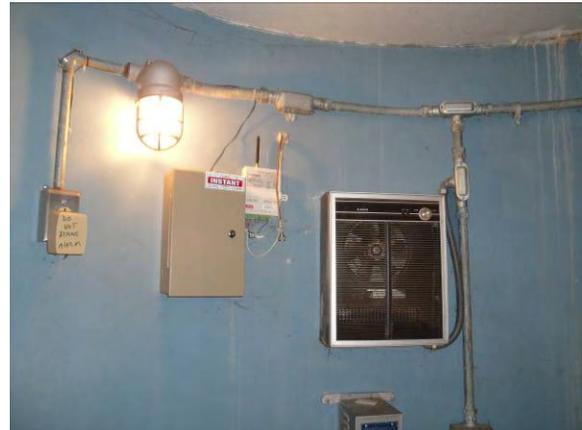
Figure 12.17 – Wall Light and Unit Heater

The interior walls and ceiling appear to be painted and in fair condition. The ceiling shows several areas with leaks and damage to the plaster (figure 12.17).

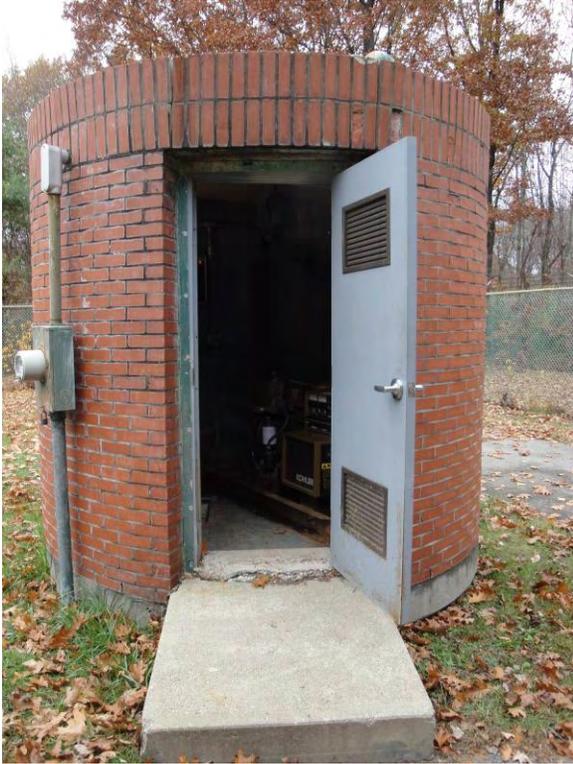
Figure 12.18 – Entrance Door

The concrete sill at the door threshold is damaged and pieces have chipped off (figure 12.18).
