ASSESSMENT FOR THE:

COOLIDGE SCHOOL BUILDING

MAYNARD, MA

Project Overview

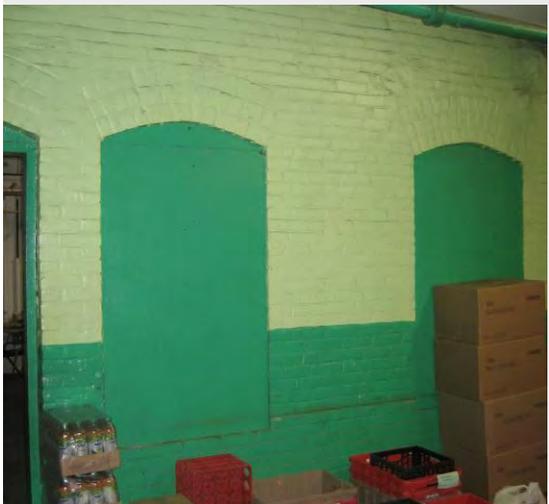
Interior Building Conditions

2. **Plaster Walls:** The original interior plaster walls show signs of wear. Isolated cracking and damage is evident through out the building. It should be noted that within the electrical closet on the first floor adjacent to the entry shows serious failure and should be immediately repaired.

- *Recommendation: Ensure that the source of the cracks or damage is repaired such as roof or envelope leaking and patch and repair plaster as required.*

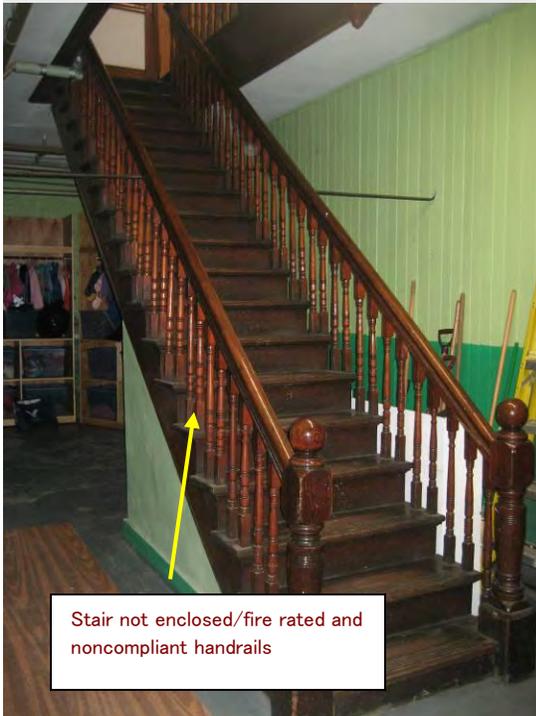
Stair connecting between first floor and second

The main connecting stair between the first and second floor are wood stairs with metal inset plates are showing signs of wear and age. The railing is not compliant and the stair does not serve as an enclosed fire rated egress

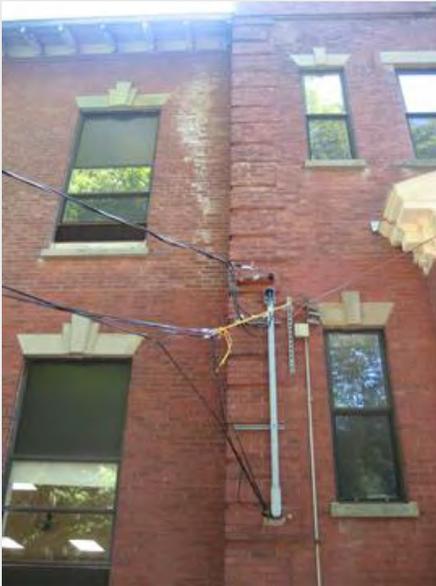
Overhead Electric Service

Recommendations: Upgrade electrical service to provide enough capacity for Acs. If major renovation is undertaken, central AC maybe considered in areas of full time occupancy.

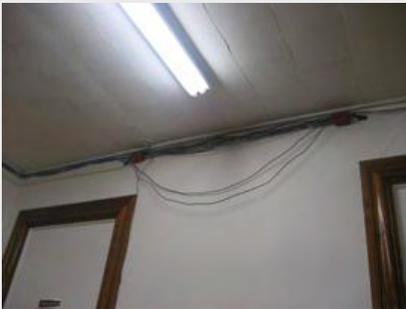
Surface mounted Wiring

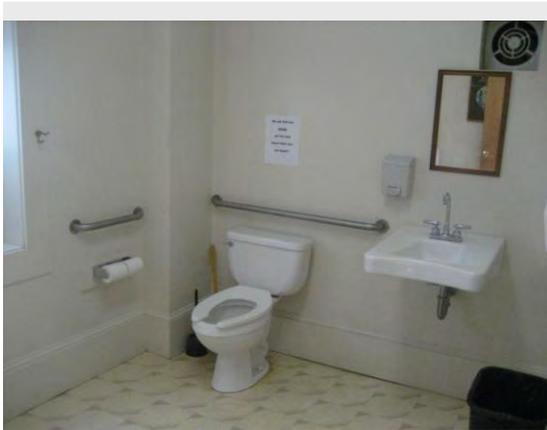
Toilet room

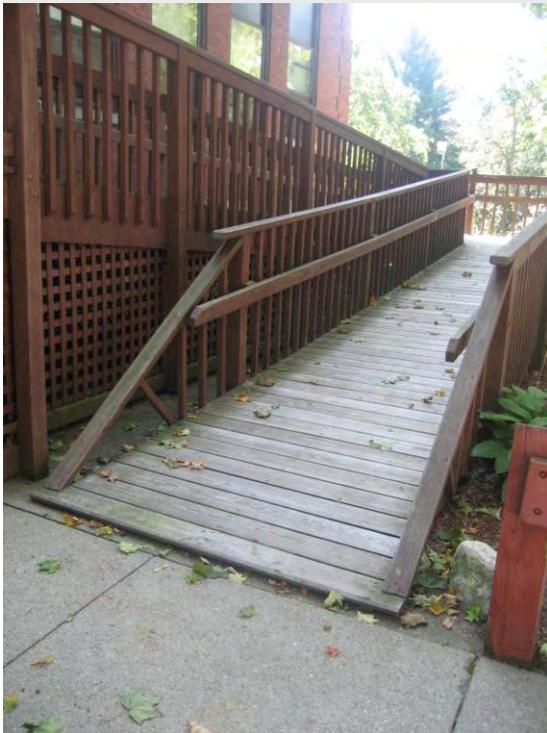
1. **Elevator:** Building does not have an elevator or handicap accessible lift.
2. **Hardware:** Interior door hardware is non-compliant. (Knob type)
3. **Stairs:** Stairs do not meet Code requirements for handrails and handrail extensions as well as exceeding maximum allowed nosing projection at treads.
4. **Toilet rooms:** It appears that the toilet rooms were recently renovated and an attempt was made to size them to accommodate a wheelchair. However items such as grab bars and mirror, plus clearances around the toilet are non-compliant.
5. **Building entrance:** wood HC accessible ramp and steps built over existing original stone and brick steps provide accessibility at the front entrance, although not in full compliance with current code. (Single handrail instead of High/low; bottom of ramp exceed ½” vertical where the ramp meets the ground.)

Wooden Ramp at Main Entry
