Coolidge Administration Building

Exterior

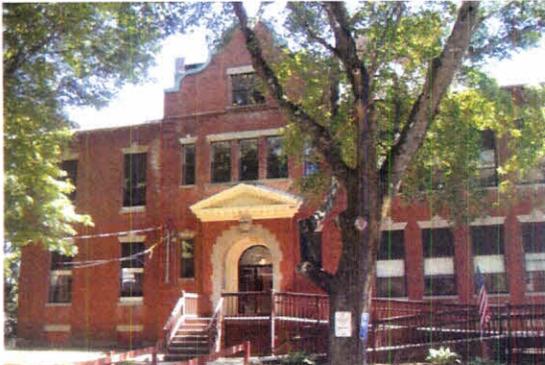
Figure 5.01 – Coolidge Administration Building

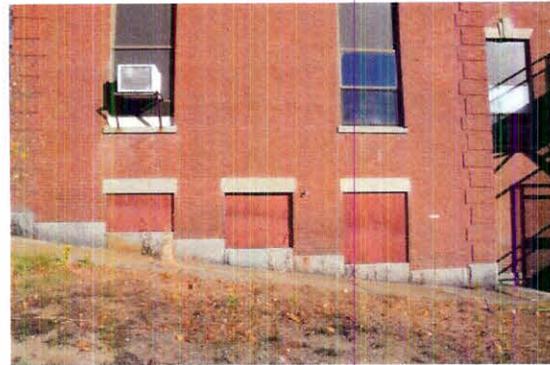
The building is constructed of approximately 12-inch thick solid brick exterior walls with cast stone sills/headers supported by stone foundation walls (figure 5.02)

Figure 5.02 – Typical Exterior Wall

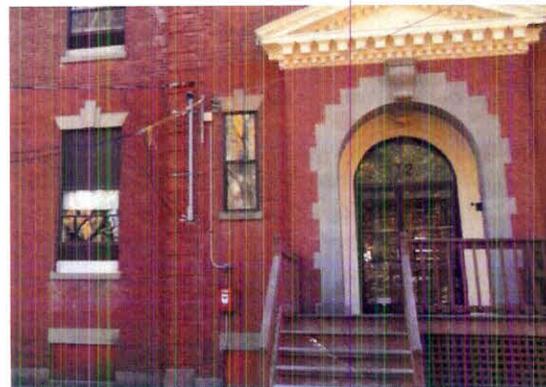
There are several different types of exterior doors and frames. The main entrance door consists of an aluminum and glass storefront assembly system, which appears to approximately 25-years old (figure 5.03). The basement doors consist of painted insulated metal doors within painted metal frames. The second floor exterior doors and frames at the fire escape are painted wood doors and frames.

Figure 5.03 – Main Entrance Door

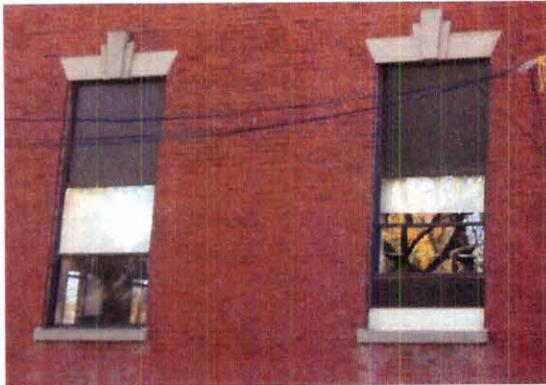
The exterior windows are aluminum double-hung windows with insulated glass and insulated opaque metal transom panels. The windows have cast stone sills and heads with decorative keystones. The windows appear to be approximately 25-years old (figure 5.04).

Figure 5.04 – Aluminum Windows

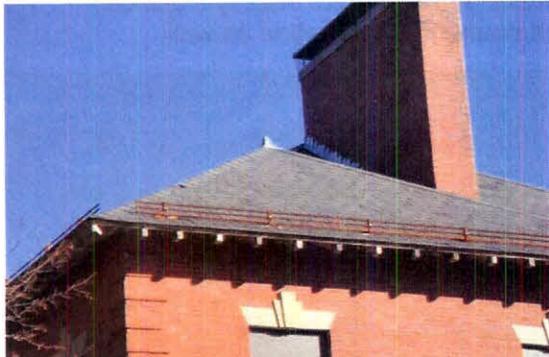
The building has a slate shingle roof with a perimeter snow fence (figure 5.05). The roof appears to be original to the building.

Figure 5.05 – Slate Shingle Roof

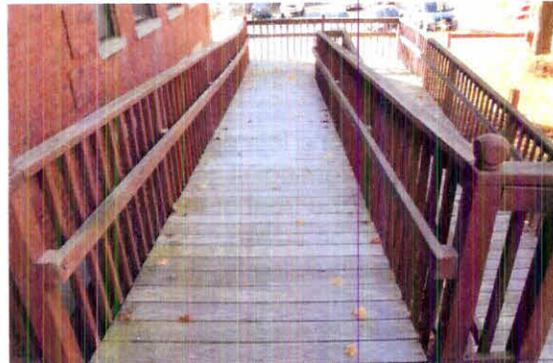
The main entrance has a raised wood framed platform accessed by a wood framed stair with painted wood guardrails and painted wood balusters with a painted wood handrail assembly. The stairs and platform have pressure treated wood treads with painted wood risers. The platform is also accessed by a wood ramp of similar construction (figure 5.06). Access to the basement level was directly from grade.

Figure 5.06 – Front Entrance Accessible Ramp

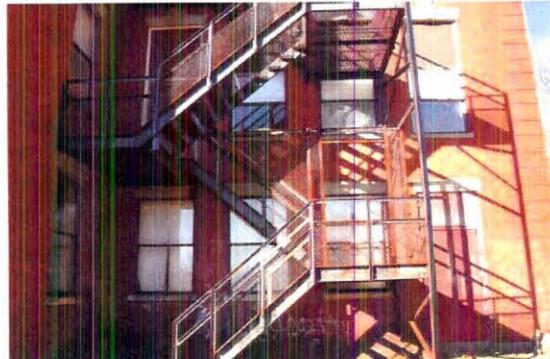
The second floor is provided with exterior egress via two painted steel framed fire escape stairs, one located on either side of the building (figure 5.07). Both fire escape stairs lead directly to grade.

Figure 5.07 – Fire Escape Stair Assembly

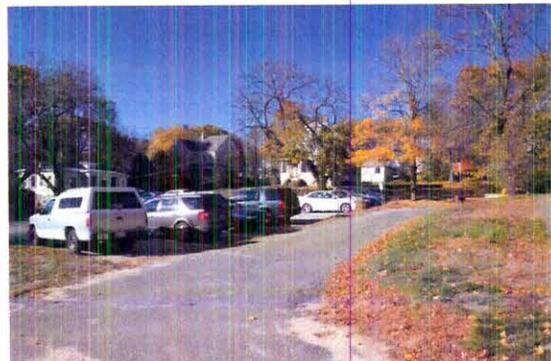
The site has an asphalt parking lot with asphalt walkways leading to the street. At the rear of the building, the grade slopes down to the playfields at the rear of the site (figure 5.08).

Figure 5.08 – Parking Lot and Walkway

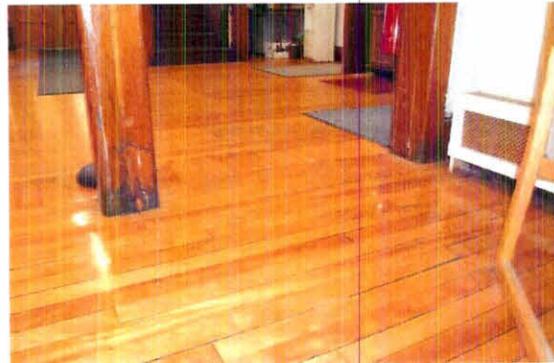
The basement floor is a painted concrete slab on grade. The first floor consists of clear finished hardwood flooring assemblies throughout, some of which have been refinished (figure 5.23).

Figure 5.23 – Wood Flooring

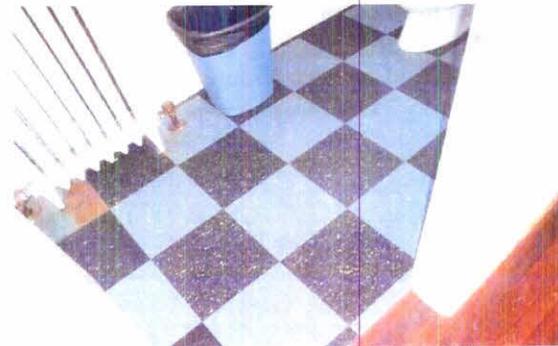
The toilet rooms had 12"x12" vinyl composite tile (VCT) floors (figure 5.24).

Figure 5.24 – VCT Tile

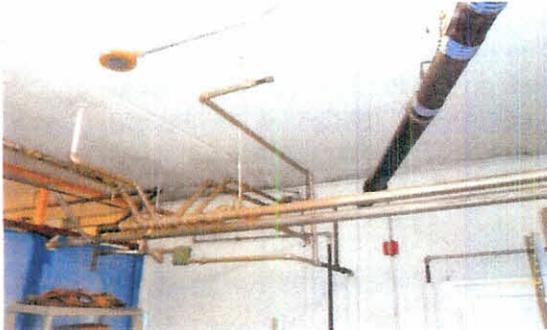
There are several types of ceilings systems throughout the building. The majority of the rooms have plaster ceilings. The basement has plaster ceilings throughout that were in overall good condition (figure 5.25).

Figure 5.25 – Painted Plaster Ceiling

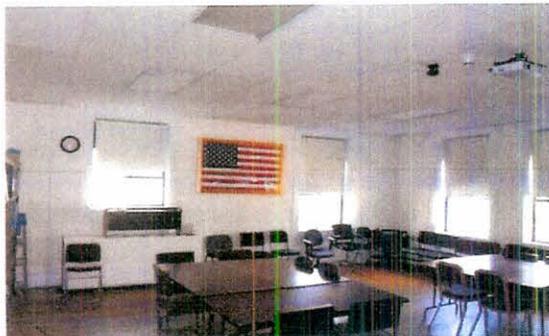
There are several rooms, mainly within the first floor offices and meeting areas that have 2'x4' acoustic ceiling tiles with a suspended metal grid system (figure 5.26).

Figure 5.26 – 2x4 Acoustic Ceilings

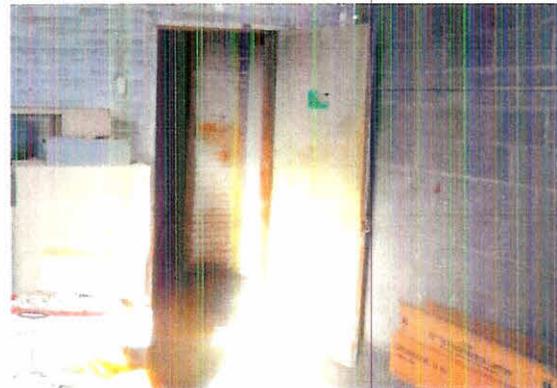
There are several types of interior doors throughout the building. The basement has painted wood panel doors within painted metal frames, and older painted metal fire doors within painted metal frames (figure 5.28).

Figure 5.28 – Basement Metal Doors

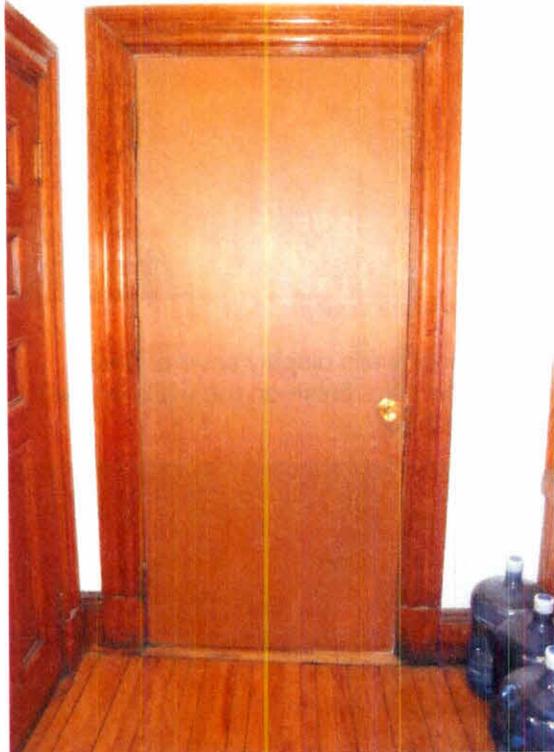
The first floor offices and meeting rooms have clear finished wood flush doors and panel doors within clear finished wood frames (figure 5.29).

Figure 5.29 – First Floor Office Doors

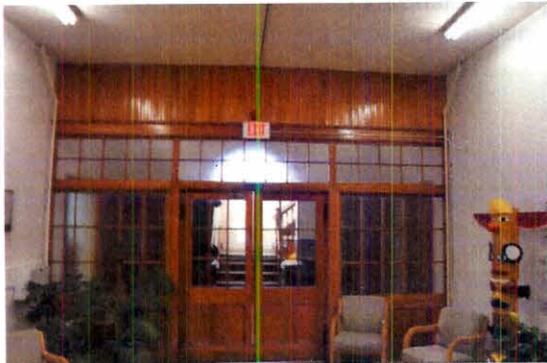
The first floor lobby has clear finished wood and glass panel doors within a wood transom/sidelight assembly (figure 5.30).

Figure 5.30 – First Floor Lobby Doors

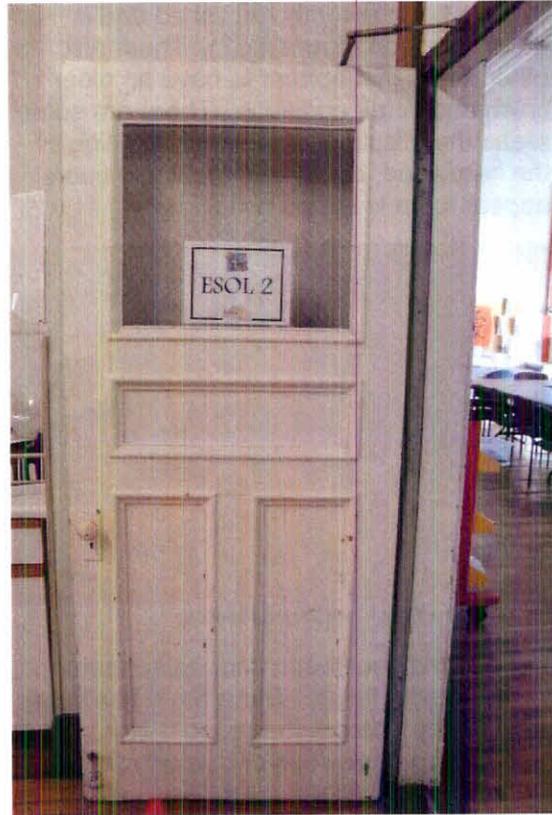
The second floor doors are mostly painted wood panel doors with wire glass vision panels within painted wood frames (figure 5.31).

Figure 5.31 – Second Floor Doors

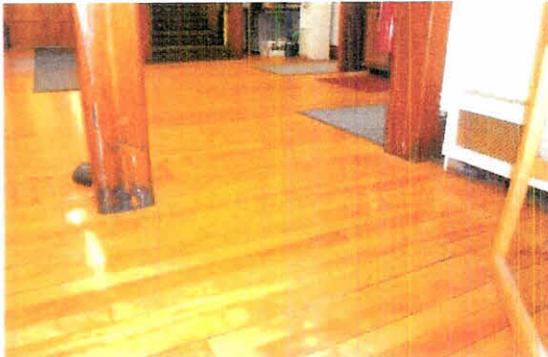
to have been recently refinished and in good condition (figure 5.32). There are other areas that appear to have an older finish and in fair condition. There are some areas that display some minor buckling of the hardwood; but overall the wood floors appear to be in sound condition.

Figure 5.32 – First Floor Wood Flooring

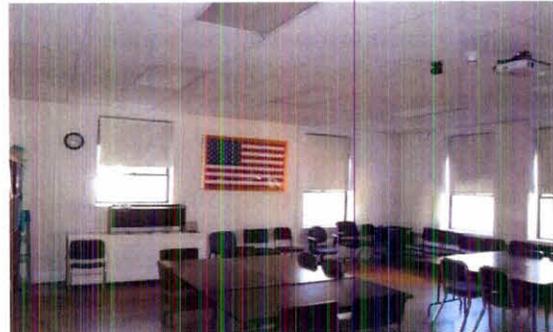
There are several rooms, mainly within the first floor offices and meeting areas that have 2'x4' acoustic ceiling tiles with a suspended metal grid system. Overall the 2'x4' ceilings are in good condition with no visible evidence of water damage (figure 5.40).

Figure 5.40 – 2x4 Acoustic Ceilings

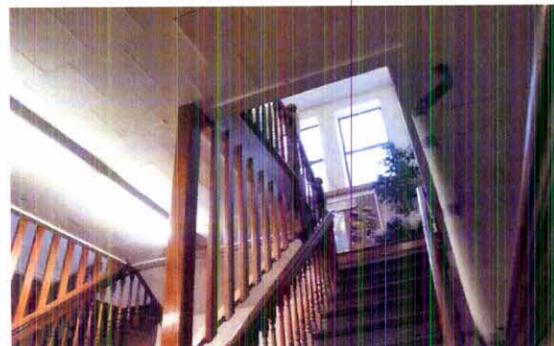
The main lobby and corridor on the first floor have 12" x 12" acoustic ceiling tiles within a concealed grid system. Overall these ceilings appear to be in good condition with no visible evidence of water damage (figure 5.41).

Figure 5.41 – 1x1 Acoustic Ceiling

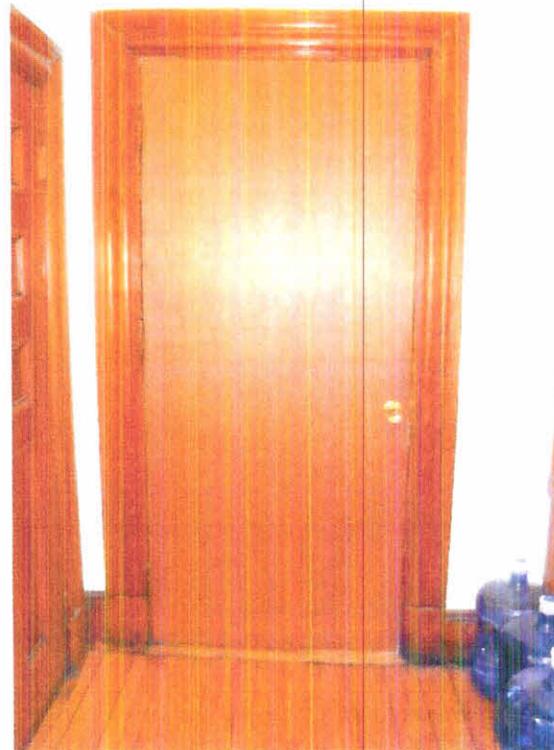
The first floor flush wood doors and frames are in good condition. The door hardware is old but appears to be functioning properly (figure 5.45).

Figure 5.45 – First Floor Office Doors

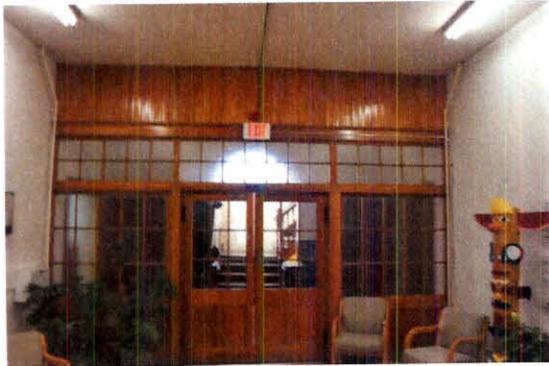
The clear finished wood panel doors and frames in the first floor lobby are in good condition. The door hardware is old but appears to be functioning properly (figure 5.46).

Figure 5.46 – First Floor Lobby Doors

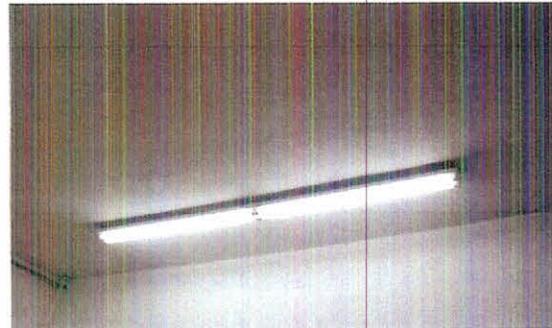
The building has two different types of light fixtures. The basement and second floors have surface mounted 4-foot dual lamp strip fluorescent lights, which appear to be relatively new and are functioning (figure 5.52).

Figure 5.52 – Strip Fluorescent Lights

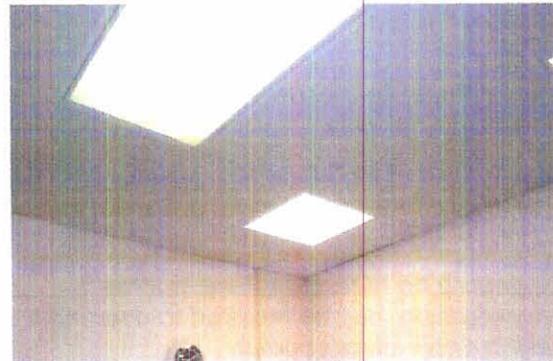
The first floor has 2'x4' recessed fluorescent light fixtures with prismatic lenses. These lights appear relatively new, in good condition and functioning. There are also several incandescent light fixtures located throughout the building (figure 5.53).

Figure 5.53 – 2x4 Fluorescent Lights

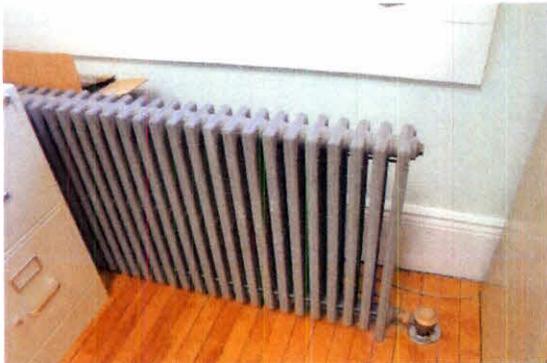
The building heating system is comprised of wall mounted unit heaters, fin tube radiators, and cast iron radiators connected to a gas fired hot water and steam boiler (figure 5.54).

Figure 5.54 – Cast Iron Radiator

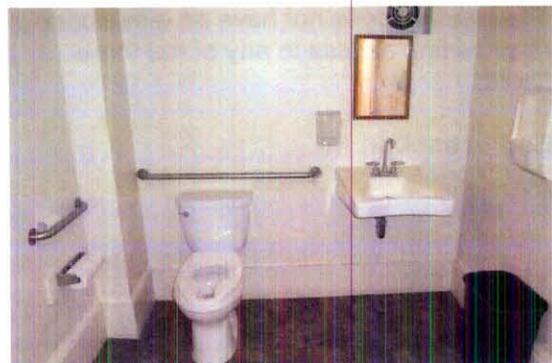
The building has three toilet rooms; one unisex toilet room on the first floor consisting of a toilet, sink, grab bars and accessories (figure 5.57); and two smaller toilet rooms on the second floor, one for men and one for women. The fixtures for the first floor appeared to be relatively new. The fixtures on the second floor appear old and likely not water-conserving fixtures, but appear to be functioning properly. The toilet rooms do not appear to be fully ADA compliant.

Figure 5.57 – First Floor Toilet Room

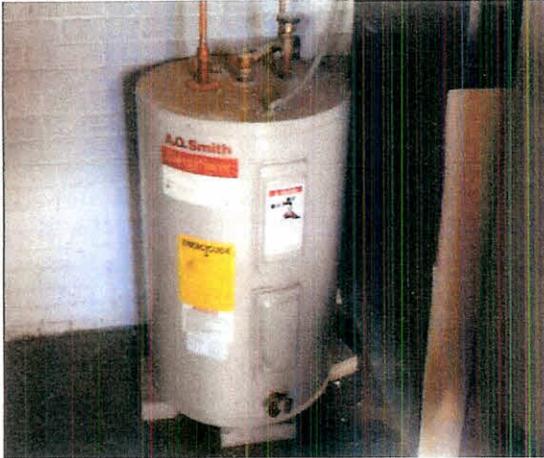
The building hot water is provided by a 40 gallon electric water heater located in the boiler room. The water heater appears to be relatively new and functioning properly (figure 5.58).

Figure 5.58 – Hot Water Heater
