**Reference: Review of Powder Mill Place Development 2,4,12,18 Powder Mill Road, Acton Massachusetts 112,114,116,118 Powder Mill Road, Maynard, Massachusetts - Sewer Impact Analysis and Condition Assessment Recommendations**

PROJECT: Powdermill Place Development  
SUBJECT: Existing System Results

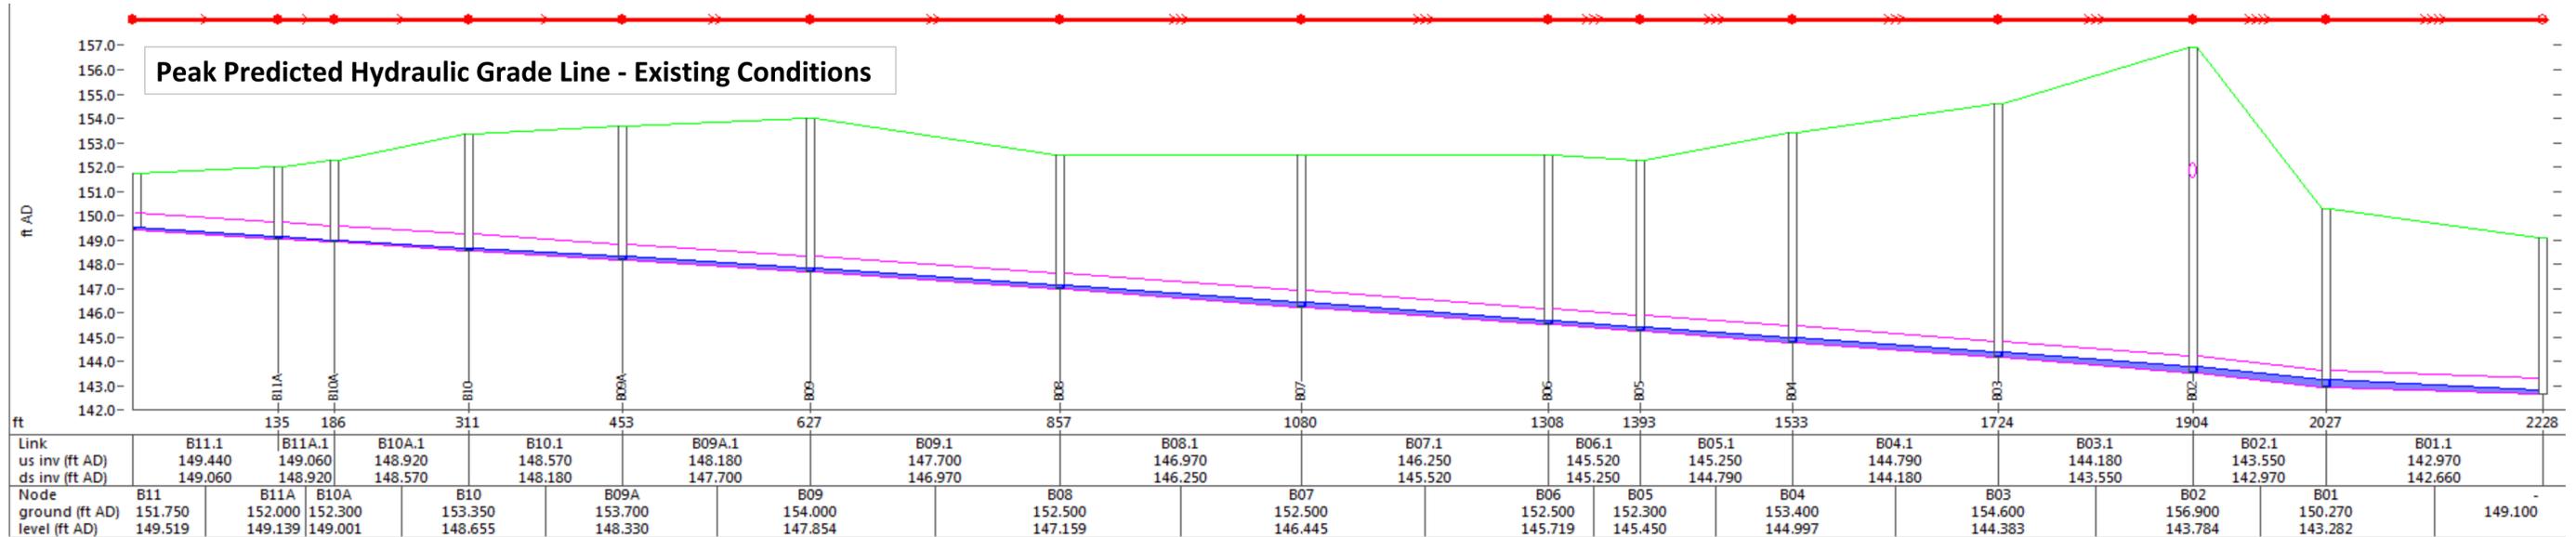
**EXISTING CONDITIONS**

US Node ID	DS Node ID	Length (ft)	Diameter (in)	Manning's Roughness	US Invert (ft AD)	DS Invert (ft AD)	Infiltration (MGD)	Gradient (%)	Conduit full capacity (MGD)	Max DS Depth (ft)	Depth/Diameter	Max DS Flow (MGD)	Flow/Capacity	Max DS Velocity (ft/s)
B11	B11A	134.50	8.00	0.015	149.44	149.06	0.0004	0.283	0.360	0.08	11.91%	0.0030	0.84%	0.199
B11A	B10A	52.00	8.00	0.015	149.06	148.92	0.0002	0.269	0.350	0.08	12.08%	0.0032	0.91%	0.205
B10A	B10	124.90	8.00	0.015	148.92	148.57	0.0004	0.280	0.360	0.08	12.68%	0.0036	0.99%	0.214
B10	B09A	141.90	8.00	0.015	148.57	148.18	0.0004	0.275	0.350	0.15	22.50%	0.0047	1.34%	0.183
B09A	B09	173.60	8.00	0.015	148.18	147.70	0.0005	0.276	0.360	0.15	23.10%	0.0329	9.14%	0.837
B09	B08	230.40	8.00	0.015	147.70	146.97	0.0007	0.317	0.380	0.19	28.35%	0.0373	9.82%	0.707
B08	B07	222.50	8.00	0.015	146.97	146.25	0.0007	0.324	0.390	0.20	29.25%	0.0600	15.38%	1.092
B07	B06	228.40	8.00	0.015	146.25	145.52	0.0007	0.320	0.380	0.20	29.85%	0.0643	16.92%	1.136

B06	B05	84.50	8.00	0.015	145.52	145.25	0.0003	0.320	0.380	0.20	30.00%	0.0676	17.79%	1.191
B05	B04	140.40	8.00	0.015	145.25	144.79	0.0004	0.328	0.390	0.21	31.05%	0.0687	17.62%	1.151
B04	B03	190.50	8.00	0.015	144.79	144.18	0.0006	0.320	0.380	0.20	30.45%	0.0729	19.18%	1.250
B03	B02	180.60	8.00	0.015	144.18	143.55	0.0005	0.349	0.400	0.23	35.10%	0.0737	18.43%	1.048
B02	B01	122.10	8.00	0.015	142.97	142.97	0.0004	0.475	0.470	0.31	46.80%	0.1128	24.00%	1.088
B01	B21 (PUM)	201.00	8.00	0.015	142.66	142.66	0.0006	0.154	0.270	0.20	29.55%	0.1142	42.30%	2.043

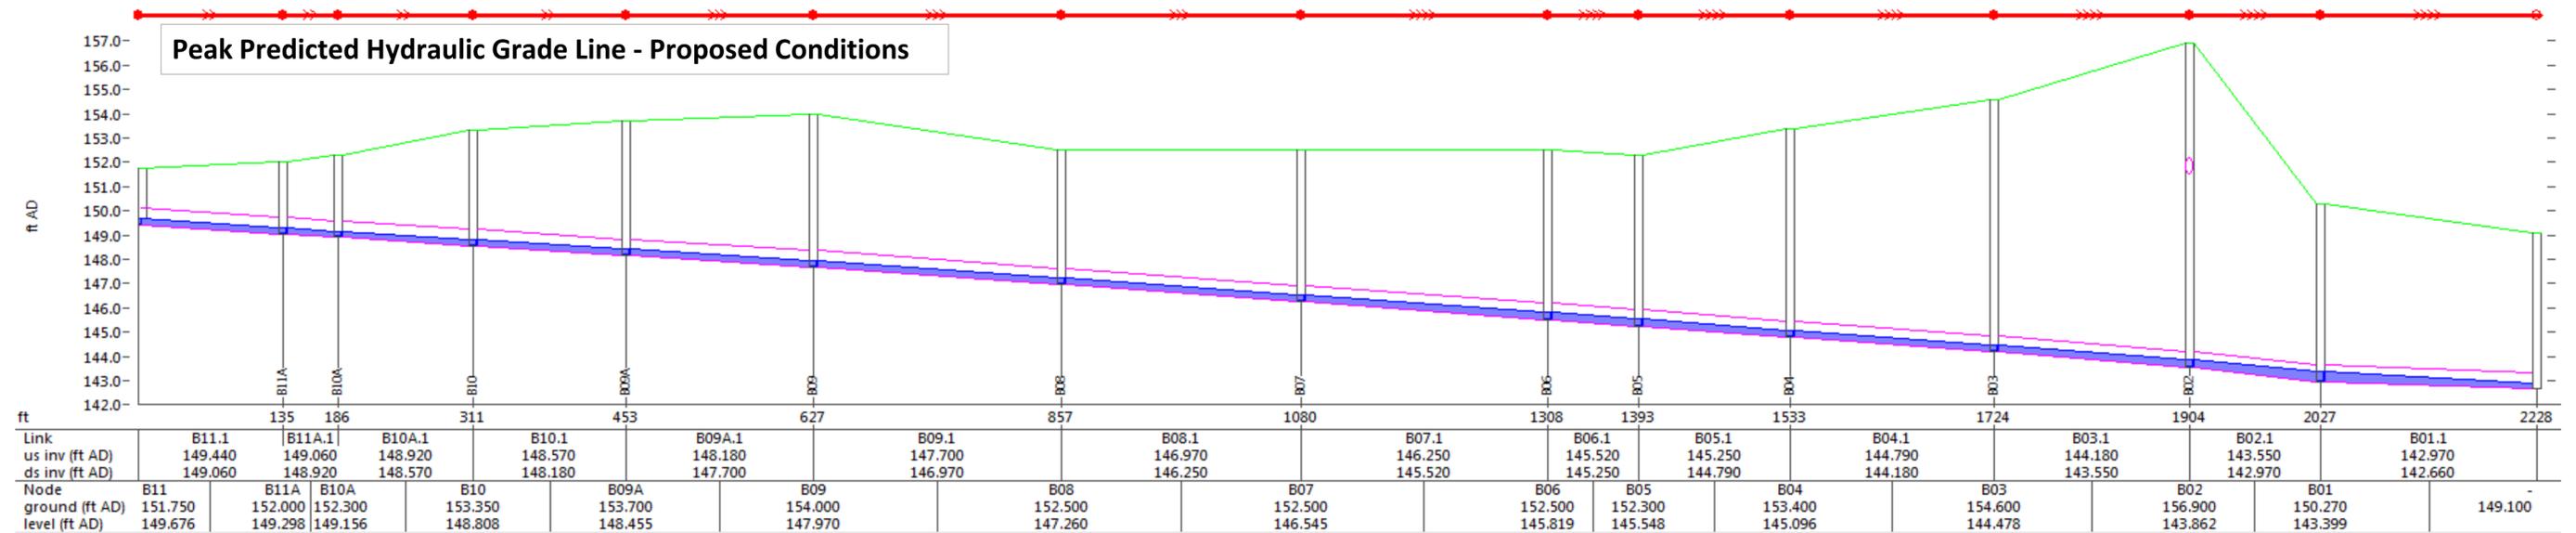
**RESULTS WITH POWDER MILL PLACE DEVELOPMENT**

US Node ID	DS Node ID	Length (ft)	Diameter (in)	Manning's Roughness	US Invert (ft AD)	DS Invert (ft AD)	Infiltration (MGD)	Gradient (%)	Conduit full capacity (MGD)	Max DS Depth (ft)	Depth/Diameter	Max DS Flow (MGD)	Flow/Capacity	Max DS Velocity (ft/s)
B11	B11A	134.50	8.00	0.015	149.44	149.06	0.0004	0.283	0.360	0.24	35.66%	0.0885	24.58%	1.226
B11A	B10A	52.00	8.00	0.015	149.06	148.92	0.0002	0.269	0.350	0.24	35.46%	0.0886	25.32%	1.237
B10A	B10	124.90	8.00	0.015	148.92	148.57	0.0004	0.280	0.360	0.24	35.75%	0.0889	24.70%	1.227
B10	B09A	141.90	8.00	0.015	148.57	148.18	0.0004	0.275	0.350	0.28	41.25%	0.0900	25.71%	1.025
B09A	B09	173.60	8.00	0.015	148.18	147.70	0.0005	0.276	0.360	0.27	40.50%	0.1179	32.75%	1.373
B09	B08	230.40	8.00	0.015	147.70	146.97	0.0007	0.317	0.380	0.29	43.50%	0.1222	32.16%	1.297
B08	B07	222.50	8.00	0.015	146.97	146.25	0.0007	0.324	0.390	0.30	44.25%	0.1446	37.08%	1.500
B07	B06	228.40	8.00	0.015	146.25	145.52	0.0007	0.320	0.380	0.30	44.85%	0.1489	39.18%	1.520

B06	B05	84.50	8.00	0.015	145.52	145.25	0.0003	0.320	0.380	0.30	44.70%	0.1521	40.03%	1.559
B05	B04	140.40	8.00	0.015	145.25	144.79	0.0004	0.328	0.390	0.31	45.90%	0.1532	39.28%	1.519
B04	B03	190.50	8.00	0.015	144.79	144.18	0.0006	0.320	0.380	0.30	44.70%	0.1573	41.39%	1.612
B03	B02	180.60	8.00	0.015	144.18	143.55	0.0005	0.349	0.400	0.31	46.80%	0.1581	39.53%	1.532
B02	B01	122.10	8.00	0.015	142.97	142.97	0.0004	0.475	0.470	0.43	64.35%	0.1963	41.77%	1.280
B01	B21 (PUM)	201.00	8.00	0.015	142.66	142.66	0.0006	0.154	0.270	0.26	39.00%	0.1978	73.26%	2.431

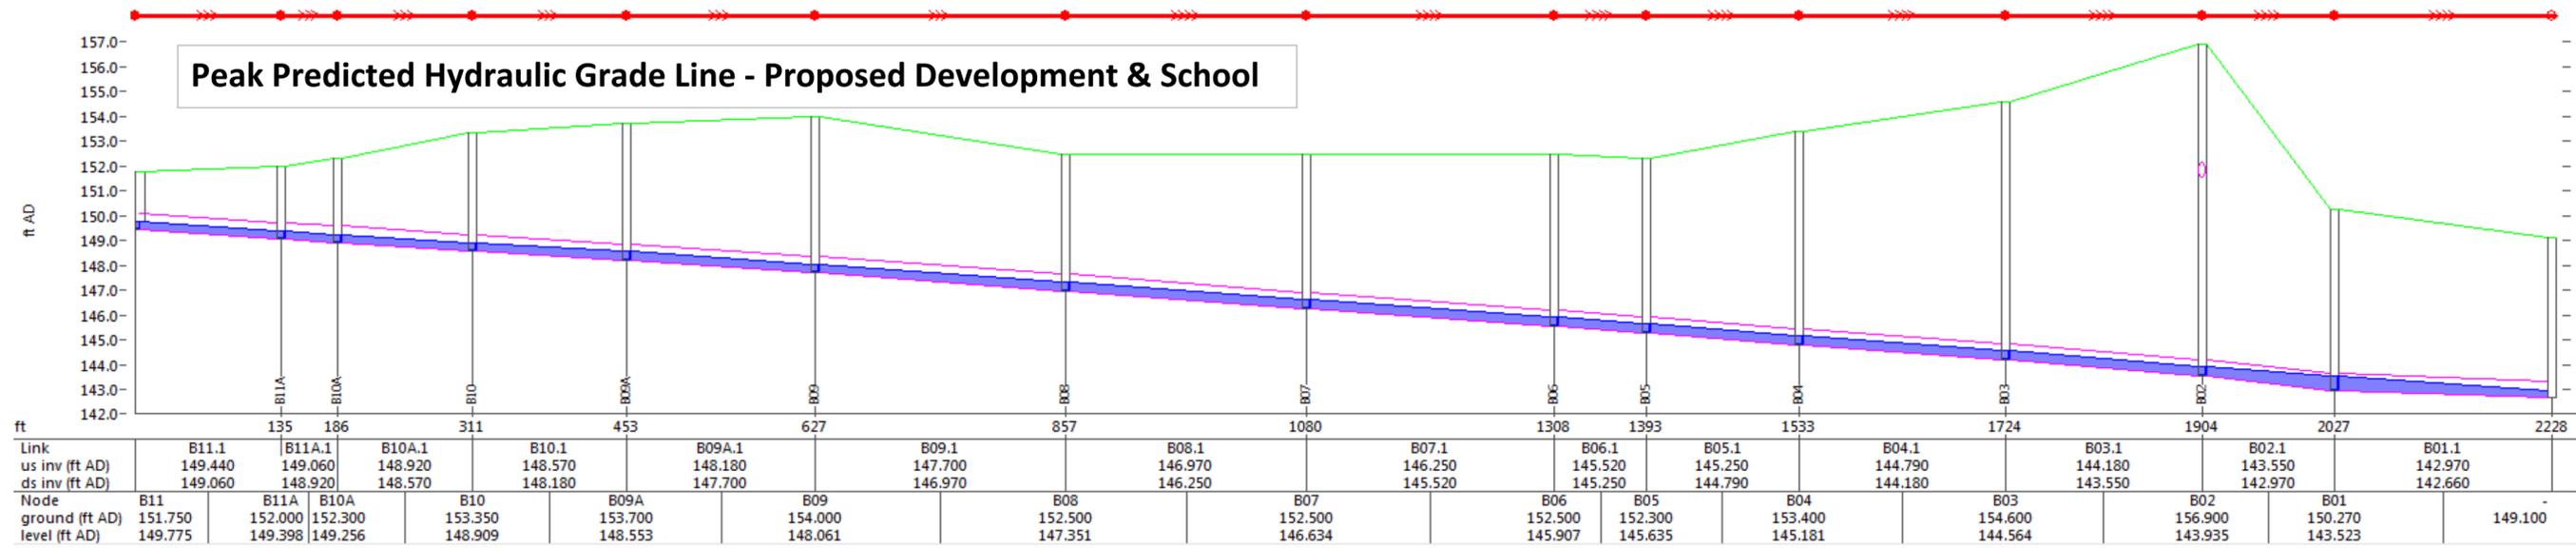
Link	B11.1	B11A.1	B10A.1	B10.1	B09A.1	B09.1	B08.1	B07.1	B06.1	B05.1	B04.1	B03.1	B02.1	B01.1
us inv (ft AD)	149.440	149.060	148.920	148.570	148.180	147.700	146.970	146.250	145.520	144.790	144.180	143.550	142.970	142.660
ds inv (ft AD)	149.060	148.920	148.570	148.180	147.700	146.970	146.250	145.520	144.790	144.180	143.550	142.970	142.660	-
